AA2016-3

**AIRCRAFT ACCIDENT
INVESTIGATION REPORT**

**SHIN NIHON HELICOPTER CO., LTD.
J A 6 7 4 1**

CRASH AFTER COLLISION WITH POWER TRANSMISSION LINES
DURING LEAVING FROM HOVERING
SHIN NIHON HELICOPTER CO., LTD.
AEROSPATIALE AS332L1 (ROTORCRAFT), JA6741
KIHOKU TOWN, KITAMURO GUN, MIE PREFECTURE, JAPAN
AT AROUND 10:51 JST, MARCH 6, 2015

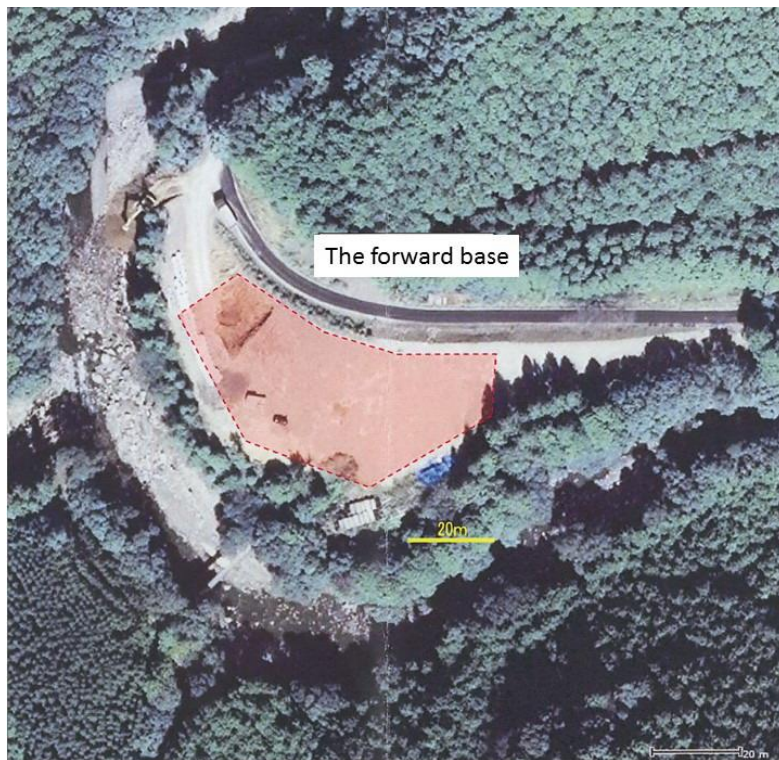
(Photo 1: The forward base (Provided by the Company))

That the forward base is located in the position as close to the unloading site as possible and with wide space accommodating vehicles in order to shorten the course of loads transportation by helicopter and reduce opportunities of crossing the power transmission lines with loads slung outboard. It is not a temporary helipad and thus landing is not permitted. (See Photo 1)

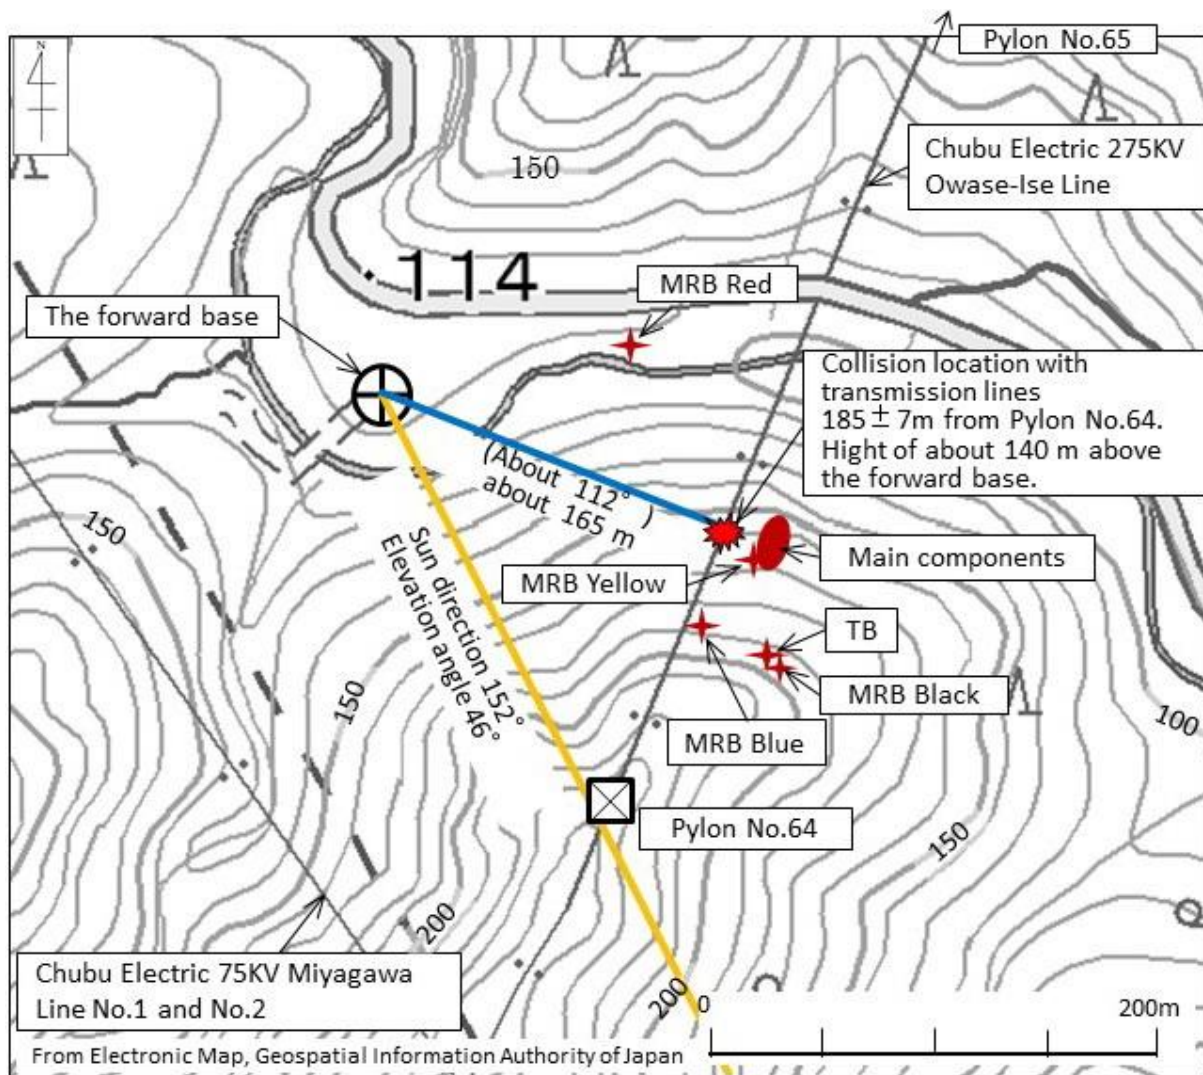
(Figure 3: Situation near the accident site)

The direction of Pylon No.64 from the forward base is about 150°, and the horizontal distance between them is about 200 m. The height difference is about 150 m between the forward base and the top of Pylon No.64, and thus the elevation angle is about 37°. (See Figure 3)

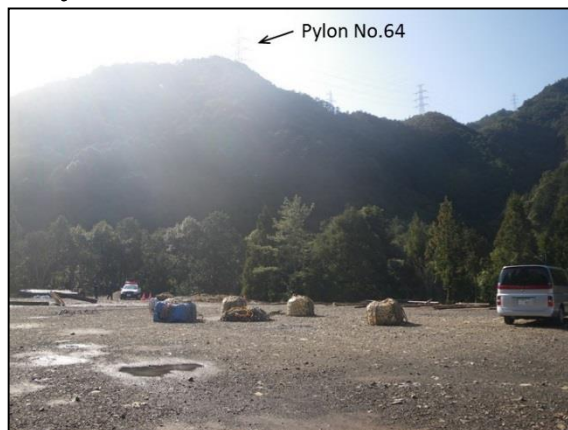
(Photo 8: View of Pylon No. 64 from the Forward Base (Photographed at 09:22, March 8, 2015))

The direction (all of directions in this report are true bearing) and height of the sun relative to the forward base at the time of the accident were calculated based on the nautical almanac issued by Hydrographic and Oceanographic Department, Japan Coast Guard, and found to be direction of 152° and elevation angle of 46°.

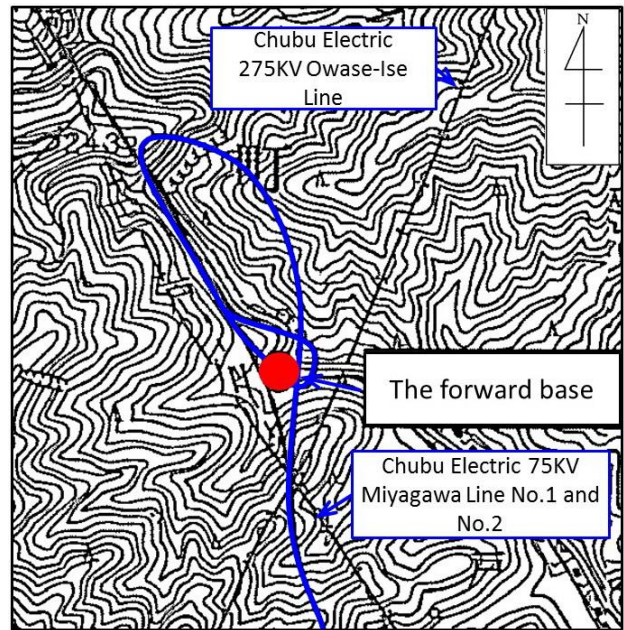
(Figure 7: figure indicating Flight Route Attached in the Application Form (The part of flight route is colored, and names of power transmission lines and display of north are added.))

Regional Civil Aviation Bureau by the Company, the Company was permitted to fly at the altitude less than the minimum safety altitude for the flight of the accident by Osaka Regional Civil Aviation Bureau. The application form described, "*Regarding the crossing (flying above) of power transmission lines, the permission is obtained from the electric company, and if the lines clearly visible, the Helicopter flies above the electric wires between pylons, otherwise it flies above the pylon after confirming the pylon number (displayed at the upper part).*" According to the figure attached in the application form, the leaving route from the forward base was a route where the Helicopter once left and turned to the northwest and then passed above the vicinity of the Pylon No.64.

As described in 2.13.2, the leaving route from the forward base in the application form approved by Osaka Regional Civil Aviation Bureau was a route in which the Helicopter once flew to the northwest and passed above the vicinity of Pylon No.64; however, as described in 2.13.4, it is highly probable that the Helicopter had extremely large excessive horse power at the accident, and it is somewhat likely that the captain selected the route over the pylon or the power transmission lines in order to directly go to the Helipad. As described in 2.13.5, it is somewhat likely that the captain tried to pass over Pylon No.64 which is closest to the forward base instead of crossing the power transmission lines which are linear shaped obstacles with visual contact, as dictated by pilot's common sense. As described in Figure 3 and 2.12.4, however, there was the sun in the direction towards the Pylon No.64, which was too dazzling for the pilot to directly look ahead; therefore, it is somewhat likely that he turned about 40° to the left and went in the direction of the power transmission lines with which the Helicopter collided.
