**AIRCRAFT SERIOUS INCIDENT
INVESTIGATION REPORT**

**Shin Nihon Helicopter Co., Ltd.
J A 6 7 4 1**

DROPPING OF OBJECT

DURING EXTERNAL CARGO SLING OPERATION

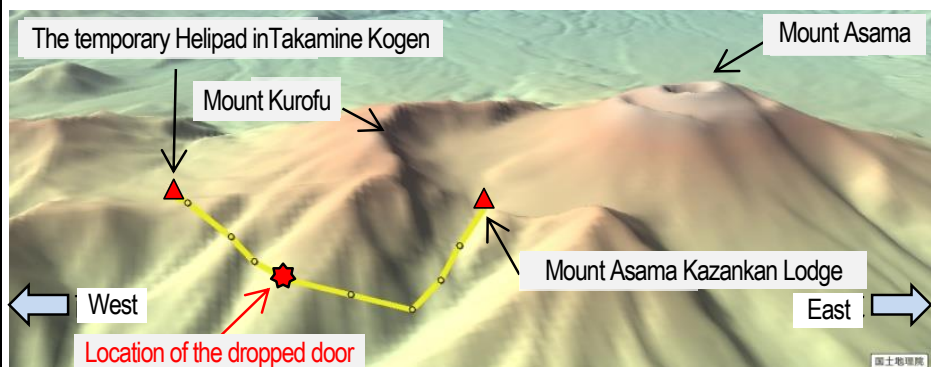
Fig. 2.1-1 Estimated flight route (3D)

The flight route was as follows: the Rotorcraft needed to gain altitude soon after departing the Helipad to fly over a mountain ridge, then it flew descending along the mountain surface and flew around the southern ridge of Mount Kurofu in a wide circling manner and flew over the site. During the flight, stable condition was maintained in the air and the Rotorcraft did not shake during flight. The Rotorcraft flew at the speed of about 60 kt, where loads could be stayed in stabilized condition during sling transport operation. On the fourth unloaded operation at the site, some assistant ground workers found that one of the hut's doors was disappeared. Meanwhile, the Captain and the mechanic had not noticed of drop of the door during the flight.

The company confirmed by checking video footage of the surveillance camera after completing the operation that a piece of door dropped around the mid-way between the Helipad and the site at 11:38.
