**AIRCRAFT ACCIDENT
INVESTIGATION REPORT**

**CHUBU REGIONAL BUREAU, MINISTRY OF LAND,
INFRASTRUCTURE, TRANSPORT AND TOURISM
(OPERATED BY CONTRACTED NAKANIHON AIR SERVICE)**

J A 6 8 1 7

HARD LANDING
CHUBU REGIONAL BUREAU, MINISTRY OF LAND,
INFRASTRUCTURE, TRANSPORT AND TOURISM
(OPERATED BY CONTRACTED NAKANIHON AIR SERVICE)
BELL 412EP (ROTORCRAFT), JA6817
UPSTREAM OF NAGASHIMA DAM TEMPORARY HELIPAD
KAWANEHON-CHO, HAIBARA-GUN, SHIZUOKA PREFECTURE,
JAPAN
12:54 JST, JUNE 29, 2012

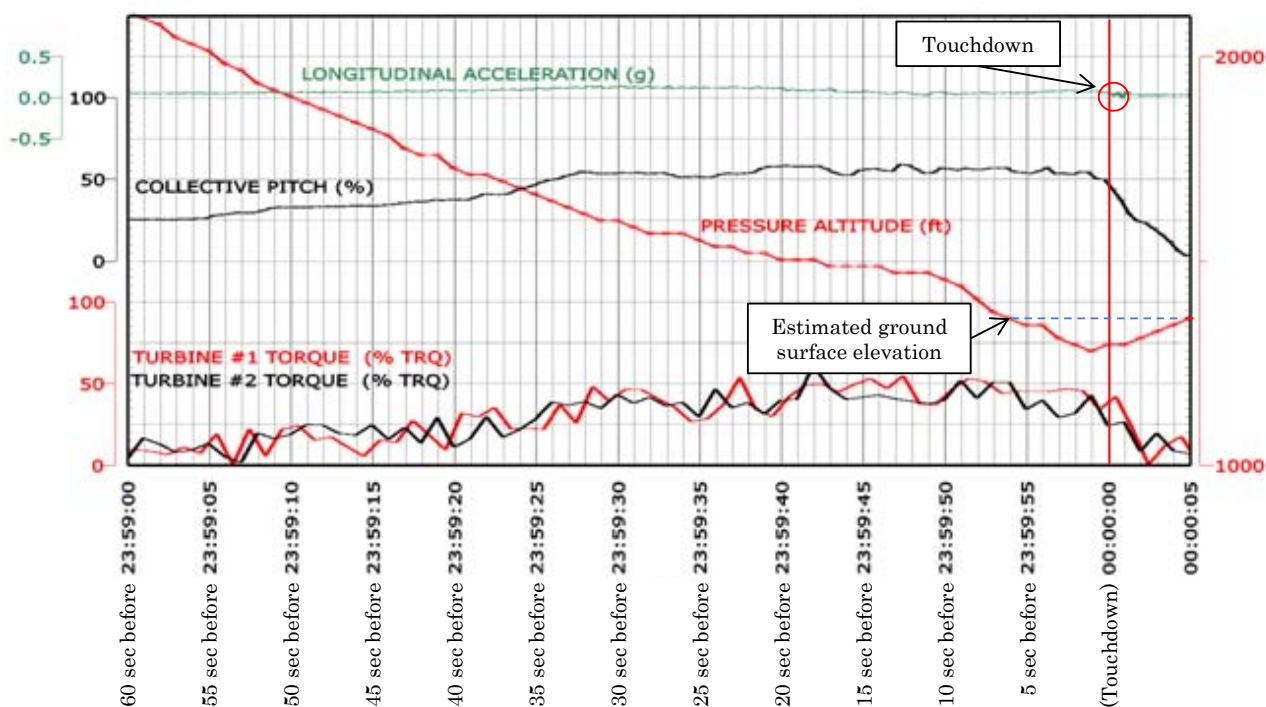
Diagram 3: DFDR Data at Time of the first Landing

During the first landing, although the CP position was about 26% at 55 seconds before touchdown (The touchdown on Diagram 3 where sudden change in longitudinal acceleration is observed.), it increased from that point just as for the landing during the accident, reaching 34% at 45 seconds before touchdown, 46% at 35 seconds before, 54% at 30 seconds before, and

58% at 20 seconds before, at that point reaching its maximum output position and then remaining at or near that position until touchdown.

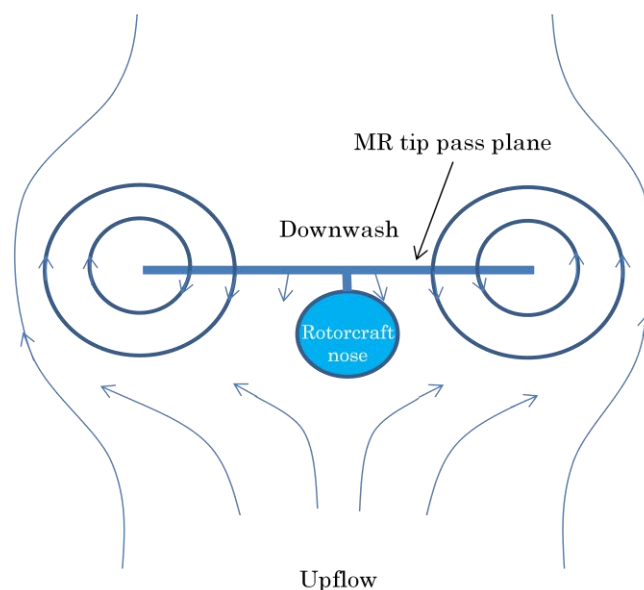
Diagram 4: Condition of Air Currents during Increasing Descent Rates at Low Speeds

In general, when a rotorcraft increases its descent rate at low speeds, the downwash from the main rotor (hereinafter referred to as “MR”) collides with the upward-flowing air currents generated by the descent, creating currents that flow from the MR’s lower surface around to its upper surface (vortices) at the MR tip. By attempting to increase lift under these conditions, even if the CP is pulled, the downwash will not move below the MR, instead flowing around from the lower surface to the upper surface of the MR and preventing an increase in lift. A helicopter will actually end up descending by its own downwash instead, possibly leading to an increase in descent rate. This condition is generally known as the vortex ring state (hereinafter referred to as “VRS”), or as settling with power, and the conditions for its occurrence are expressed as either a ratio between the induced velocity, which is the speed of the downwash, and the vertical velocity or a ratio between the induced velocity and the forward airspeed.

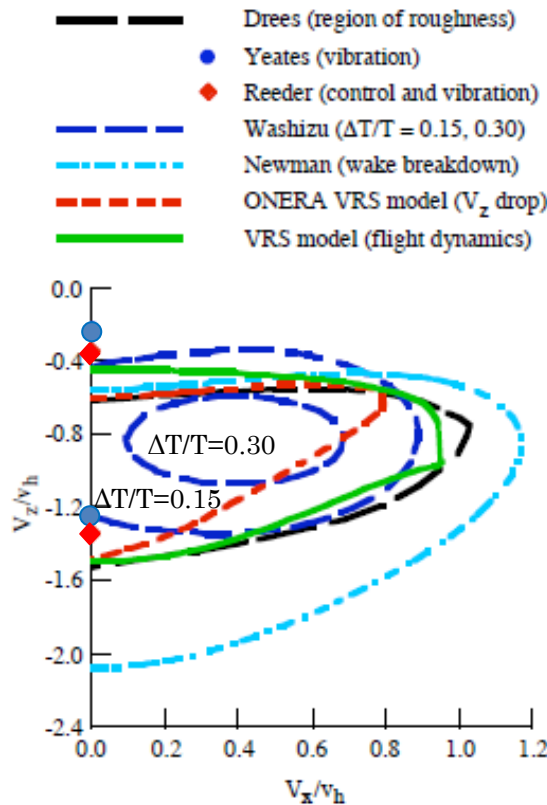
Figure 33. Vortex ring state boundaries.

A number of the boundaries that have been proposed for vortex ring state are presented in Figure 33. The boundary from the ONERA VRS model is based on the V_z drop encountered in helicopter flight tests. The boundary for the VRS model of the present investigation is based on the flight dynamics stability of helicopters and tiltrotors. The other boundaries are based primarily on the vibration and roughness that a helicopter encounters in VRS. Of particular note are the boundaries that Washizu constructed for $\Delta T/T = 0.15$ and 0.30 (ref. 30), which are found in numerous documents on VRS (including the U.S.Army Field Manual FM 1-203, Fundamentals of Flight). (omitted)

As the airflow was smooth on the day of the accident, it is firstly possible that the cause of the inability to stop the sinking of the Helicopter due to its high descent rate, and of the resulting hard landing, could have been a failure to begin pulling the CP in enough time to allow sufficient compensation for the downward inertial forces on the Helicopter before touchdown. However, in this case, the Pilot began pulling the CP by a significant amount at 10 seconds before touchdown, and nearly sufficient power output for hovering was achieved at five seconds before touchdown at 100 ft AFL. Under normal conditions, the descent rate is reduced before touchdown by the ground effect generated as the Helicopter approaches the ground, and by the effects of increasing the power output, but as also shown by the DFDR data, in this case touchdown was made with no decrease in descent rate. Judging from this, it is probable that the cause of the hard landing was not a lateness in the pulling of the CP; on the contrary, a condition in which the power output was increased but there was no increase in MR lift, suggesting the occurrence of VRS as described in 2.9.3.

After the Helicopter's flight at conditions outside of the VRS boundaries during the latter half of its base leg as indicated by ① in Diagram 6, it is probable that along with the decrease in speed it experienced when entering its final approach, the descent rate indicated by ② began to approach 55% of the induced velocity, entering into the VRS boundaries.

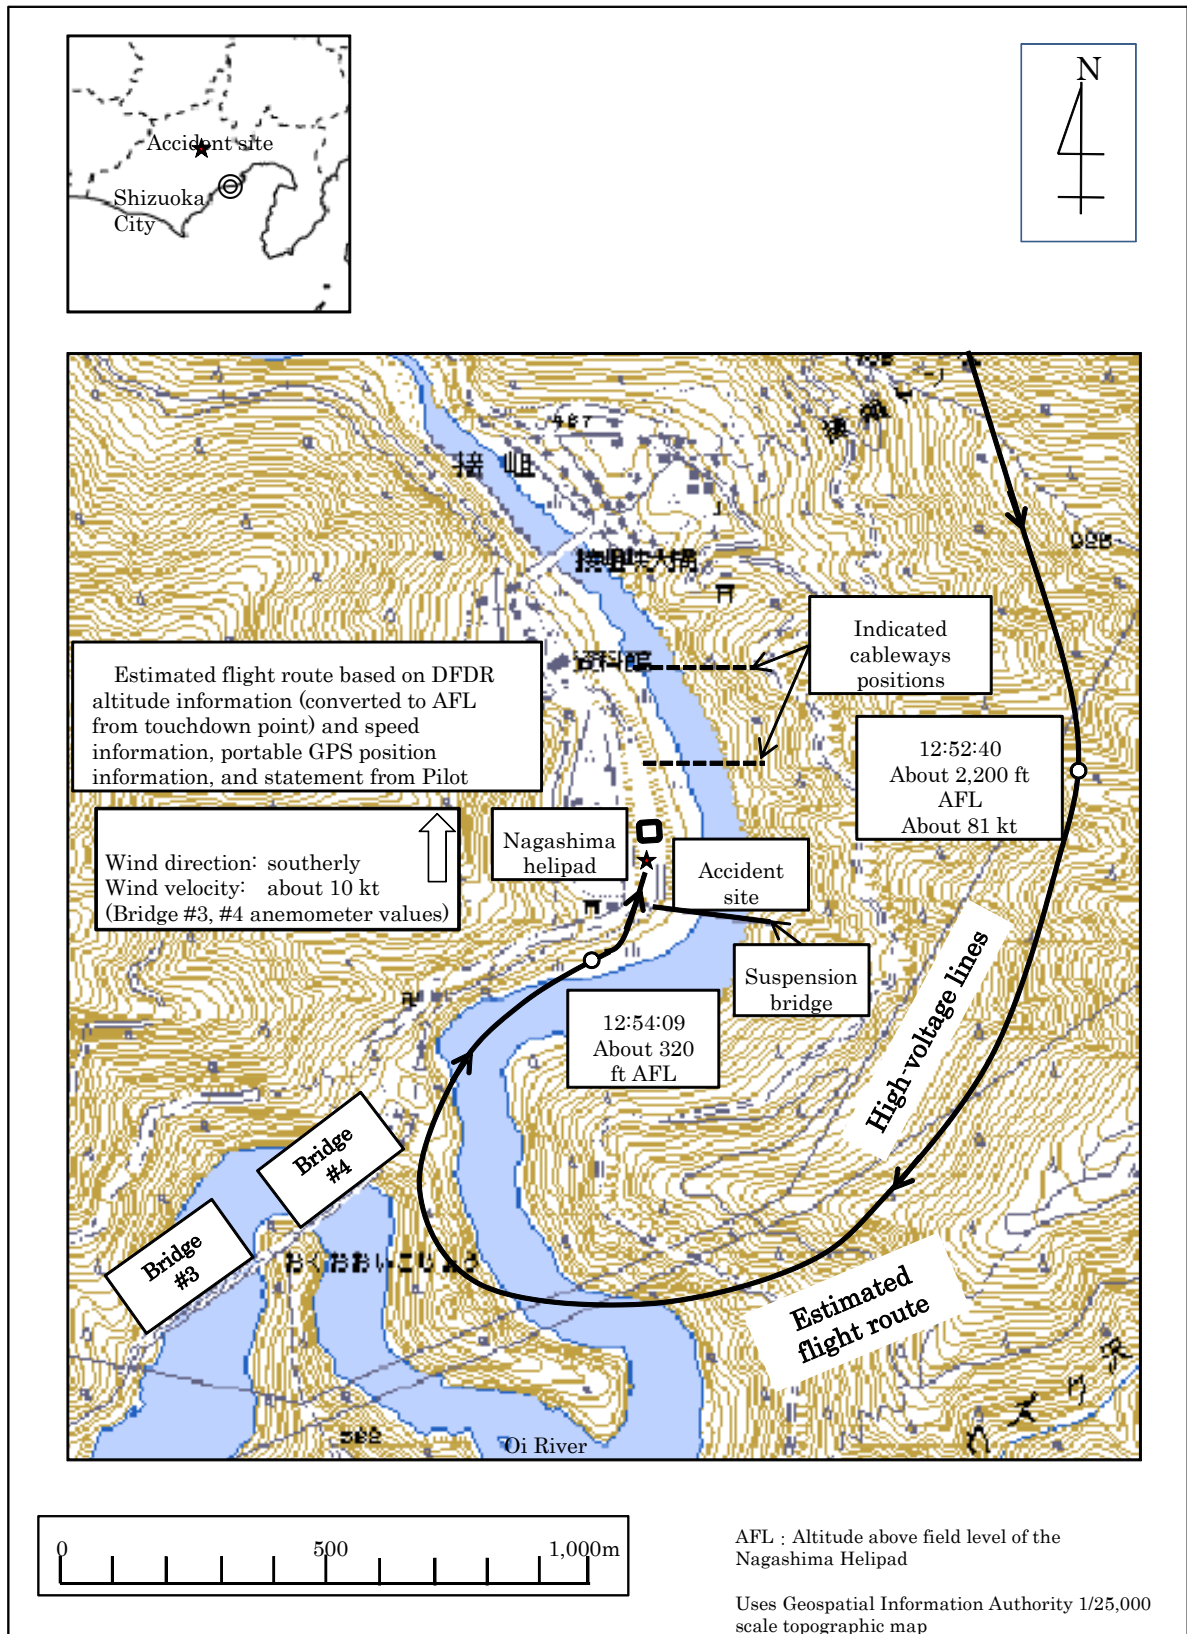
Figure 1: Estimated Flight Route

From these conditions, making an approach from a comparatively high altitude with a target in front of the unmarked helipad, it is probable that the resulting approach was made at a high angle. From the distance between the final portable GPS position data (16 seconds before touchdown) described in 2.9.1 b. and the touchdown point (222.7 m), and the altitude recorded by the DFDR at the same time (320 ft AFL), the approach angle for the final approach is estimated at about 23.7°, which is a considerably high angle when compared with the approach surface gradient (1/4) of about 14° of the Nagashima Helipad's

As described in 2.9.2 b., from a time of 50 seconds before touchdown during the latter half of the base leg, the Helicopter continued to maintain a high descent rate of about 1,300 ft/min while approaching at a high angle, which corresponds to about 55% of the induced velocity. Also, as described in 3.3, the wind at the time of approach was a tailwind. Under such wind conditions, it is probable that maintaining a high approach angle would have led to a significantly high descent rate. Also, because the starting altitude of the final approach was high, it is probable that the Pilot would have needed to increase the descent rate to manage the Helicopter's altitude, and it is possible that he may not have noticed an unexpectedly large increase in descent rate arising from the tailwind conditions.

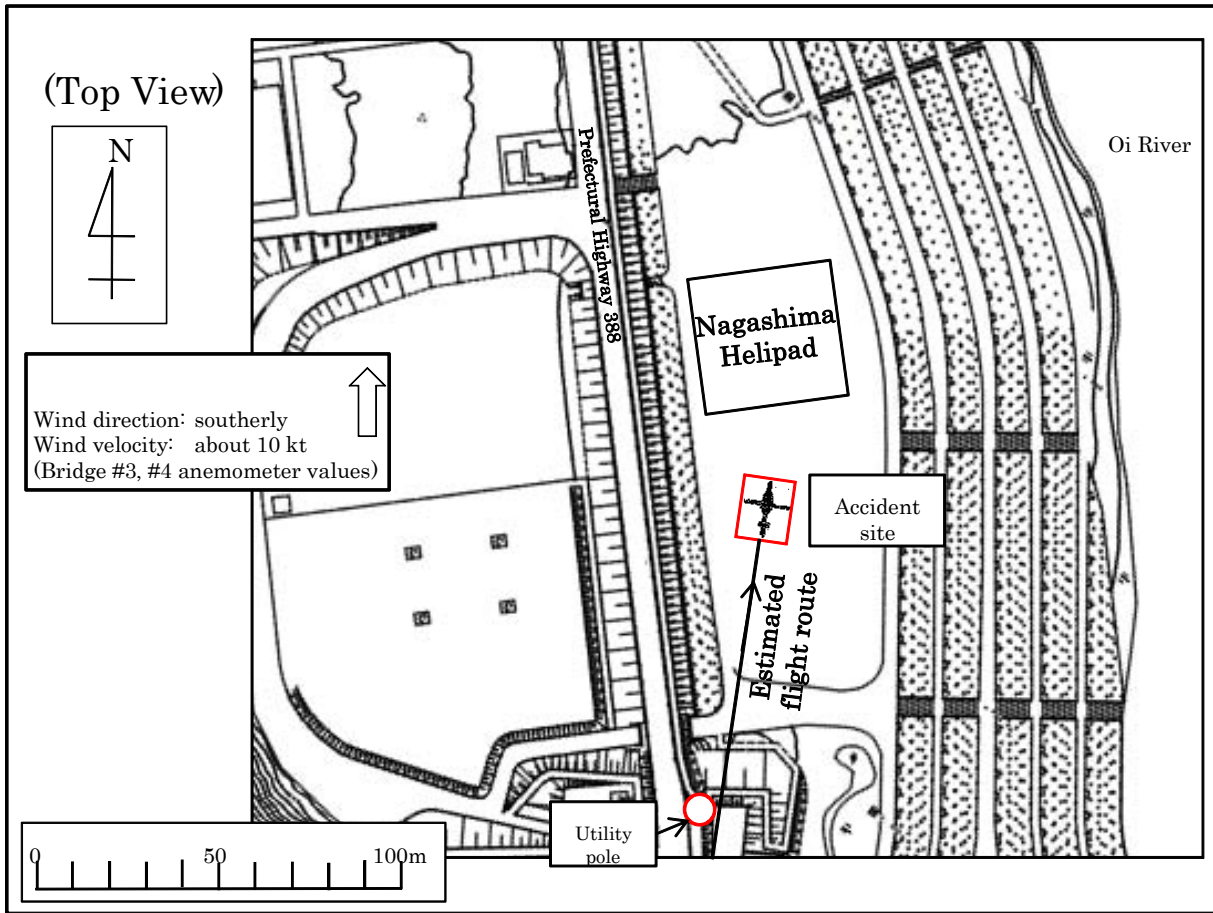
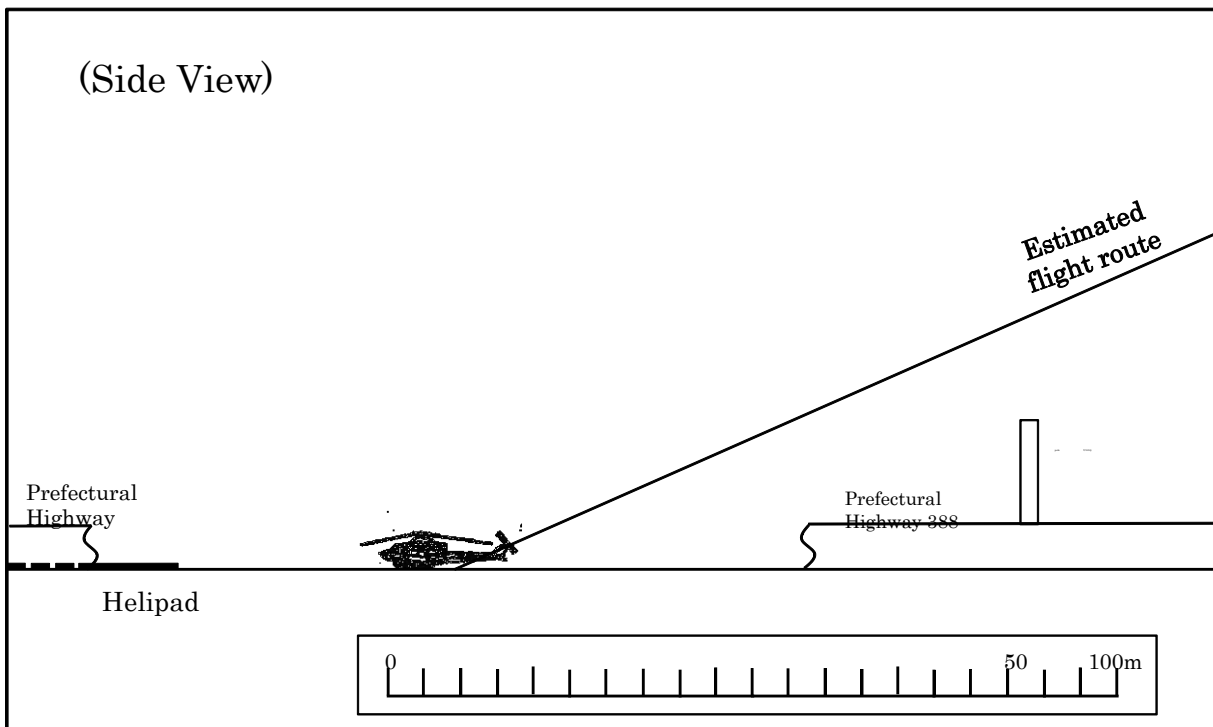
Figure 2: Accident Site Layout

According to the Pilot's statement in 2.1.2 a., when landing at Nagashima Helipad for the first time, he determined that the wind was calm from the conditions of the nearby trees, etc, and avoided a southward approach that would pass over hardly visible cableways indicated to the north of Nagashima Helipad, deciding to use a northward approach instead. For the approach at the time of the accident, because there were no windsocks set up on the Helipad, the Pilot could not make an accurate evaluation of the wind, but determined that the wind was calm just as during the first landing. From the south he passed through a relatively low area between a suspension bridge and a road, making the approach on a northward route with as shallow a pass as possible.

Judging from this, the Pilot probably believed from the conditions of the nearby trees, etc. that the wind was not strong, and without having an accurate grasp of the wind conditions, made a northward approach with a tailwind of about 10 kt as described in 3.3, passing over an easily-visible suspension bridge.
