**AIRCRAFT ACCIDENT  
INVESTIGATION REPORT**

**JAPAN COAST GUARD**

**J A 6 9 0 3**

**SIKORSKY S-76C (rotorcraft), JA6903**

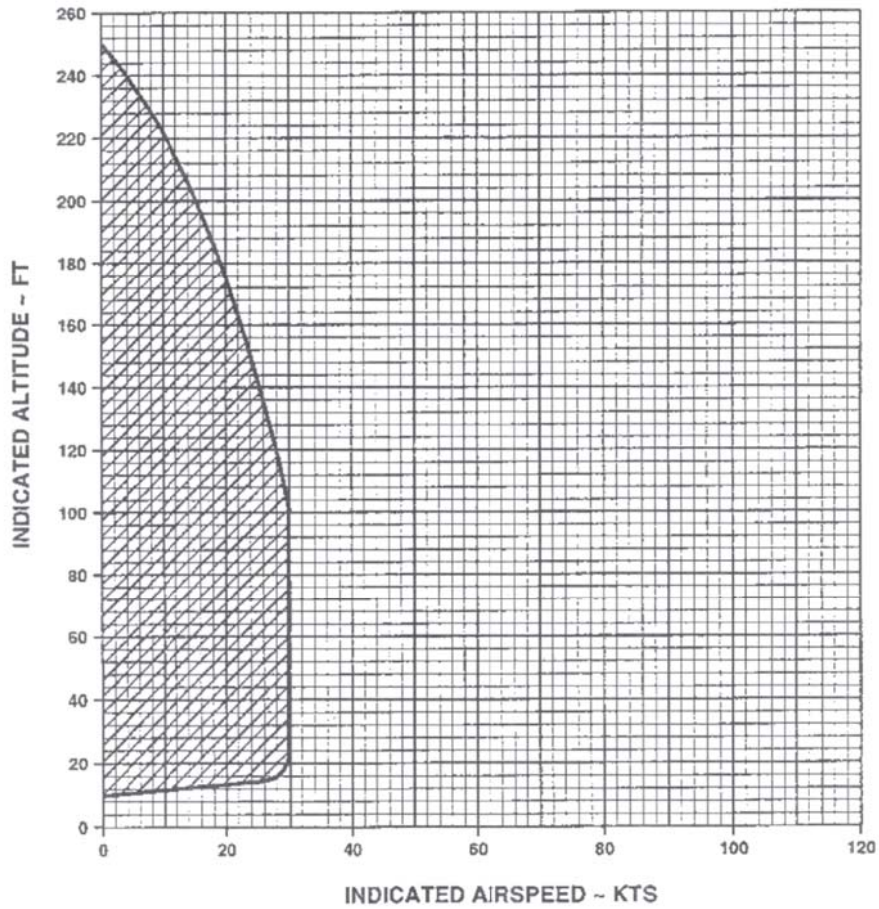
Figure 3 Height/Velocity diagram

**LIMITING HEIGHTS AND CORRESPONDING  
SPEEDS FOR SAFE LANDING AFTER AN  
ENGINE SUDDENLY BECOMES INOPERATIVE**

NOTE: AVOID FLIGHT WITHIN SHADED AREA EXCEPT AFTER INITIATING FLARE FOR A NORMAL LANDING.
