AIRCRAFT ACCIDENT INVESTIGATION REPORT
INJURY TO A GROUND OPERATOR DURING CARGO SLING
OPERATION

SHIKOKU AIR SERVICE CO., LTD.

BELL 412EP (ROTORCRAFT), JA6977

MIYAKONOJO CITY, MIYAZAKI PREFECTURE

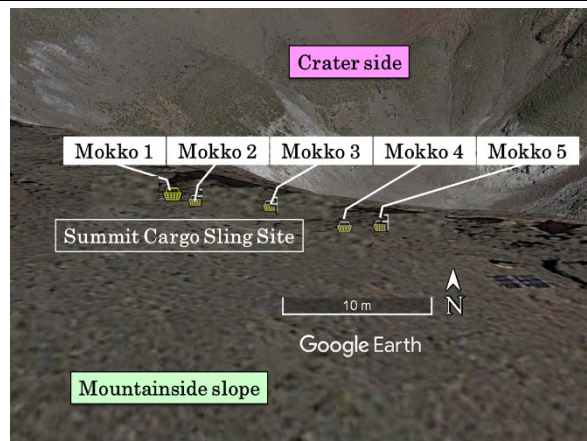
Figure 2: Mokko Location

As the weather improved, the helicopter took off from the Operation Site at about 10:48 for the 1st Heli Cargo Transport, hovering over at a heading of about 70° about 20 m short (west side) of Mokko 1 among five pieces of Mokko (called Mokko 1 to 5 in order from the west). At this time, it was confirmed that there would be no problem with the five-meter length of sling to be used (see Figure 2 and Figure 3).

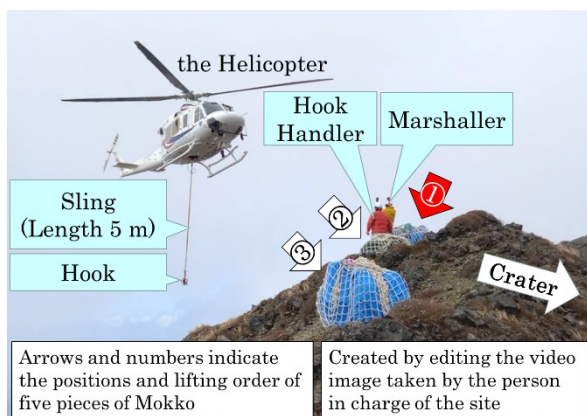
Figure 3: Marshaller and Hook Handler

At the Summit Cargo Sling Site, five ground operators including the person in charge of the site (described later in Table 1 in 2.7 (1)) were deployed, among whom are a summit marshaller (hereinafter referred to as “the Marshaller”) and a handler hooking cargo (hereinafter referred to as “the Hook Handler”), two people in total were engaged in the work by entering in the area underneath the helicopter. In addition, from the helicopter, the Marshaller was located viewed on the left side of Mokko 1 (west side) and the Hook Handler on the right side (hereinafter, the descriptions indicating the directions, which are used for explaining the position and their movements of Mokko 1 and operators working around it, such as (front, back, ahead of, behind, right and left) shall be described as viewed from the helicopter unless specified otherwise.) (See Figure 3).

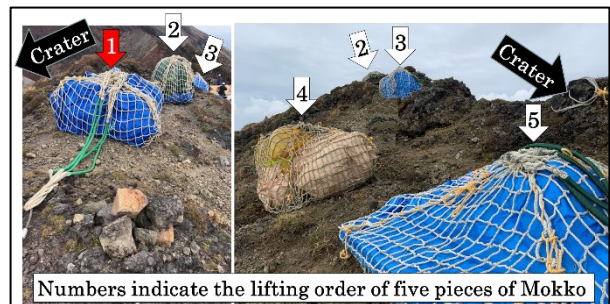
Figure 9: Summit Sling Cargo Site

The Summit Cargo Sling Site is set up along the ridge of the crater within the restricted area, the ground surface is slippery with large and small volcanic gravel piled up, and rough terrain.

Five pieces of the Mokko were placed in the range of about 23 m in the direction of east-southeast looking from Mokko 1, and Mokko 1 was placed at the highest elevation among them (see Figure 9).

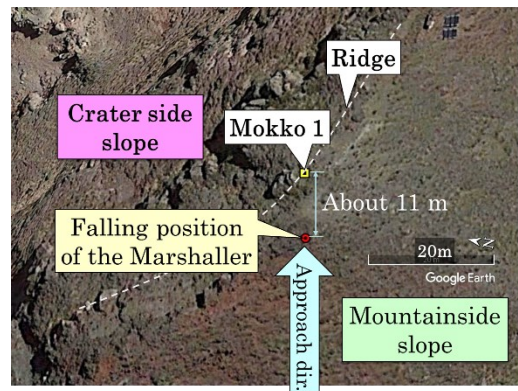
Figure 10: Topography around Mokko 1

The Mokko 1 had been placed selecting relatively plane place of the summit ridge. Around Mokko 1, there was a slope on the crater side from the left to behind and a slope on the mountainside from the right to ahead of it (see Figure 10). In addition, about 70 cmahead of Mokko 1, there was a rock with about a height of 60 cm (“a lofty rock” according to the statement of the Marshaller) (Figure 11 a).

The JTSA concludes that the reason that the Marshaller forced to remain in the position constrained topographically was possibly because all persons concerned did not properly perform hazard prediction for the sling operation such as confirming refuge area around Mokko 1.
