**AIRCRAFT SERIOUS INCIDENT
INVESTIGATION REPORT**

**ALL NIPPON AIRWAYS CO., LTD.
J A 7 0 1 A**

ENGINE INTERIOR DAMAGE
ALL NIPPON AIRWAYS CO., LTD.
BOEING 777-200, JA701A

AT AN ALTITUDE OF APPROXIMATELY 32,600 FT,
ABOUT 90 KM WEST OF TOKYO INTERNATIONAL AIRPORT
AT AROUND 08:44 JST, DECEMBER 13, 2013

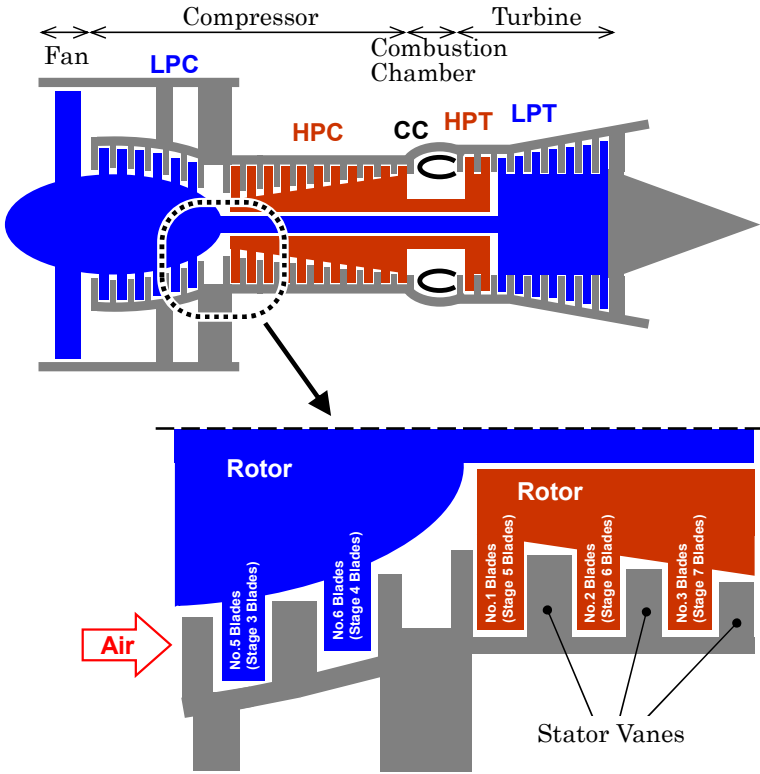
PW4074 Engine (Schematic Diagram)

The Engine is a two-spool turbopfan engine and consists of Fan, Low Pressure Compressor (LPC), High Pressure Compressor (HPC), Combustion Chamber (CC), High Pressure Turbine (HPT), and Low Pressure Turbine (LPT).

The Fan has one stage, and the LPC is made of six stages in total. There was no damage in the fan blades and the first stage (stage 1.1) through the fifth stage (stage 3) blades of LPC in the fore. In the sixth stage (stage 4) blades of the LPC, all of the blades exhibited trailing edge damage including nicks, dents, tears.

The HPC is made of 11 stages in total. The first stage blades of HPC (stage 5) were severely damaged around the entire periphery of disc, and all the blades were either fractured at the airfoil roots, or missing from the grooves for installing the blades on the disk (hereinafter referred to as “slot”). All the blades of the second stage (stage 6) blades of HPC were fractured at the airfoil roots. There was also a damage in the area aft the second stage blades of HPC that were probably caused by the fractured blades of the first and the second stage blades of HPC.
