**AIRCRAFT ACCIDENT
INVESTIGATION REPORT**

**JAPAN COAST GUARD
J A 7 2 7 B**

DAMAGE TO THE AIRFRAME DURING LANDING JAPAN COAST GUARD, BOMBARDIER DHC-8-315, JA727B SENDAI AIRPORT AT ABOUT 15:58 JST, MAY 30, 2015

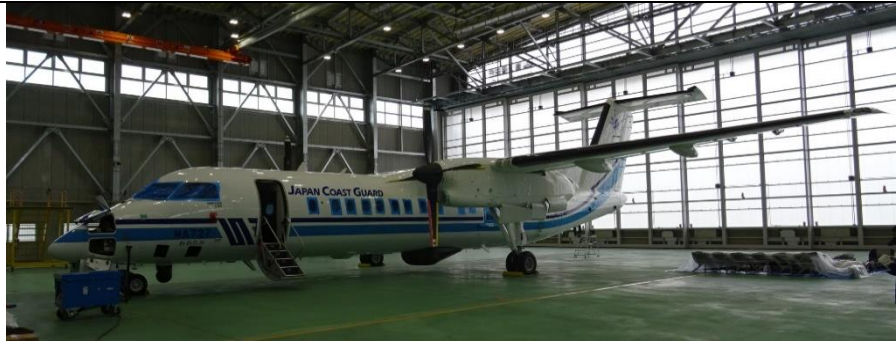
Photo 1 The aircraft

<p>2.2 Injuries to Persons</p>	<p>None</p>
<p>2.3 Damage</p>	<p>Extent of damage of the aircraft : Substantially damaged</p> <ul style="list-style-type: none"> • Nose landing gear The bottom of strut was partly attrition, components of shock strut were broken and deformed marks of both tires. • Fuselage Left and right fuselage skins of the airframe were deformed in the rear of the nose landing gear mounting areas.
