AIRCRAFT ACCIDENT INVESTIGATION REPORT

AIRCRAFT DAMAGE DUE TO ROLLOVER DURING LANDING

ROBINSON R22 BETA (ROTORCRAFT), JA7875

TOYAMA CITY, TOYAMA PREFECTURE

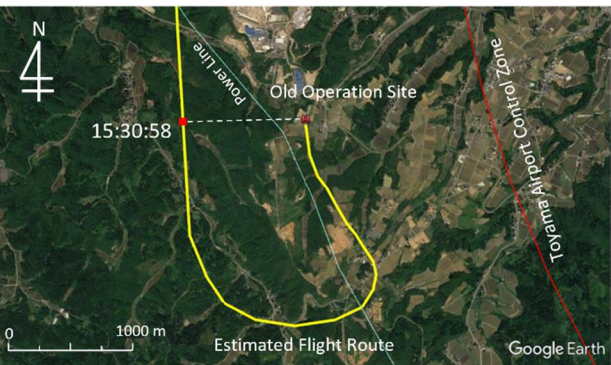
Figure 2: Estimated Flight Route before the Helicopter's Rollover (Based on the statement of the pilot)

At 15:32, as shown in Figure 2, as the helicopter approached the Old Operation Site from its south side, it encountered a strong westerly wind and lost directional control shortly before touchdown, rolling over with its leaning against the grapevine shelves on the east side.

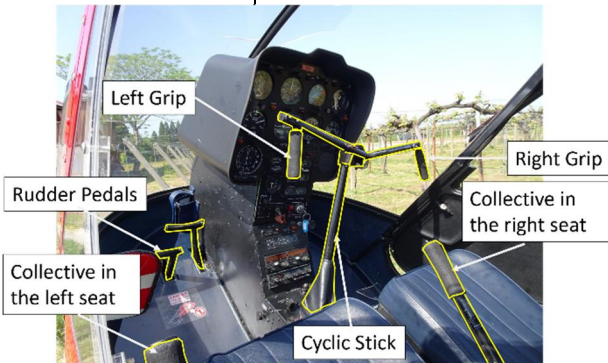
Figure 12: Cockpit of the Helicopter

The Robinson R22 Beta's control system has a single cyclic stick in the center, with cyclic grips connected on both sides at the top as a pivot point. The left and right cyclic grips can be operated by moving in parallel to the center mounted stick. For example, if the right grip is operated at a position slightly above the knees, the left grip is designed to be raised and is therefore at a different height to that normally operated on the right seat. The cyclic stick does not tilt when the grip is moved up or down like a steering wheel. Collectives are provided for each seat and connected by a rod. The left and right pedals are connected by a rod, but the pedal control is not linked to the Cyclic and collective. In addition, it is possible to remove the left seat pilot controls, but the helicopter's left seat pilot controls had been left in place to allow the pilot in the left seat to control the helicopter, as shown in Figure 12.

many cases where the flight control performed in the left seat caused excessive flight control inputs, resulting in the rollover accident, therefore, it is probable that a pilot without a flight instructor certificate should avoid controlling from the left seat.
