**AIRCRAFT ACCIDENT  
INVESTIGATION REPORT**

**PRIVATELY OWNED  
JA7907**

AIRFRAME DAMAGED BY ROLL-OVER UPON LANDING  
ODAIRA, ITOIGAWA CITY, NIIGATA PREFECTURE, JAPAN  
AT AROUND 15:13 JST, MARCH 18, 2017

PRIVATELY OWNED  
ROBINSON R44 (ROTORCRAFT), JA7907,

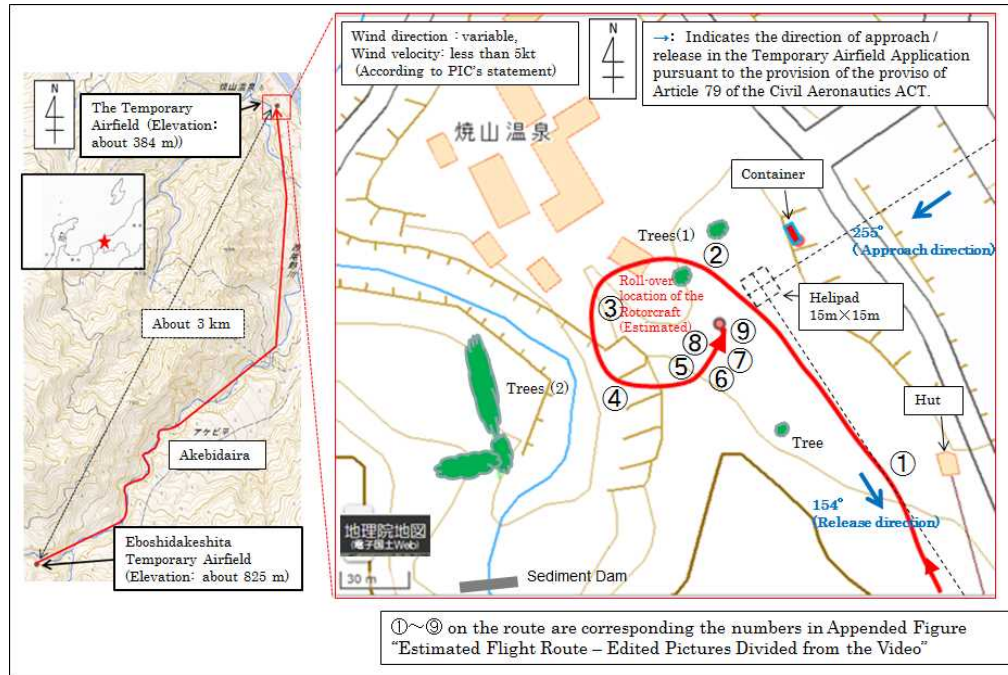
Figure 1: Estimated Flight Route  
(According to the video , pictures and statements)

After taking off, in repeating changing its course, the Rotorcraft flew at a low AGL along the downhill slope of the valley in the mountains. At around 15:12, climbing a little from around Akebidaira and checking visually the Temporary Airfield, the Rotorcraft approached it from the south-southeast. (See Figure 1: the left one and ①) Afterward, passing over the Helipad, with its nose down, the Rotorcraft made a steep left turn and nosedived. However, as trees were looming in front of the Rotorcraft, in order to avoid those trees, the Rotorcraft further took a deeper bank angle, and therefore, it rapidly decreased its altitude. (See Figure 1: ② ③)). At this time, the rotor sound changed and the low rotor rpm(revolutions per minute) warning horn(hereinafter referred to as "the Warning horn", described later in 2.8(3)①) sound. (See Figure 1: ④ ⑤) Subsequently, immediately after turning its nose to the northeast with a shallow bank angle, the Rotorcraft touched the snowy slope on the southwest of the Helipad with its left side. As its main rotor touched the snowy slope on the left side and got stuck in the snow, with its rebound, the Rotorcraft rolled over and its engine stopped. (See Figure: ⑥ ⑦ ⑧ ⑨)

According to the PIC, he used to gradually descend to a low altitude as fixing his aiming point to the trees near the Helipad in his sight and make a direct approach to land at the Helipad. However, as he had a passenger shooting a video on that day, he decided to consciously attempt to approach from a little higher altitude, descend and land by turning. He remembered lowering the collective lever when the Warning horn rang, however, he did not understand why the Warning horn rang. As the altitude was deemed enough, the PIC descended but only to find that the Rotorcraft has touched down on the snowy surface.

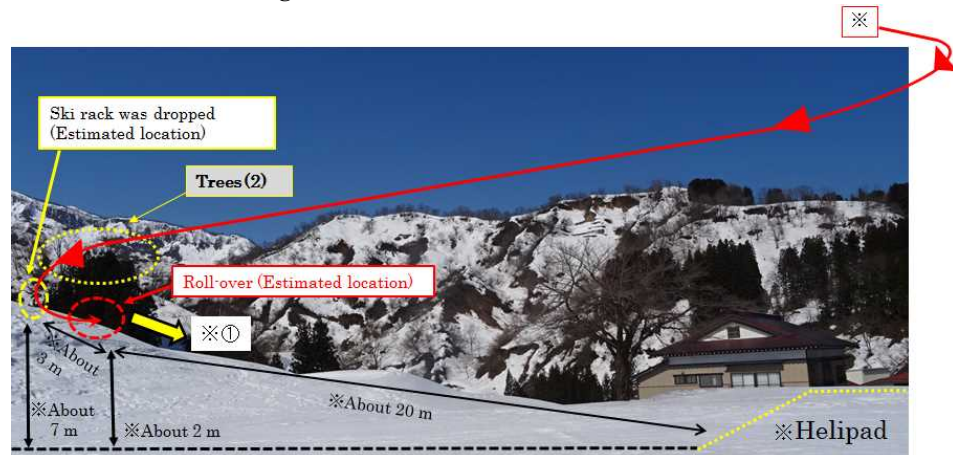
Figure 3: Situation in the Accident Site

It is also probable that the ski rack was dropped out from the fuselage about three meters southwest of the roll-over location along the snowy slope and the height was about seven meters from the Helipad.

Seen from the roll-over location on the snowy slope, the Helipad (Container side in the northeast) and the slope come together in the snow and looked all flat. (See Figure 3)

※ Image (Scale, estimated flight route and the Helipad are indicated as reference)
