AIRCRAFT ACCIDENT INVESTIGATION REPORT

CRASH PRIVATELY OWNED ROBINSON R22 BETA, JA7975 HADANO CITY, KANAGAWA PREFECTURE AT ABOUT 06:48 JST, OCTOBER 7, 2021

December 20, 2024

Adopted by the Japan Transport Safety Board

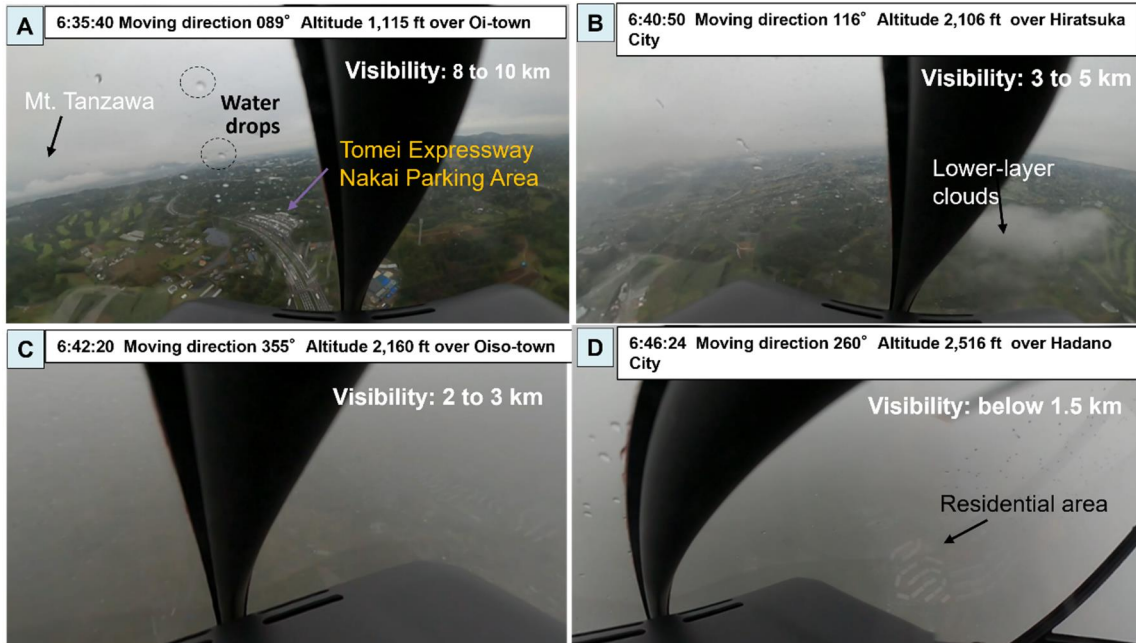
Figure 5: Clouds Conditions as Seen from the Cockpit and Estimated Flight Visibility during the Flight (created from GoPro video)

A: It was cloudy at about 1,100 ft over Oi-town, visibility was 8 to 10 km and there were drops of water on the cockpit window.

D: The ground surface was slightly visible at about 2,500 ft over Hadano City with a visibility of less than 1.5 km.

As described in 2.11.4, at high humidity and when in doubt, assuming conditions conducive to carburetor ice, carburetor heat should be applied as required. In addition, full carburetor heat should be used during run-up to preheat the induction system and as shown in the picture in Figure 5A, it is important to re-confirm that carburetor heat has been applied when it is confirmed that there are drops of water on the cockpit window in flight.

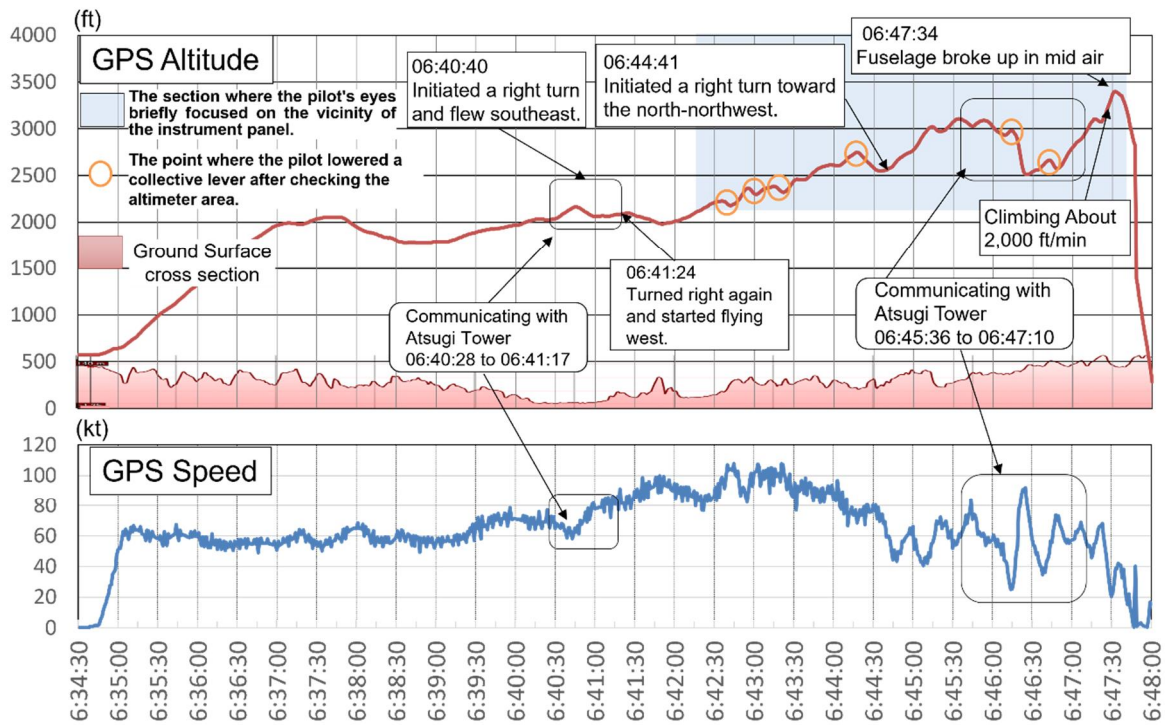
Figure 6: Changes in Altitude and Speed, and the Pilot's Line of Sight and Control Operations (based on the records on GoPro)

According to the records on the GoPro, the changes in altitude and speed from take-off to the crash were as shown in Figure 6. The pilot did not adjust the carburetor heat control lever from just before takeoff until the helicopter broke up in mid-air. In these records, from 06:42:20 to 06:47:31, the pilot's eyes were mainly around the instrument panel. In addition, there was one point where the pilot's eyes briefly focused on the vicinity of the altimeter, and then the pilot lowered a collective lever to reduce the altitude. Furthermore, just before the helicopter broke apart in mid-air, it had been climbing at approximately 2,000 ft/min from 06:47:17, and by 06:47:29, when the "LOW RPM warning" was activated, it was climbing at approximately 2,300 ft/min and had reached an altitude of approximately 3,400 ft when bringing apart in midair.

Regarding the fact that the helicopter climbed without maintaining altitude, confirmation of the pilot's line of sight with the video revealed the following the pilot's eye was directed around the instrument panel after visibility deteriorated and the horizon could not be visually confirmed, as shown in Figure 6. The speed and course were almost maintained, so it is probable that the pilot cross-checked the attitude indicator, the airspeed indicator and the directional gyro. In addition, the altitude correction points were checked by comparing the movement of the pilot's line of sight and the collective control lever down operation, which showed that there were several altitude corrections made by the collective control lever down operation, but these corrections were not fully made, thus it is probable that the change of information from the altimeter and vertical velocity indicator, located to the left of the attitude indicator, had not been properly understood.

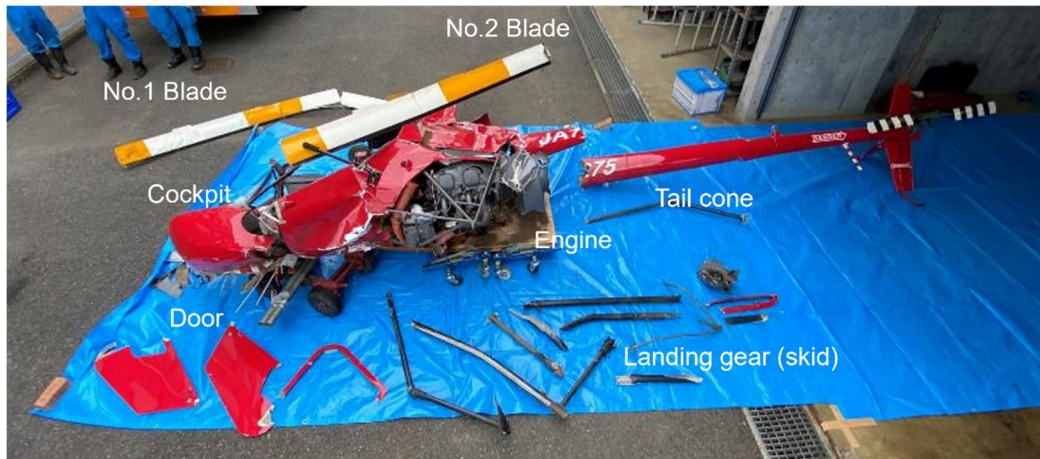
Figure 9: Damage Condition of the Helicopter after Wreckage Repositioning

- a. The mast fairing had traces of collision with the main rotor blades.
- b. The fuselage width of the aircraft was compressed and deformed from 112 cm to 90 cm.
- c. The frame of the cockpit was deformed, and the windshield and door windows were broken and scattered.
- d. The tail cone broke off at the location of the impact mark with the main rotor blades in the forward part. In addition, the horizontal stabilizers had traces of collision with the main rotor blades.

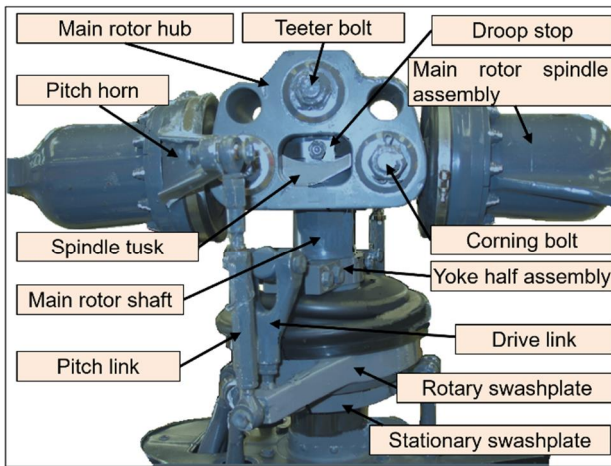
Figure 11: Properly Installed Equipment around the Main Rotor Hub

- d. The rotary swashplate on the No.1 Blade side were broken at the overhanging root. (See Figure 11, Figure 12, Figure 15, and Figure 16)
- e. The No.1 Blade pitch link was broken at the joint of swashplate and the No.2 Blade pitch link was broken at the joint of blade. (See Figure 11, Figure 12, and Figure 15)

- f. The spindle tusk of the No. 1 Blade had its tip scraped off and rotated in the direction of the underside of the No. 1 Blade, which was partially compressed and deformed. (See Figure 11 and Figure 14)

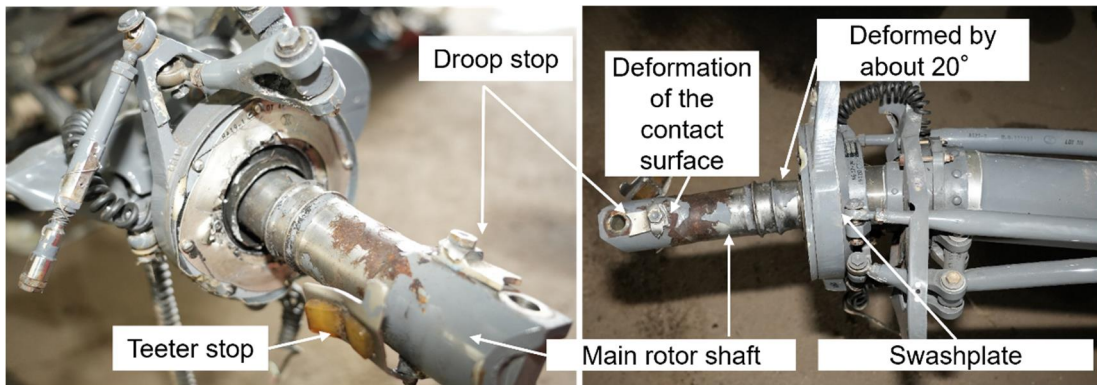
Figure 13: Deformation of the Main Rotor Shaft and Droop Stop

- b. The main rotor shaft was deformed by about 20° near the swashplate. (See Figure 13)
- c. No significant impact marks were confirmed on the surface of the main rotor shaft, but the teeter stop had impact marks and the surface in contact with the spindle tusk in the lower part of the droop stop*7 was deformed. (See Figure 13)

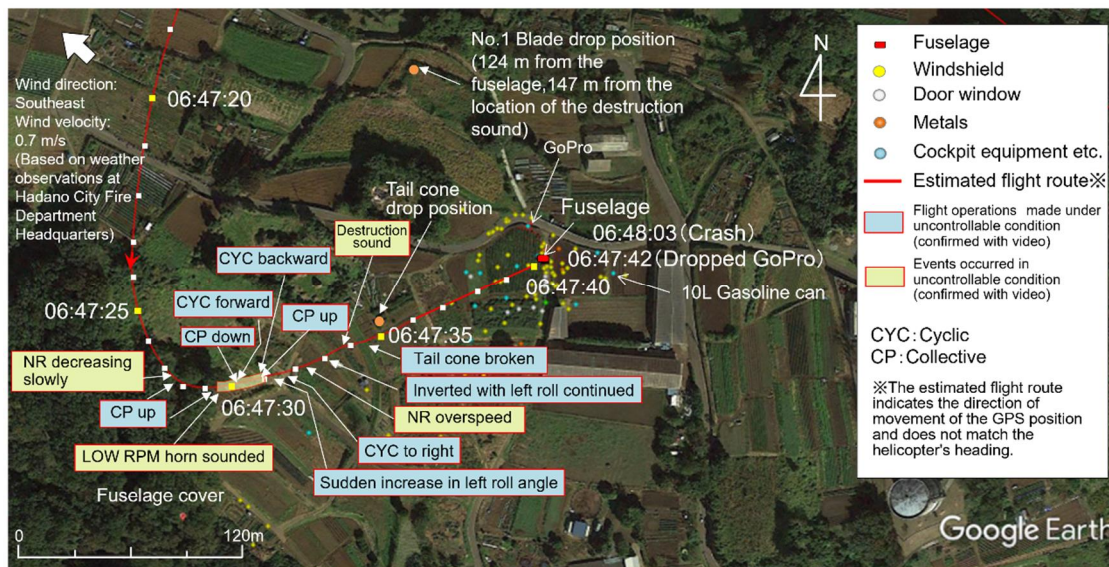
Figure 25: Comparison between the Helicopter's Estimated Flight Route before the Crash and the Wreckage Positions

Figure 1 of the Appended Figure 3 shows the metadata recorded on the GoPro graphically, synthesizing the characteristics of the pilot's flight operation confirmed by the video and the peculiar points from the acoustic analysis. In addition, Figure 25 shows the superimposition of the wreckage positions described in 2.9.1 and the events confirmed by the video on the estimated flight route of the helicopter.

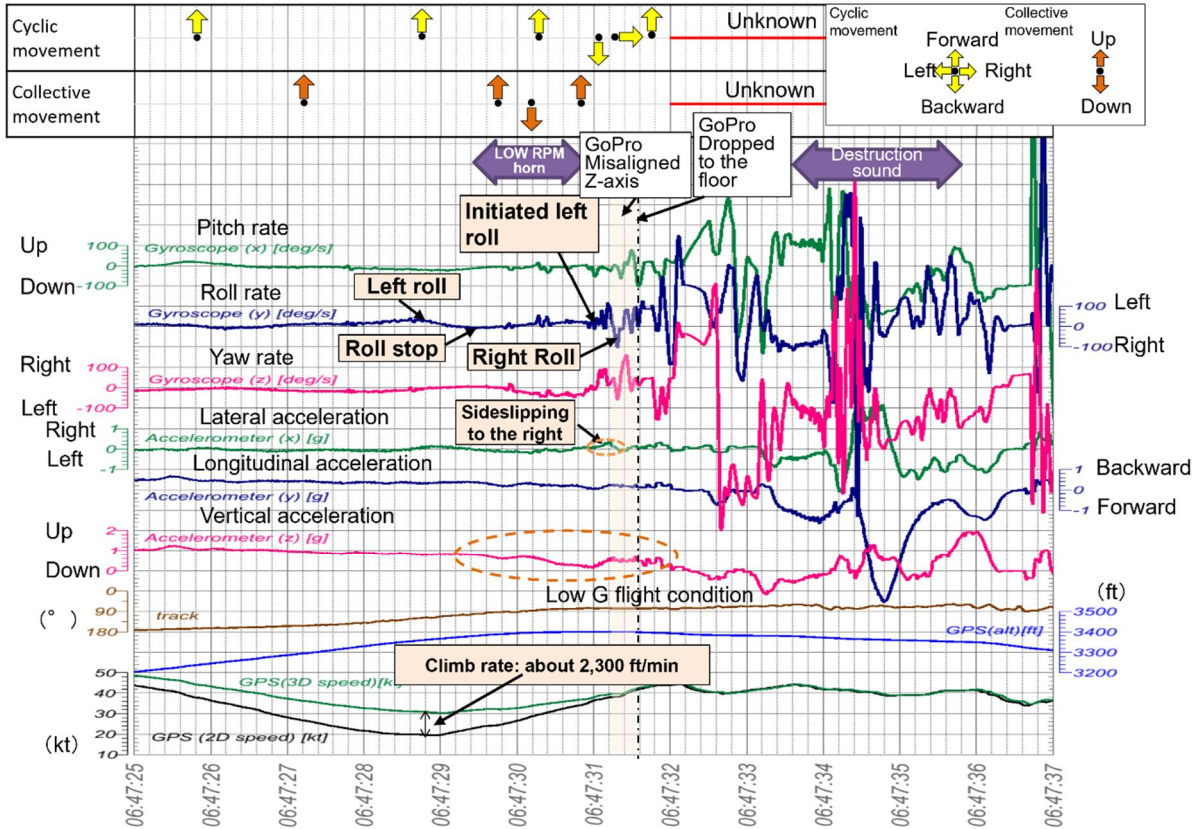
Figure 1: Analysis of the Metadata on the GoPro

The occurrence of catastrophic mast bumping was analyzed by coordinating each record with the time from the video and comparing them. The 360° video is highly distorted when displayed in its entirety, therefore it was necessary to zoom on each frame to check the feature points. Metadata is sensitive and has a high sampling rate, thus excessive amplitude of the data was excluded by using the smoothing filter value of the application software, which was set at 20 %, and the feature points were compared. However, as for the metadata, the installation angle of the GoPro was not aligned with the axis of the helicopter, thus it was necessary to correct it by checking it against the video, but it was possible to identify a dynamic change trend.
