AA2016-4

**AIRCRAFT ACCIDENT
INVESTIGATION REPORT**

**ORIENTAL AIR BRIDGE CO., LTD.
J A 8 0 1 B**

DAMAGE TO THE AIRFRAME DURING LANDING
ORIENTAL AIR BRIDGE CO., LTD.
BOMBARDIER DHC-8-201, JA801B
NAGASAKI AIRPORT
AT ABOUT 14:07 JST, FEBRUARY 12, 2014

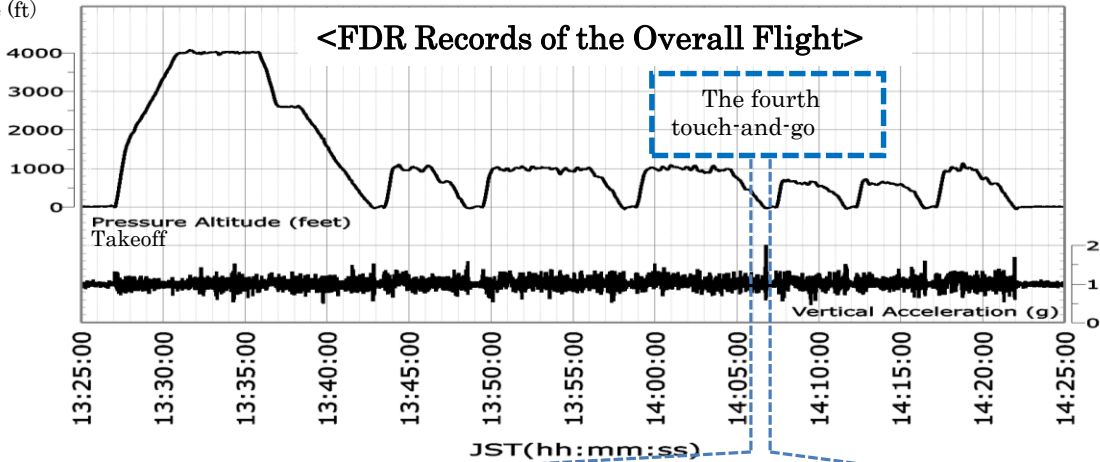
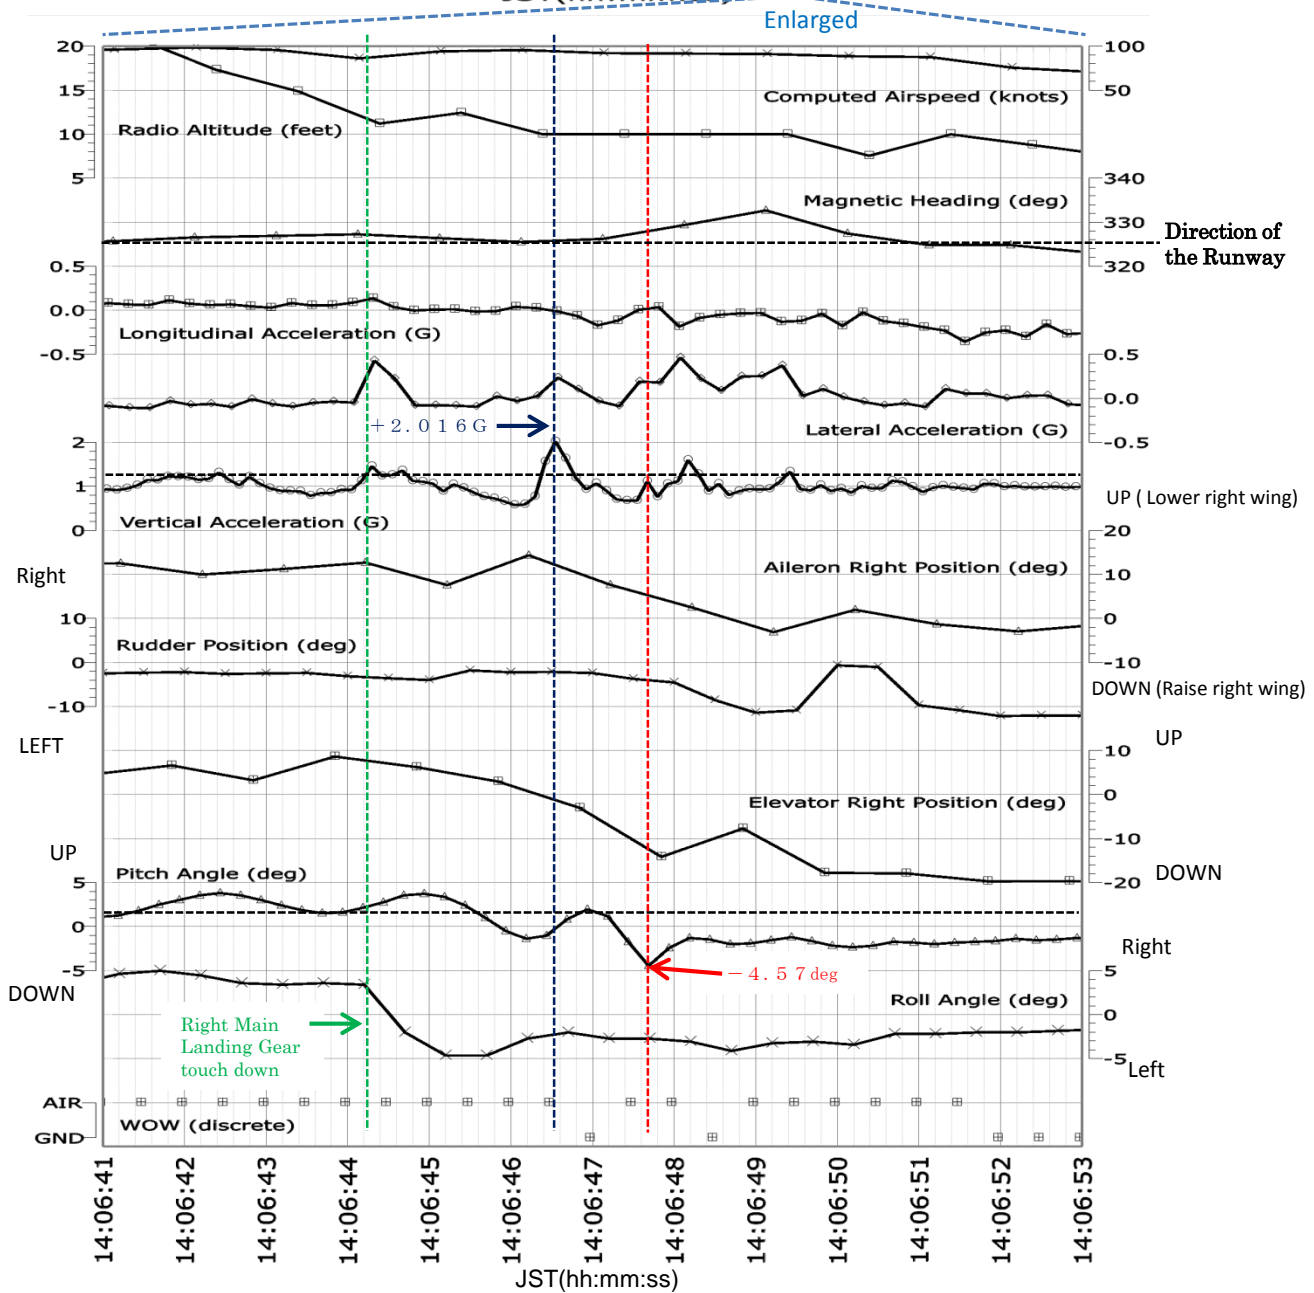
Figure 1 FDR Records

According to the statements of the captain and the trainee described in 2.1.2, the timing of the vertical and lateral acceleration changes and the significant decrease in the roll angle recorded in the FDR as indicated in Figure 1, it is highly probable that the under the crosswind situation blowing from the right, the aircraft changed from the crab method to wing low method and landed with the right landing gear first.
