**AIRCRAFT SERIOUS INCIDENT
INVESTIGATION REPORT**

**PEACH AVIATION LTD.
J A 8 0 5 P**

AIRCRAFT DISABLED TO CONTINUE TAXIING DUE TO DAMAGED NOSE LANDING GEAR PEACH AVIATION LTD. AIRBUS A320-214, JA805P AT FUKUOKA AIRPORT, JAPAN AROUND 08:11 JST, MARCH 24, 2018

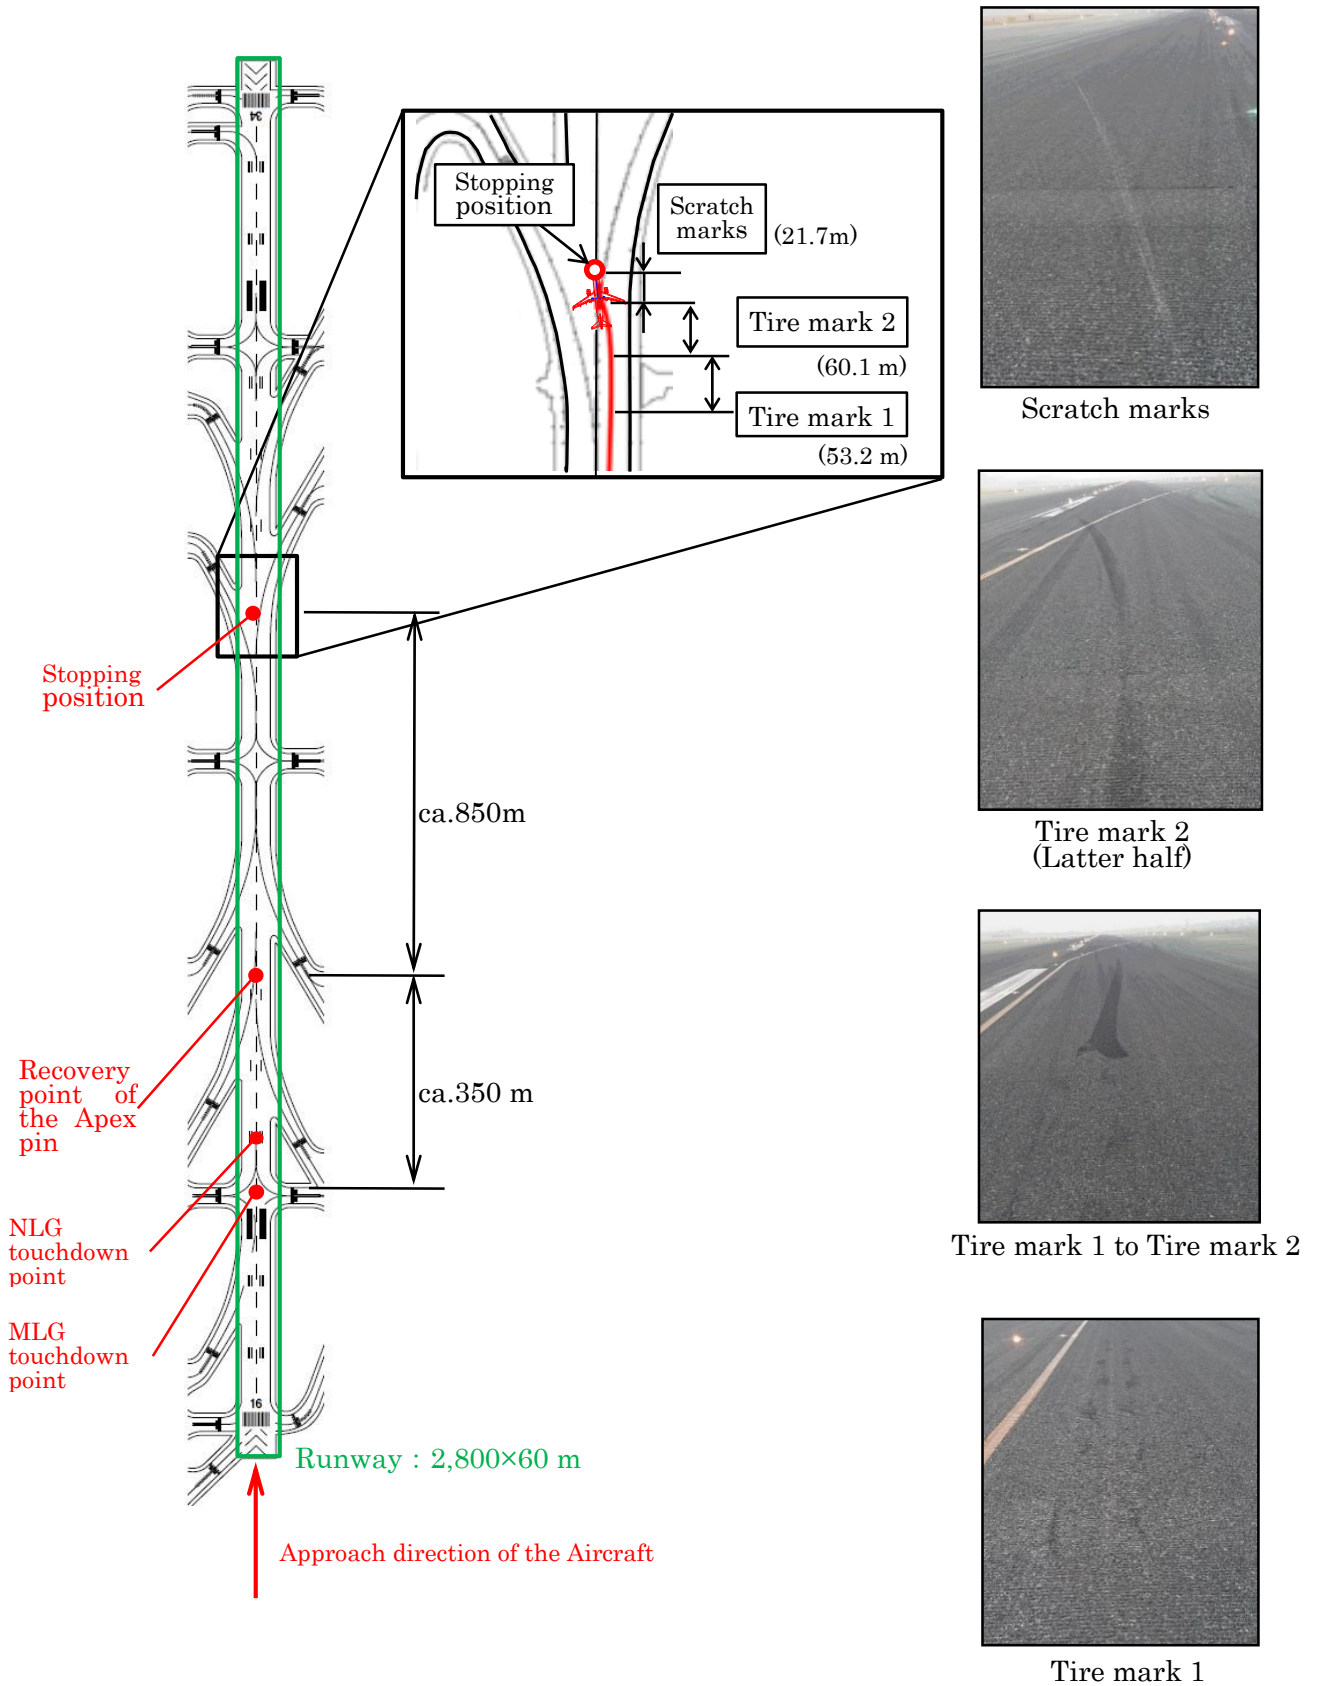
Appended Figure 1: Serious Incident Site

1.1 Summary of the Serious Incident	<p>On Saturday, March 24, 2018, an Airbus A320-214, registered JA805P, operated by Peach Aviation Ltd., was forced to stop on the runway with its nose wheel turned sideways after landing at Fukuoka Airport as a scheduled flight 151. Consequently, the aircraft was unable to continue taxiing.</p>
