**AIRCRAFT SERIOUS INCIDENT  
INVESTIGATION REPORT**

**Peach Aviation Limited  
J A 8 0 6 P**

## CASE EQUIVALENT TO LANDING ON A RUNWAY USED BY OTHER AIRCRAFT

PEACH AVIATION LIMITED, AIRBUS A320-214, JA806P  
ON RUNWAY 34L (RUNWAY A)  
AT TOKYO INTERNATIONAL AIRPORT  
AT ABOUT 01:03, NOVEMBER 30, 2019

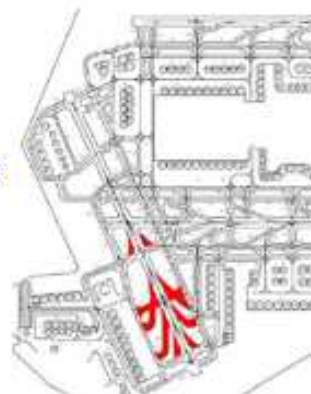
From 23:30 on November 29 to 06:00 the next day (Japan Standard Time), taxiway B3 B4 B5 B6 B8 T3 T4 T5 T6 T8 will be closed for maintenance work.

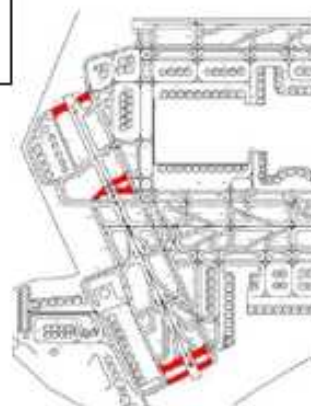
Figure 6-2: NOTAM concerning the closing of Taxiway connected Runway B

From 23:30 on November 29 to 06:00 the next day (Japan Standard time), taxiway B1 B2 B10 B11 B14 T1 T2 T11 T14 will be closed for maintenance work.
