AIRCRAFT SERIOUS INCIDENT INVESTIGATION REPORT

September 11, 2025

Adopted by the Japan Transport Safety Board

Company	Academic Corporate Body Hiratagakuen
Type, Registration Mark	Eurocopter EC135P2+ (Rotorcraft), JA824H
Incident Class	Case equivalent to “landing on an unassigned runway” Case equivalent to the item (ii), Article 166-4 of the Ordinance for Enforcement of the Civil Aeronautics Act of Japan (item (xviii) of same Article)
Date and Time of the Occurrence	At about 13:45 Japan Standard Time (JST: UTC+9 hours), August 8, 2024
Site of the Incident	On the runway at Kobe Airport

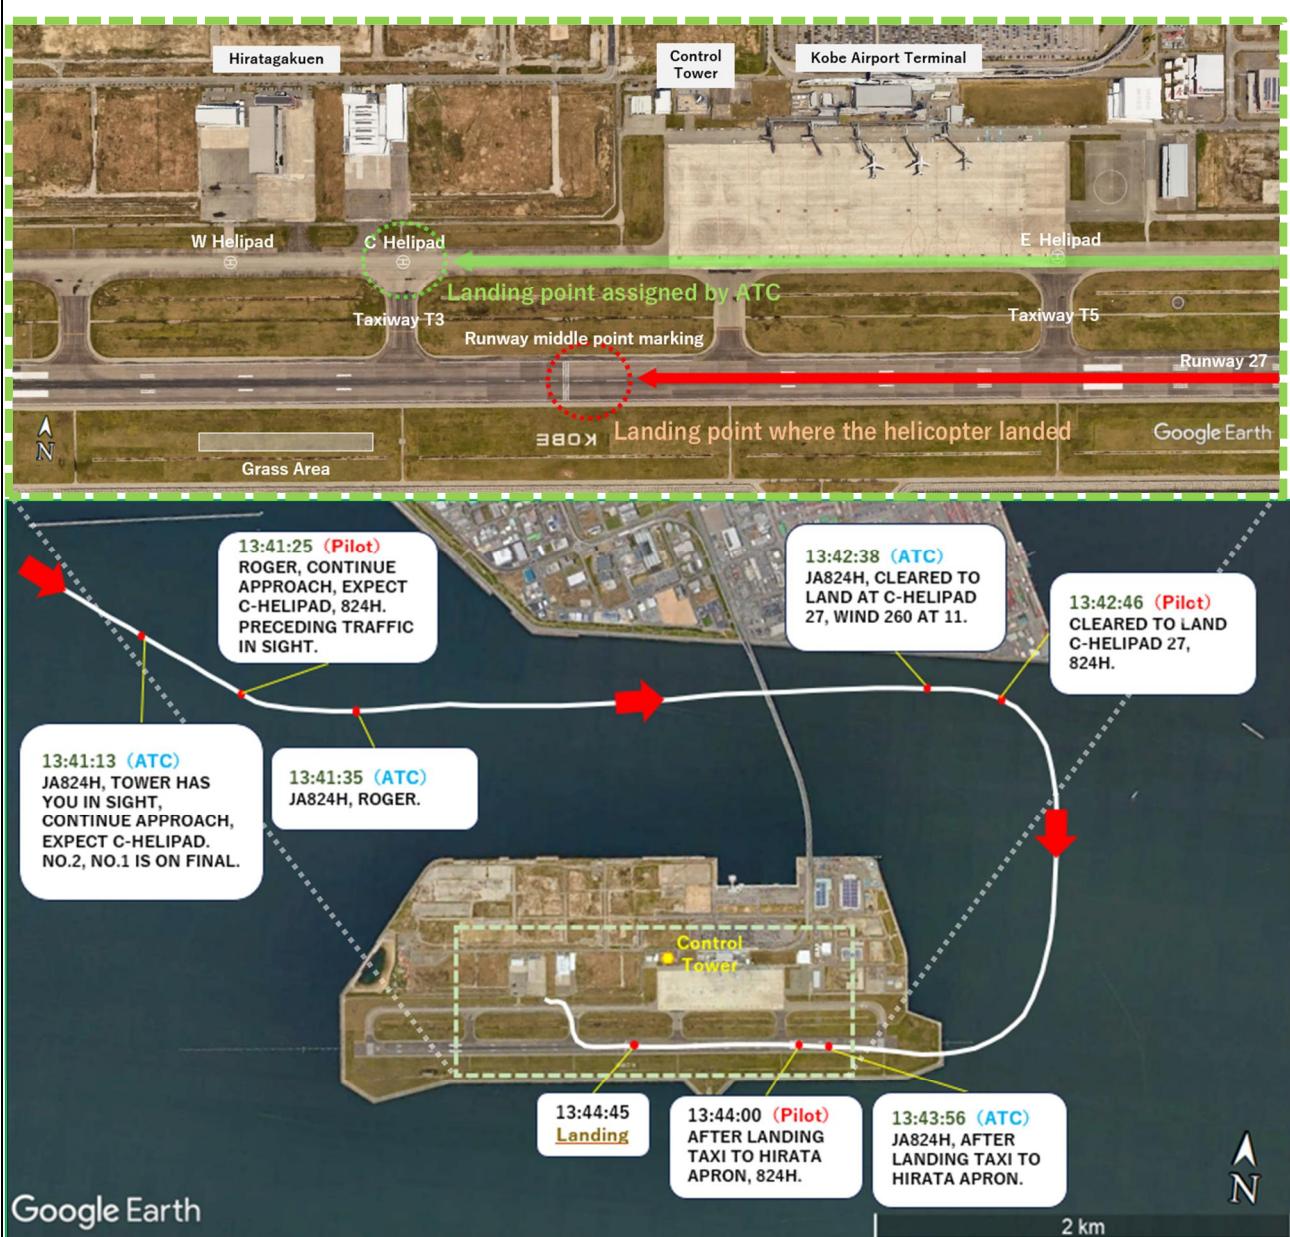
At around 13:38, the pilot asked the ATC at the airport for landing instructions, and the pilot was instructed by the ATC to report on the right downwind leg of Runway 27. At around 13:41, as the helicopter was entering the right downwind leg, the ATC instructed the helicopter to continue its approach to C helipad and provided the traffic information of another helicopter (hereinafter referred to as the "preceding helicopter") that was flying on the final leg. The pilot read back the instructions and informed the ATC that the preceding helicopter was in sight. The pilot felt relieved that the preceding helicopter had been visually recognized, and thought it became possible to concentrate on the pilot's own approach. While flying the downwind leg, the pilot remembered that the heading for the downwind leg specified in the course implementation guidelines established by Hiratagakuen Aviation School (hereinafter referred to as "the school") had been slightly off during the previous day's flight, and decided to fly along the route to confirm the correct heading. After confirming that the preceding helicopter had left C helipad, the ATC cleared the helicopter to land at C helipad, stating, "CLEARED TO LAND AT C-HELIPAD 27" (the ATC terminology for landing clearance will be explained in (4) below). The pilot read back the landing clearance, "CLEARED TO LAND C-HELIPAD 27," and turned to the base leg. As flying along the traffic pattern and checking the leg headings, the pilot began to think that this would be a good opportunity to brush up the pilot's own skills, and decided to fly faithfully to the specifications of the course implementation guidelines. The helicopter made the final turn toward Runway 27 without aligning with the parallel taxiway where C helipad was located. According to the pilot, landing accurately in accordance with the procedure specified in the course implementation guidelines was something the pilot often did when conducting touch-and-go training on a runway. The mechanic had been listening to radio communications while completing the check sheet and had believed that the helicopter had been cleared to land at C helipad, so felt something was off when the mechanic found the helicopter heading for Runway 27. However, the mechanic was not confident in the knowledge of ATC communications and thought that the mechanic might have misheard, so did not point this out to the pilot. The ATC visually confirmed the helicopter when issuing landing clearance to the helicopter, when it was making its final turn, and when it was flying over the area near Taxiway T5, but it did not appear to the ATC that the helicopter was attempting to land on Runway 27.

At around 13:45, the helicopter landed at the point on Runway 27, which was a little short of the runway middle point marking. After checking the situation in the vicinity of C helipad where the helicopter had been given a clearance to land, the ATC confirmed the helicopter's position and found that it was about to land on Runway 27. The pilot did not realize that the helicopter had landed at an unassigned landing point until the pilot was pointed out by a telephone call from the Civil Aviation Bureau after returning to the workplace.
