# AIRCRAFT ACCIDENT INVESTIGATION REPORT

AIR CENTRAL CO., LTD.  
BOMBARDIER DHC-8-402, JA849A  
KOCHI AIRPORT, JAPAN  
MARCH 13, 2007

May 28, 2008

Aircraft and Railway Accidents Investigation Commission  
Ministry of Land, Infrastructure and Transport

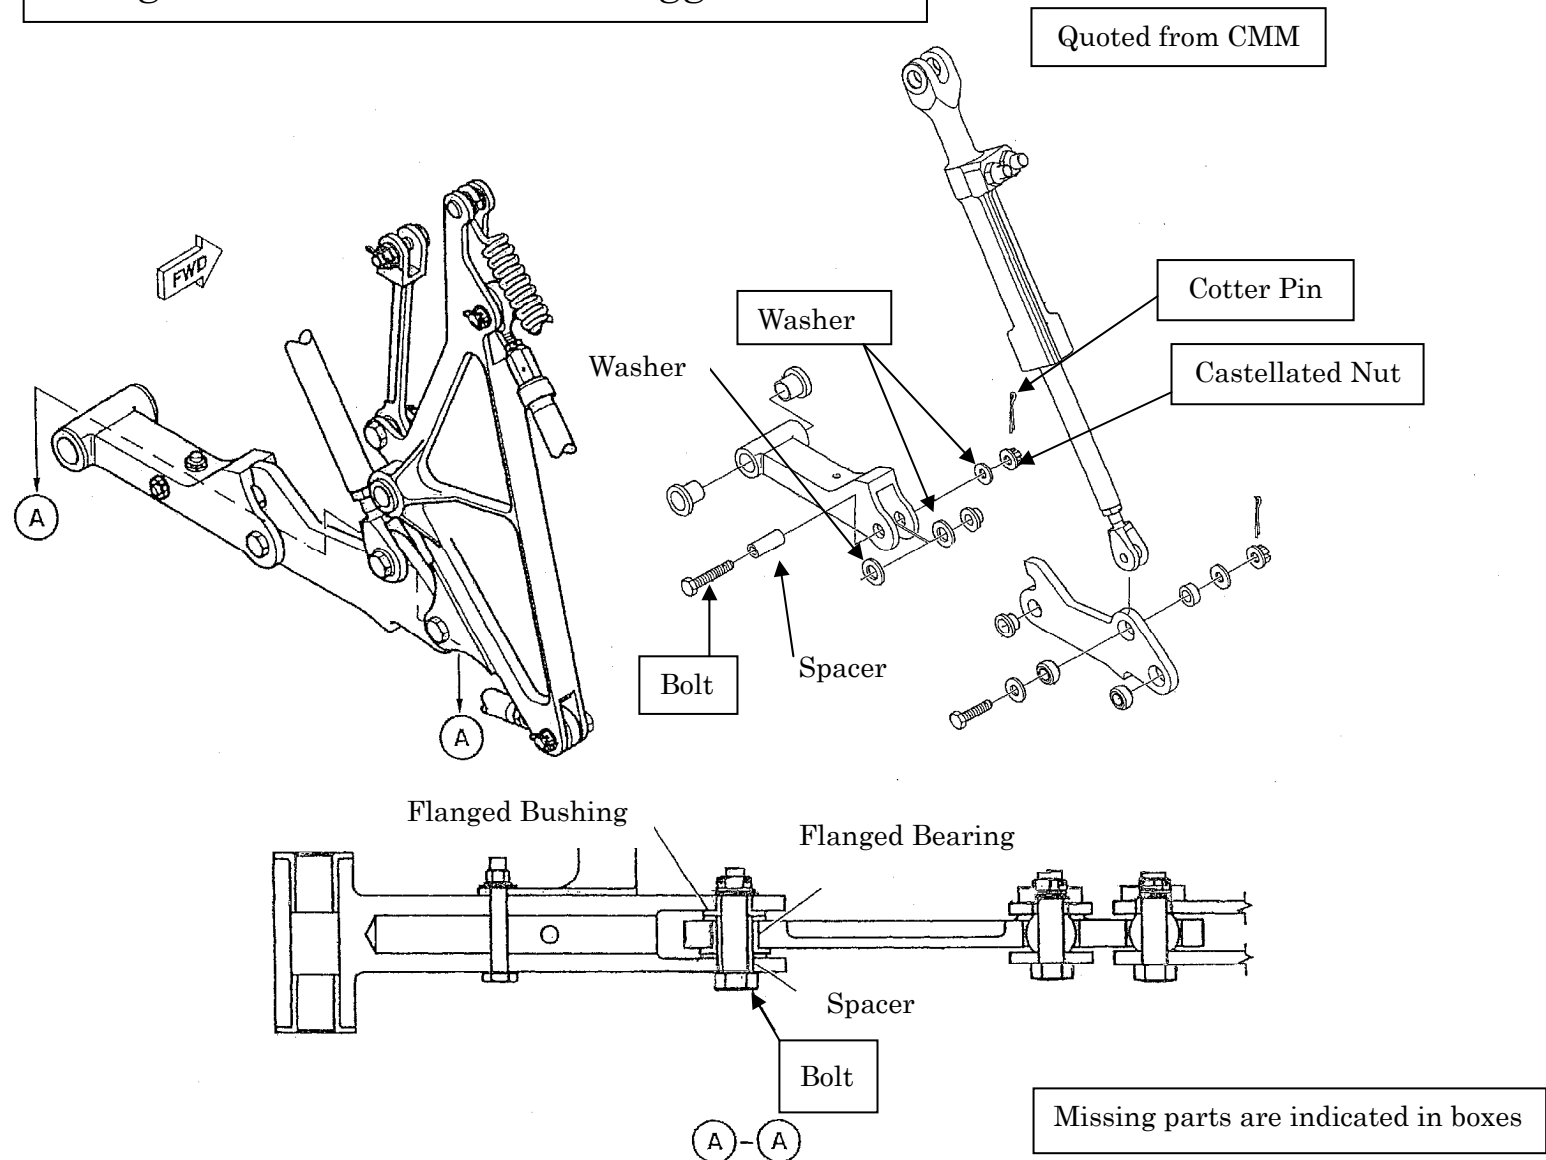
Figure 7 Details of the Toggle-Link

It is estimated that the spacer interfered with the support fitting because, as described in 2.12.1 (4), the spacer and the support fitting are in relative location susceptible to interference if the spacer migrates out aftward in case that the bolt is missing.

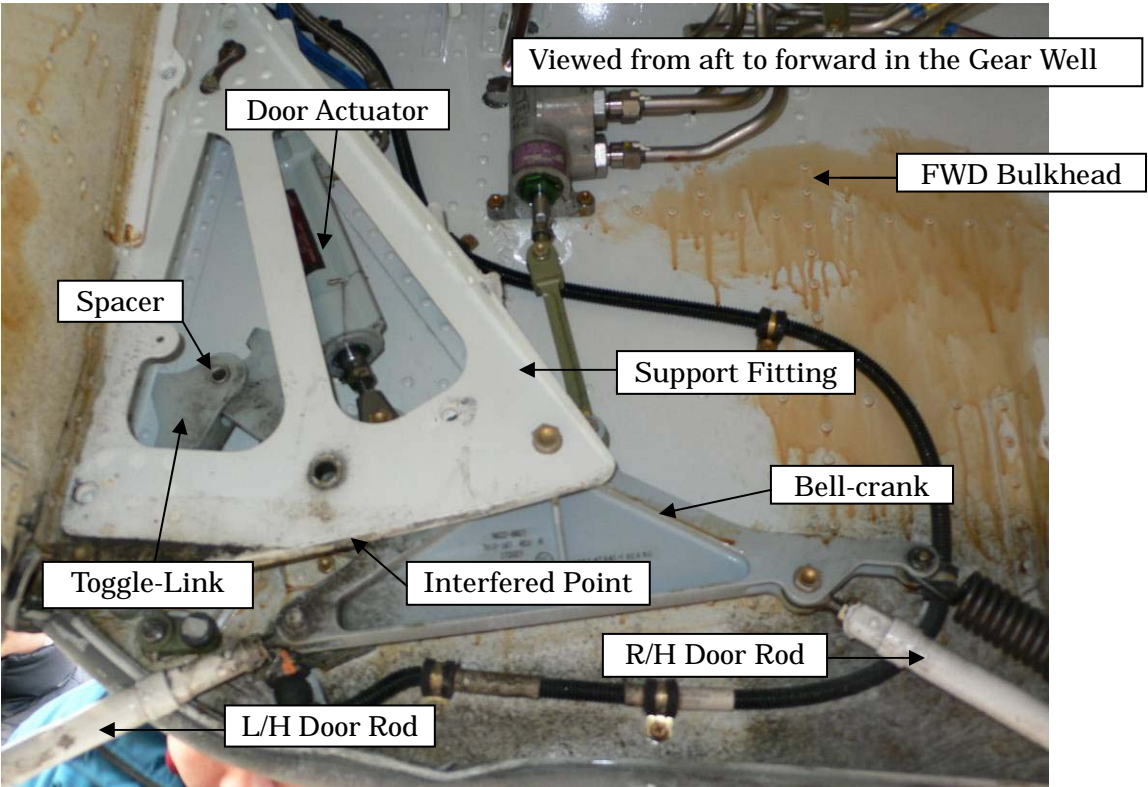
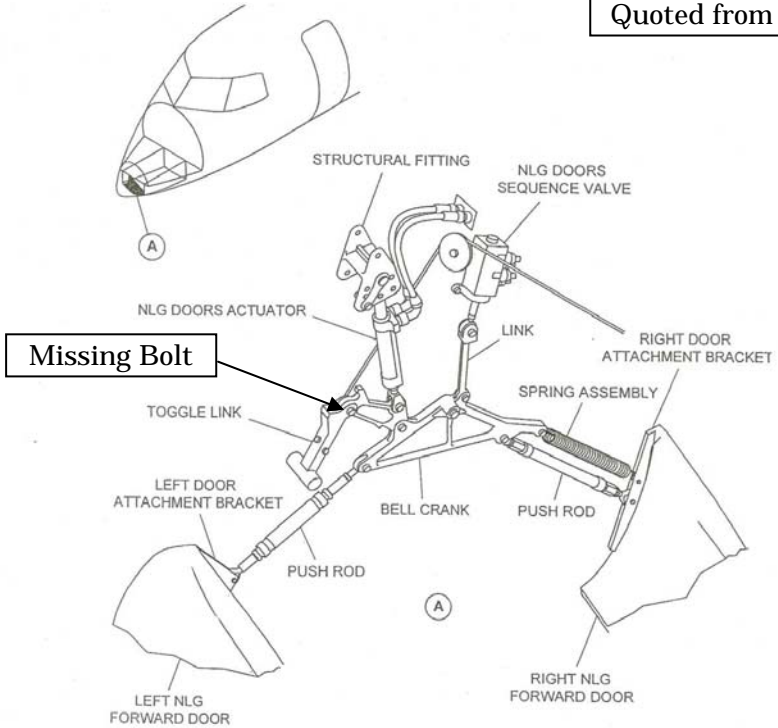
# Photo 3 Nose Gear Door Linkage Mechanism in the Gear Well

After Gear Down ( Doors are open )

Viewed from aft to forward in the Gear Well

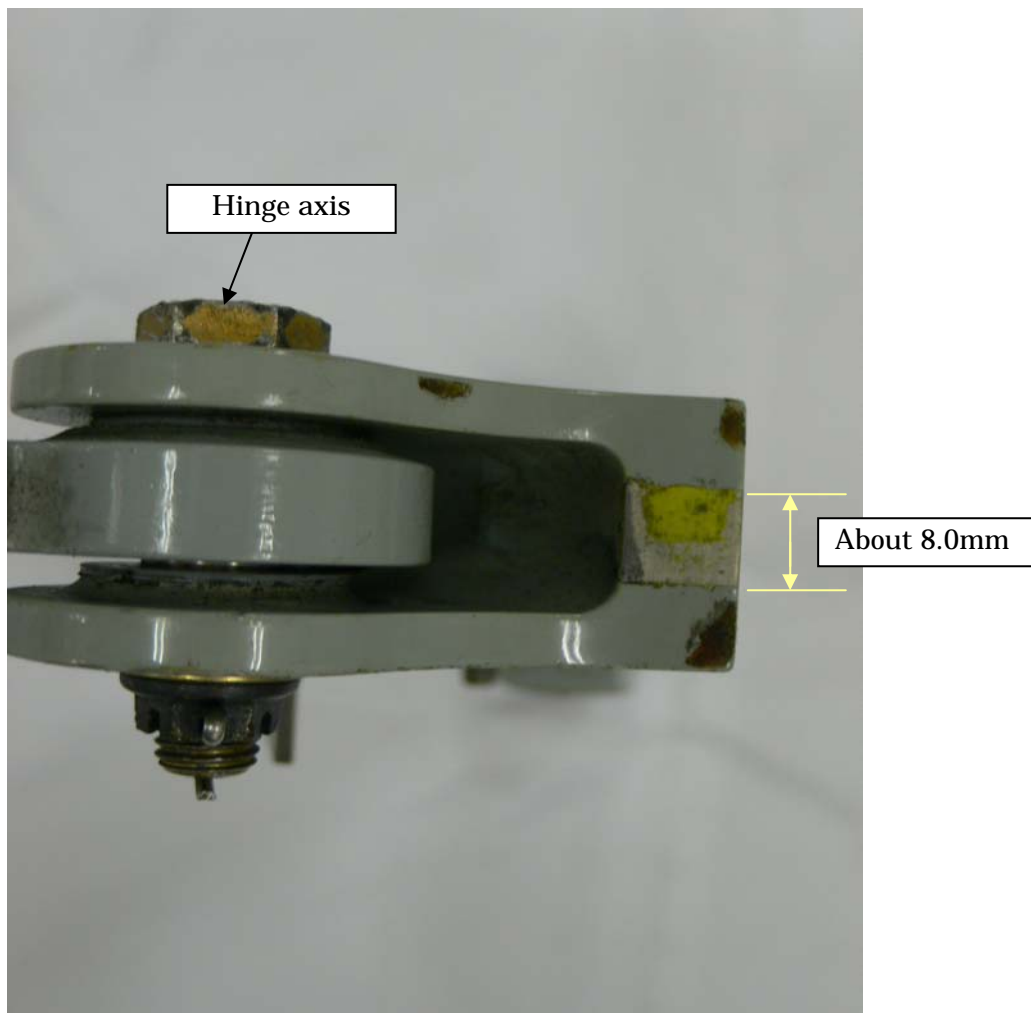
Photo 17 Impact mark on the mechanical stopper of other aircraft
