The investigation for this report was conducted by Aircraft and Railway Accidents Investigation Commission about the aircraft accident of Japan Airlines Boeing 747-400D (an approach to JA8546 of the same airline) in accordance with Aircraft and Railway Accident Investigation Commission Establishment Law and Annex 13 to the Convention of International Civil Aviation for the purpose of determining cause of the aircraft accident and contributing to the prevention of accidents and not for the purpose of blaming responsibility of the accident.

Junzo Sato,
Chairman,
Aircraft and Railway Accidents Investigation Commission

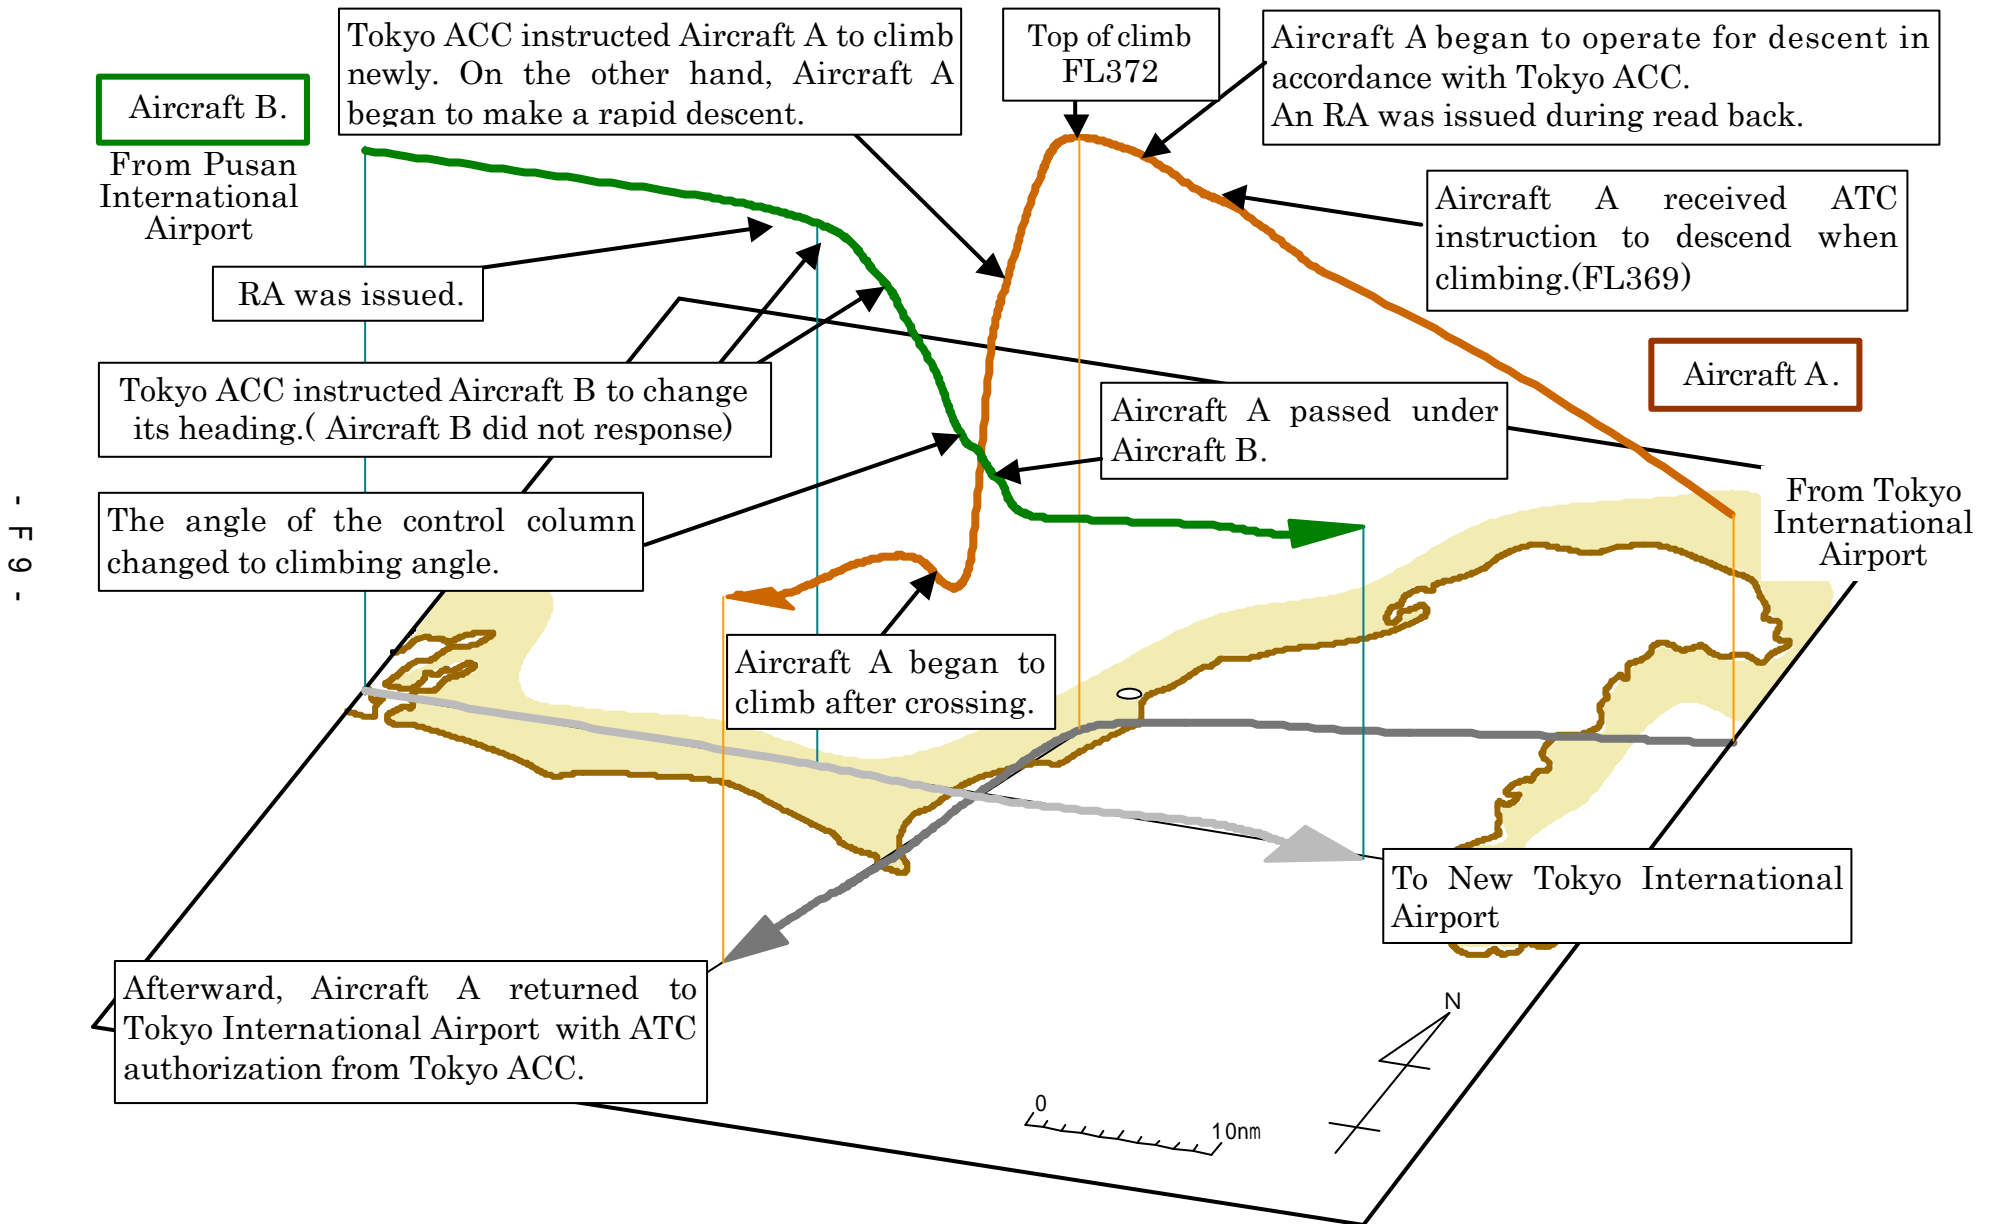
Figure 9 Flight pass around location of accident

Maneuvers executed by Aircraft-A and Aircraft-B based on the DFDR recorded data also given in square brackets for reference. Additionally, the flight paths of the two aircraft from their convergence to avoidance are shown in Attached Figure 9.

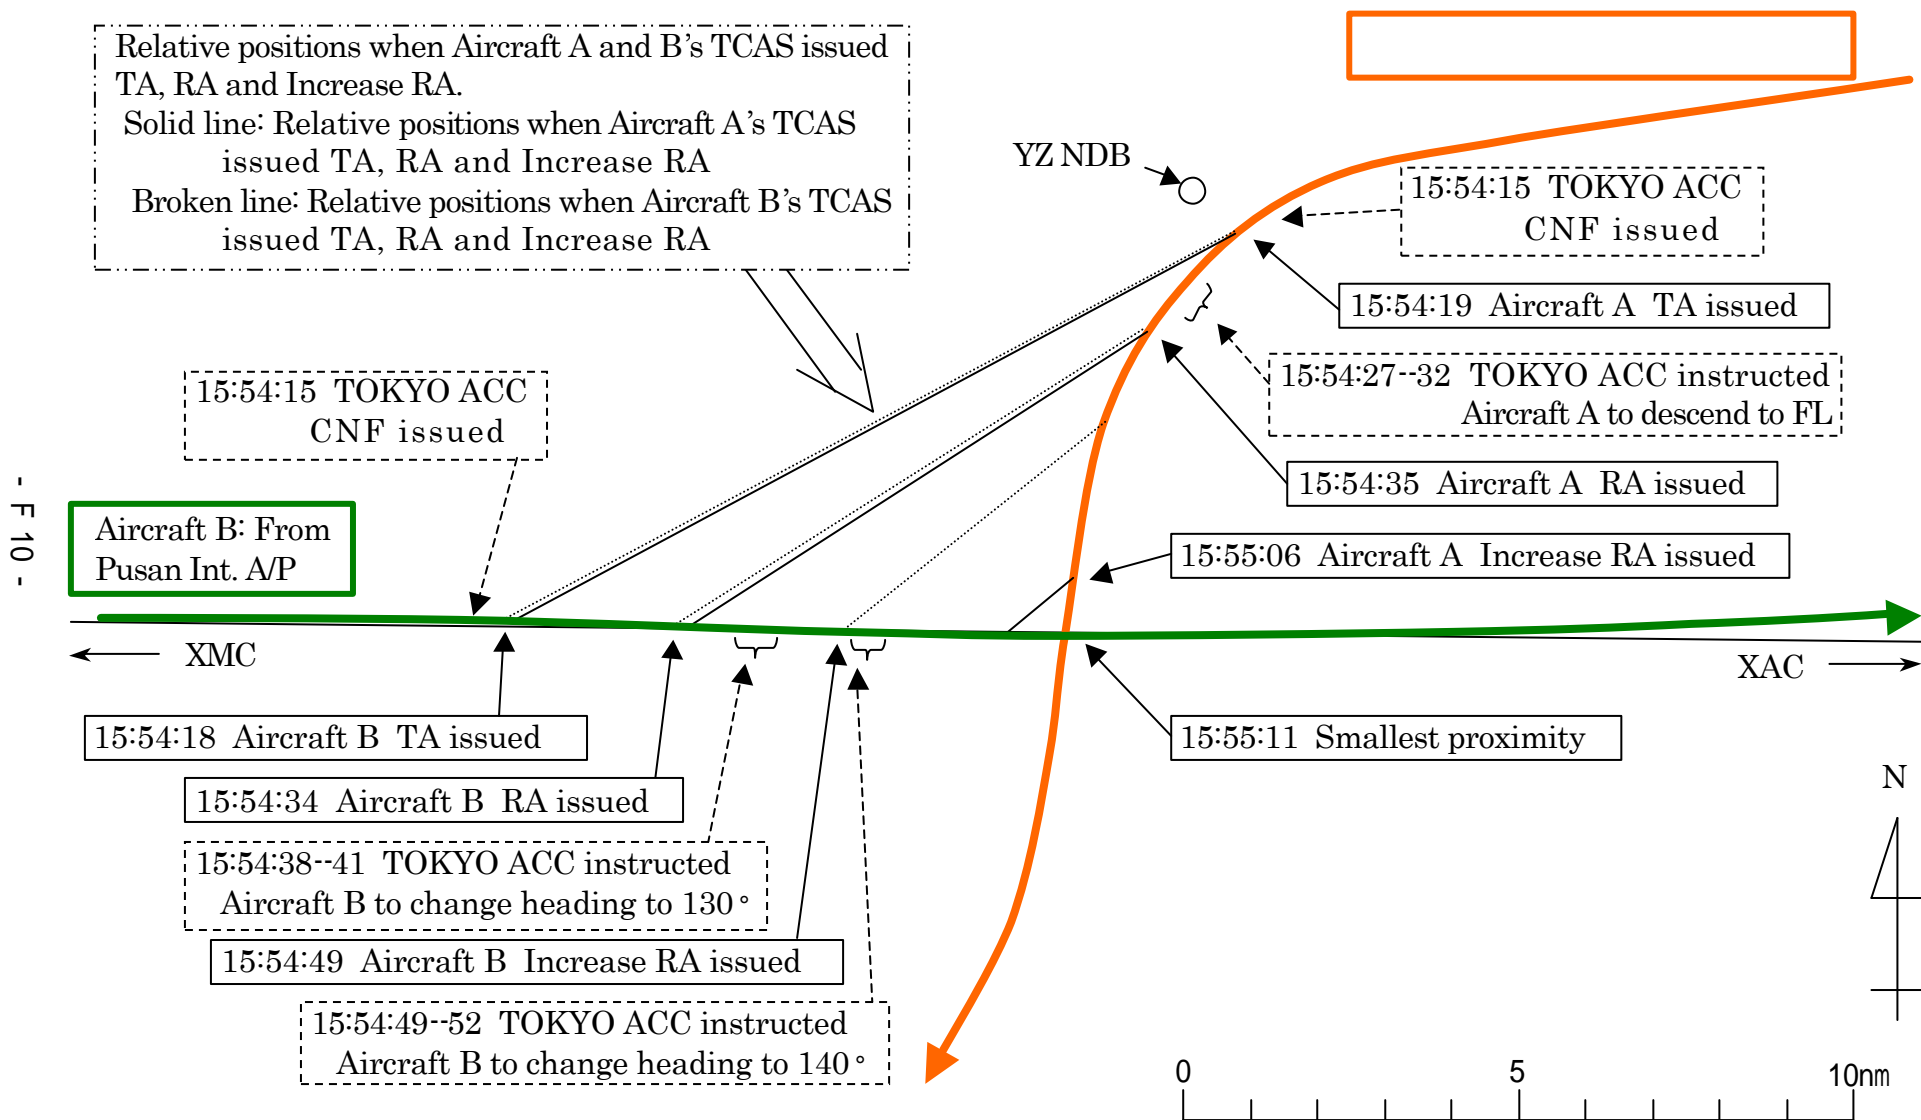
Figure 10 Proximity situation (Plane geometry)

(Refer to Attached Figure 10)

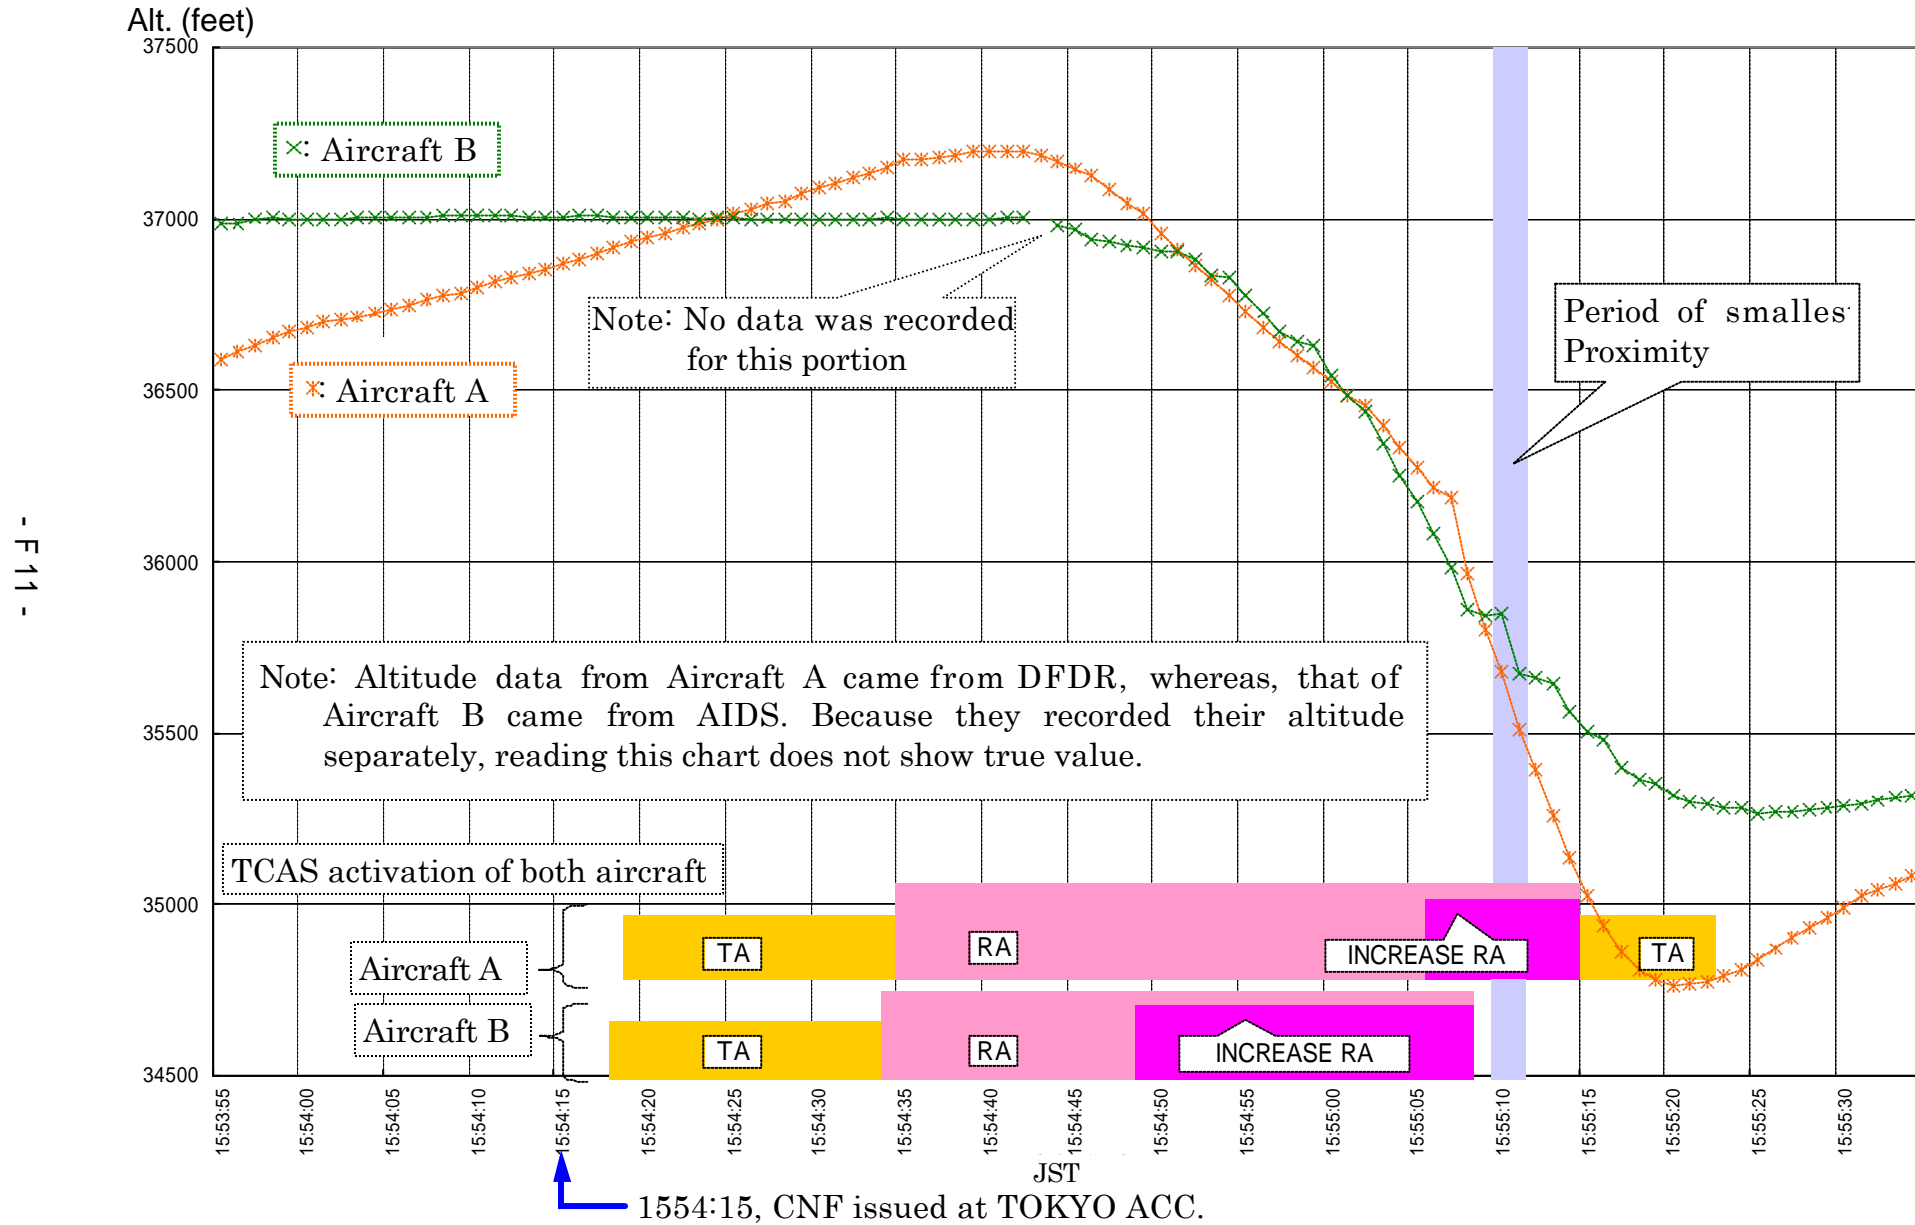
Figure 11 Altitude changes and TCAS activations

Plots of the major parameters from the DFDR, ACMS (including TCAS data), and AIDS around the time the accident occurred are shown in Attached Figures 11–13.

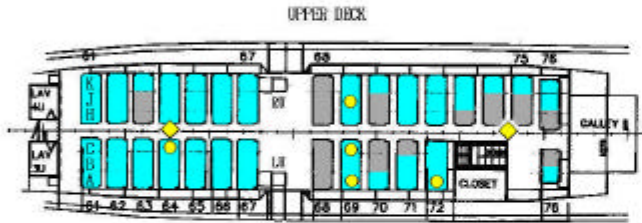
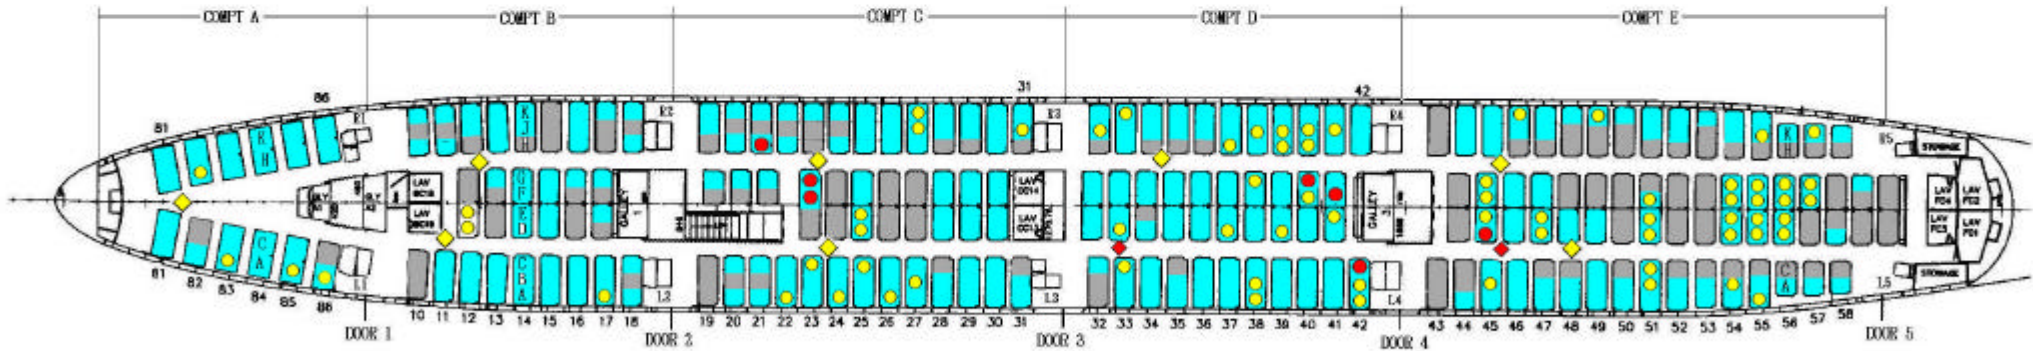
Figure 14 Injuries layout, Aircraft A

(Refer to Attached Figure 14)

(Refer to Attached Figures 14 and 15)

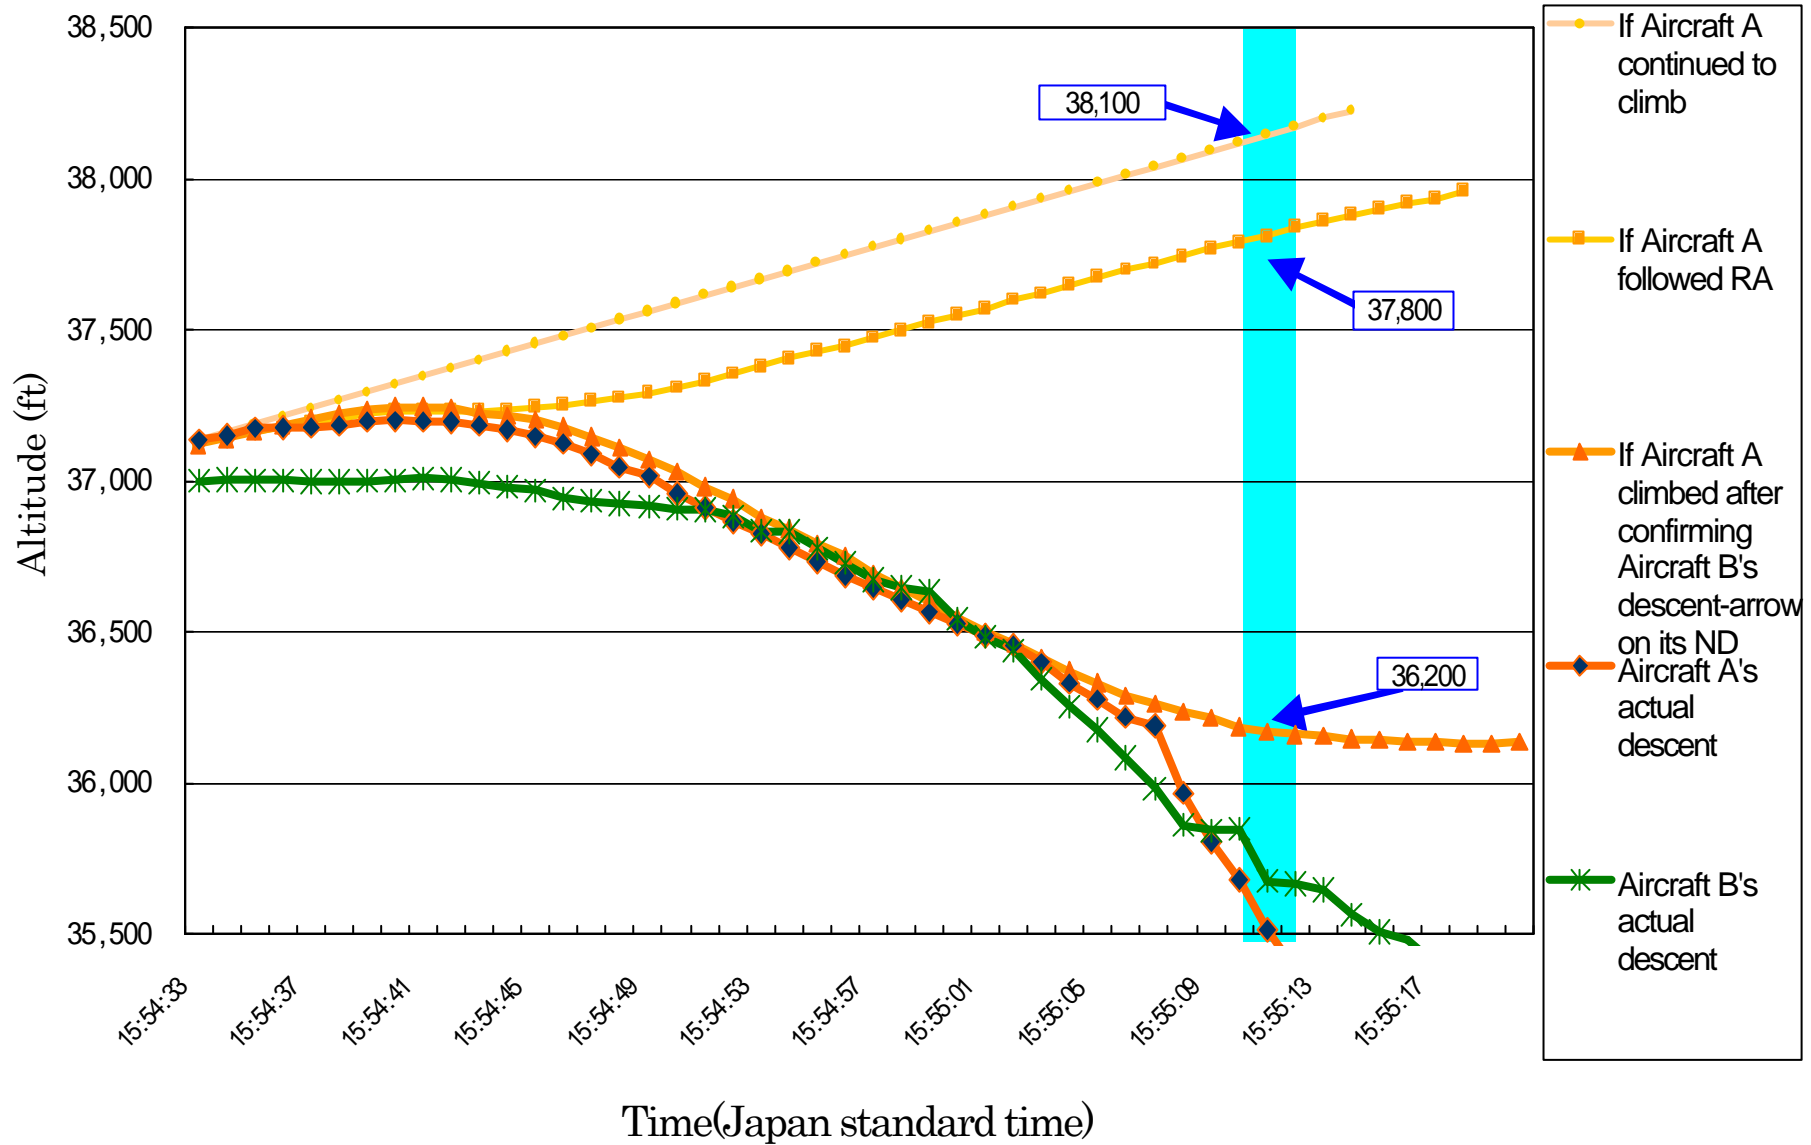
Figure 18 Aircraft A 's altitude simulation

(Refer to Attached Figure 18)

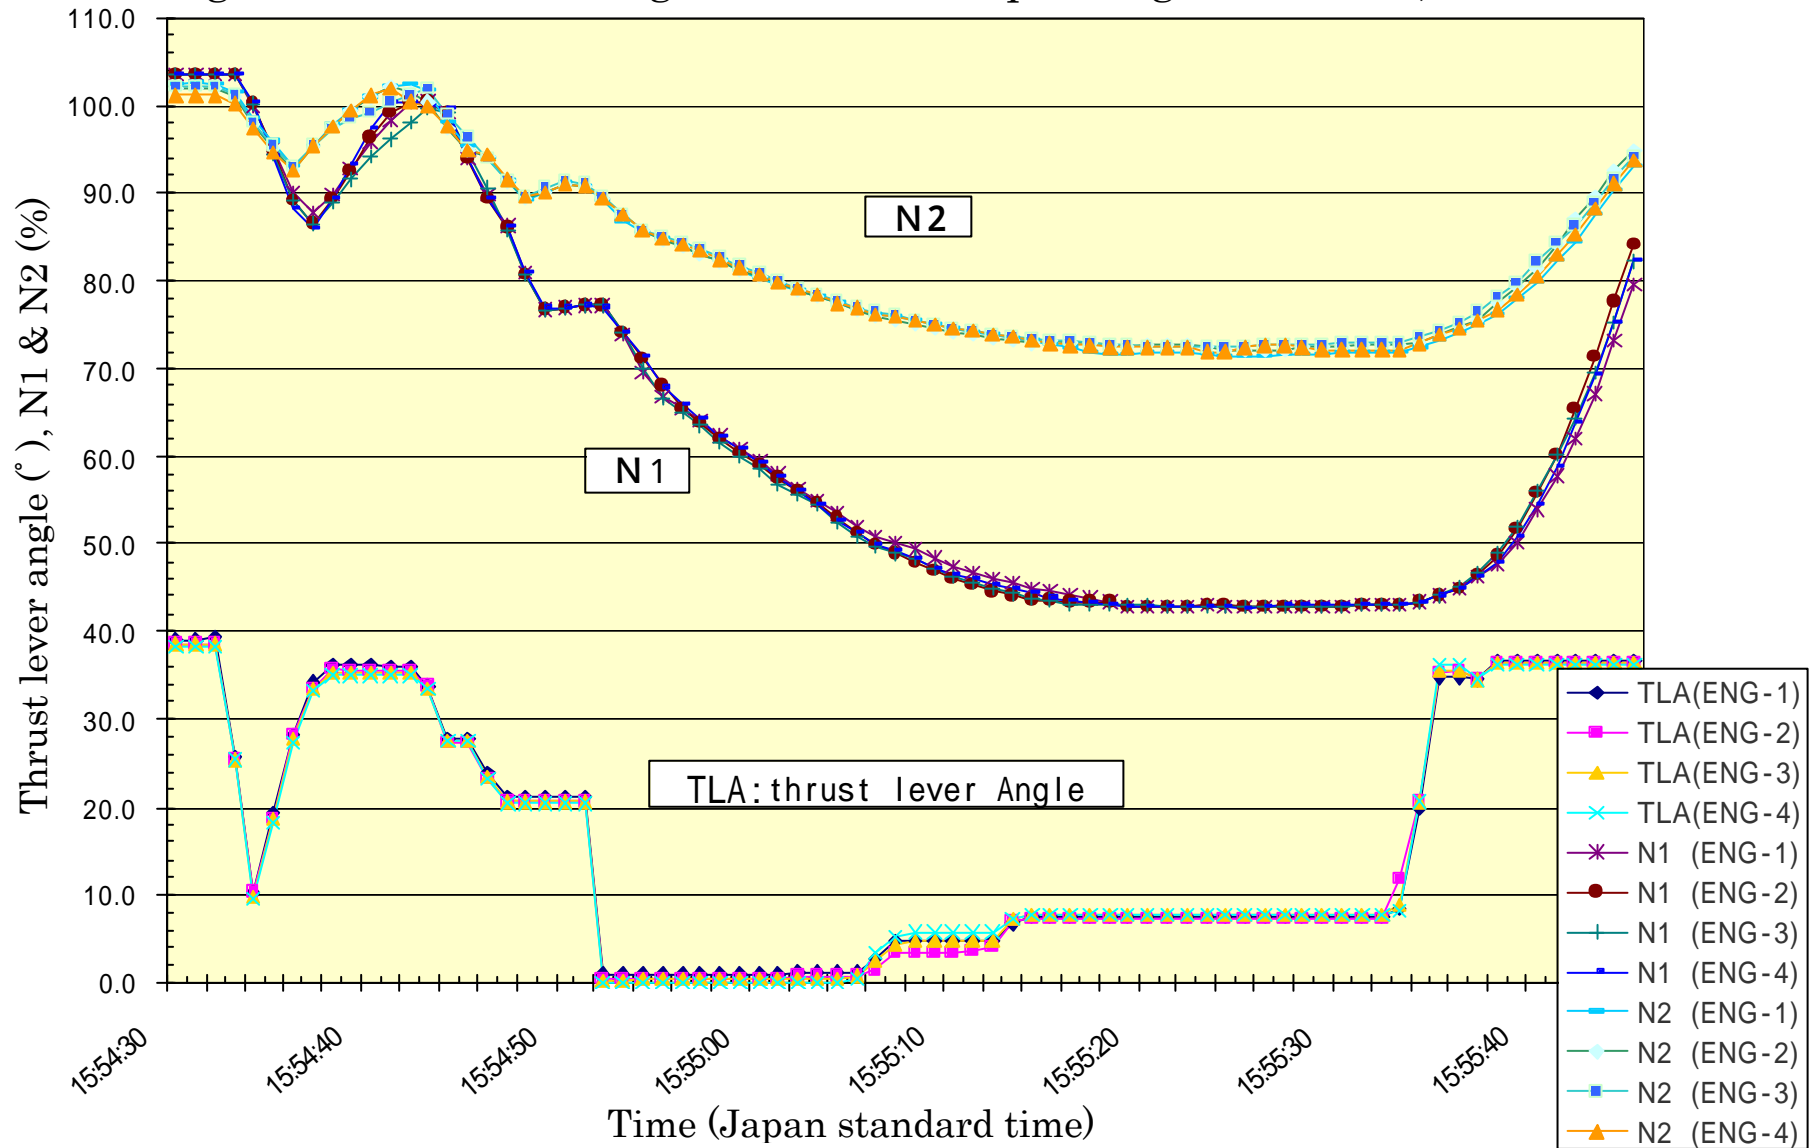
Figure 19 Throttle angle and its corresponding N1 and N2, Aircraft A

In order to confirm characteristics of the engine thrust responsiveness when transiting from descent to climb, plots of changes in N1, N2 and positions of the thrust levers before and after the occurrence of the accident recorded on Aircraft-A's ACMS are shown in Attached Figure 19.

According to data recorded on the Aircraft-A’s ACMS indicating the values of N1 and the angles of the thrust levers, shown in Attached Figure 19, the thrust levers were pulled back from the climb positions. During this period, the time lag from movement of the thrust levers until the N1 started to decrease in response was approximately one second.

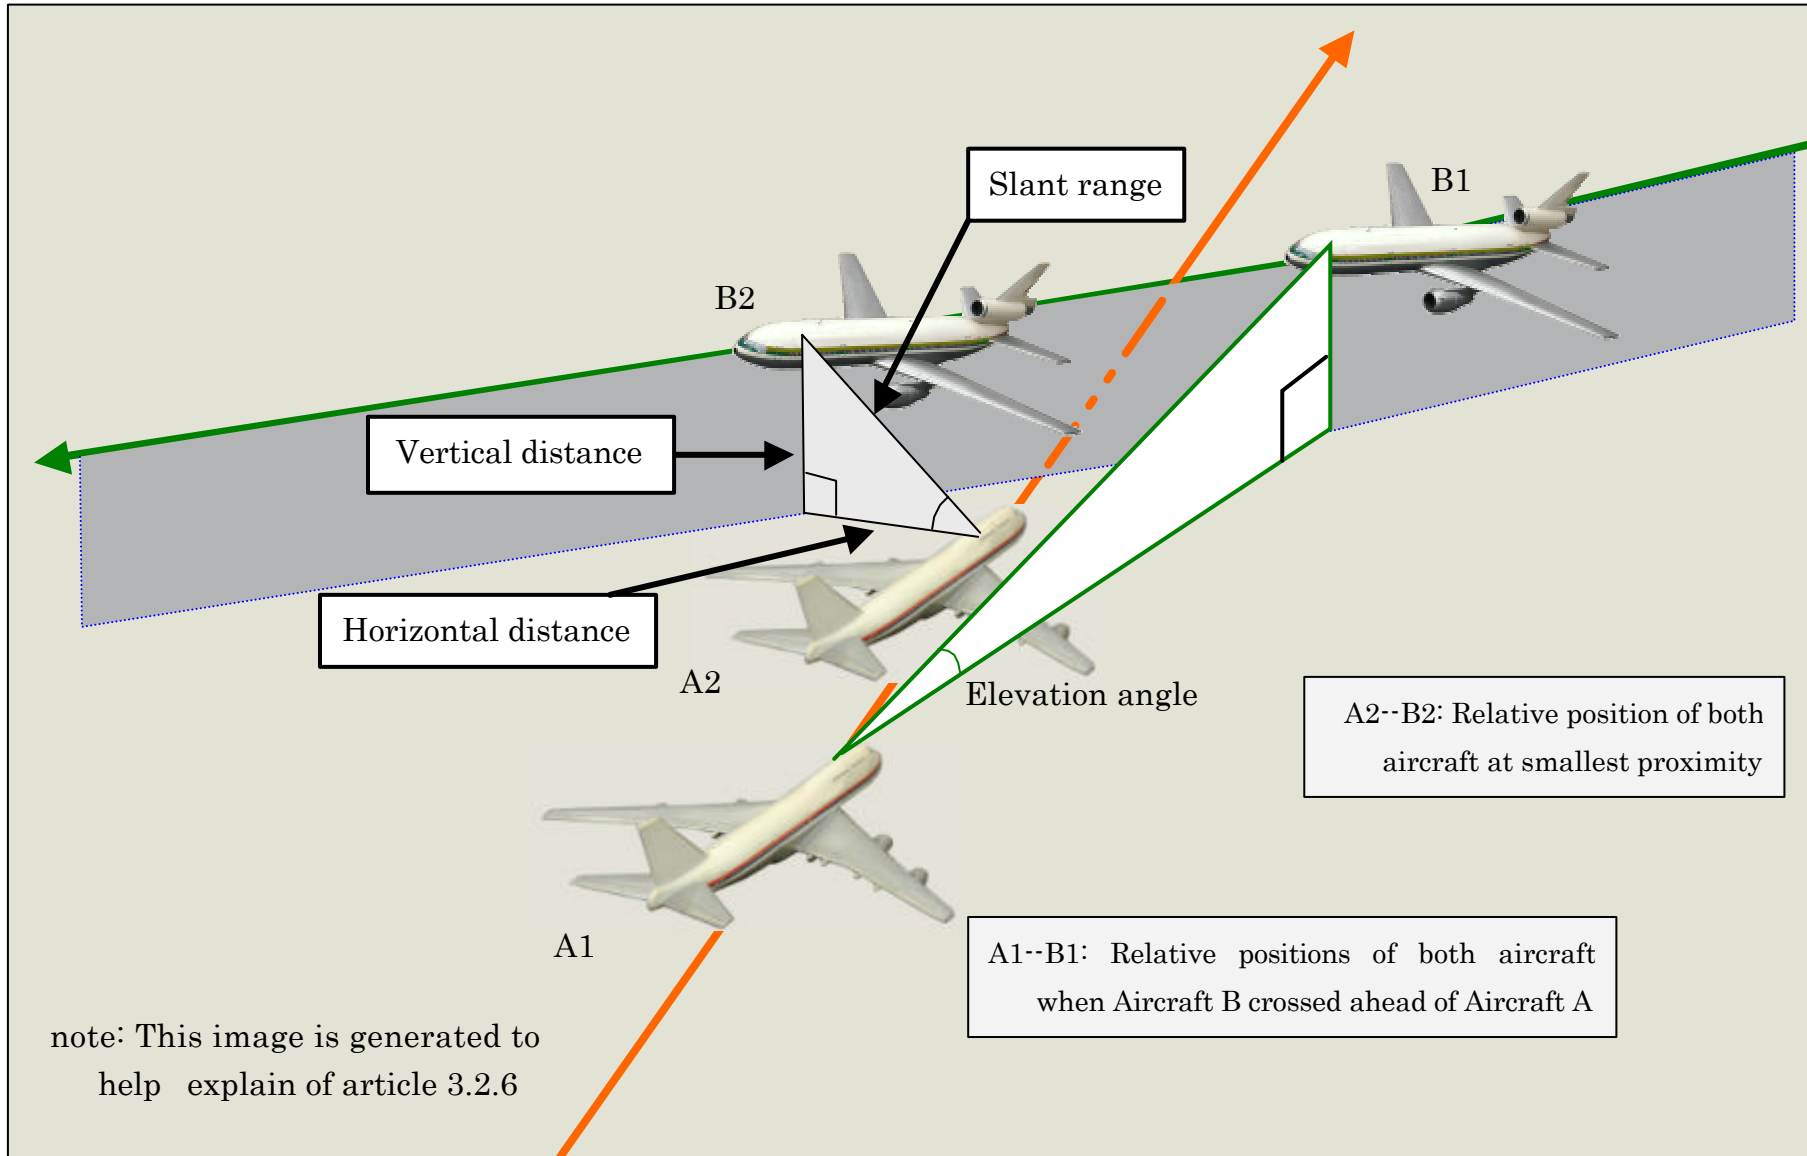
Figure 22 Explanation of closest distance

(Ref. Figure 22)

The datum point is placed on the point of smallest proximity of both aircraft
