**AIRCRAFT ACCIDENT INVESTIGATION REPORT**  
**AIRFRAME DAMAGE FROM LIGHTNING STRIKE IN FLIGHT**  
**ALL NIPPON AIRWAYS CO., LTD.**  
**BOEING 787-9, JA891A**  
**AT AN ALTITUDE OF APPROXIMATELY 1,500 M, ABOUT 77 KM**  
**EAST-SOUTHEAST OF NARITA INTERNATIONAL AIRPORT**  
**AT ABOUT 16:15 JST, MARCH 20, 2024**

Adopted by the Japan Transport Safety Board

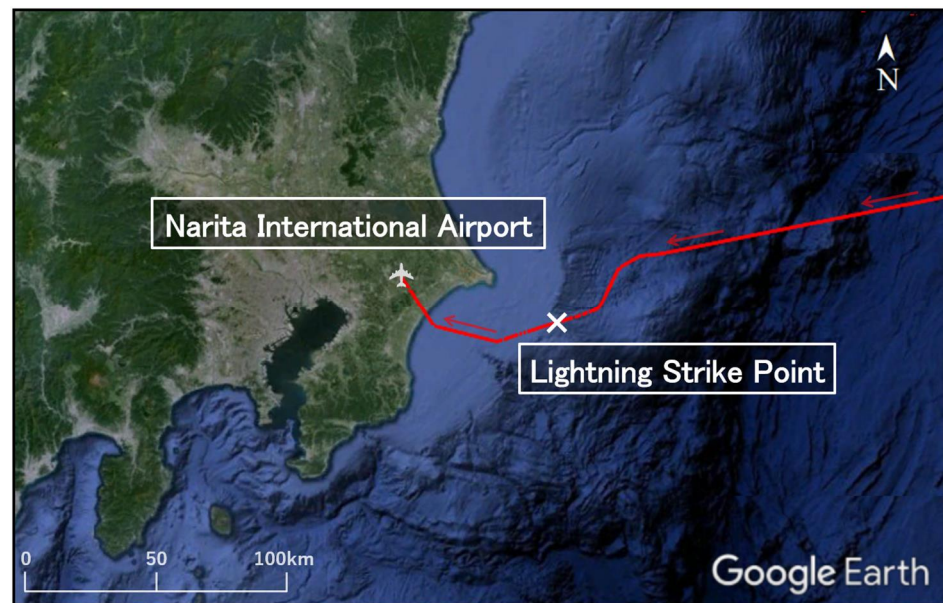
Figure 1: Estimated Flight Route and Lightning Strike Point

On March 20, 2024, at approximately 05:05 Japan Standard Time (JST: UTC + 9hrs, unless otherwise stated all times are indicated in JST on a 24-hour clock), a Boeing 787-9, JA891A, operated by All Nippon Airways, Co., Ltd., took off from Los Angeles International Airport, and at approximately 15:50 on the same day, began its descent for landing at Narita International Airport (Figure 1).

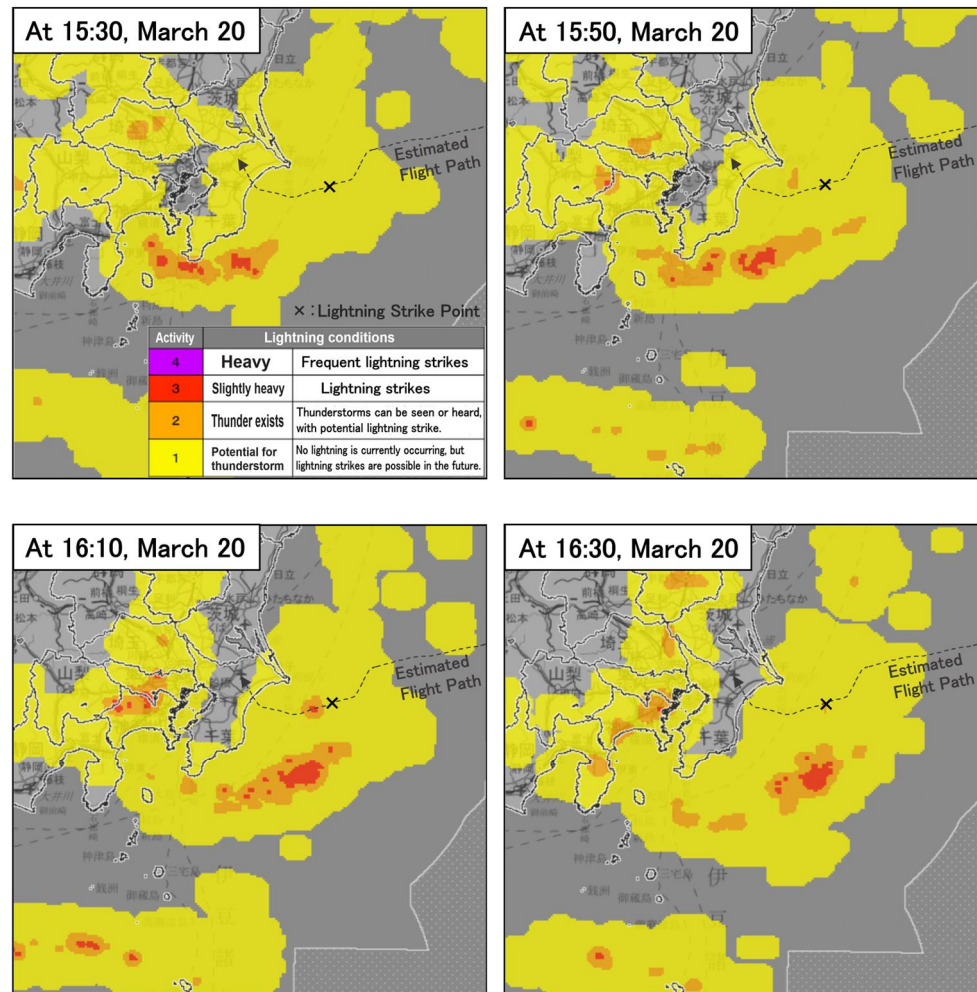
Figure 5: Thunder Nowcasts Analysis Chart

According to the analysis chart of the thunder nowcasts<sup>\*6</sup>, from 15:30 to 16:10, the degree of lightning activity increased in the vicinity of the aircraft's lightning strike point (Figure 5).

struck was within the temperature zones with a high risk of lightning strikes, and according to the analysis chart of the thunder nowcasts from 15:30 to 16:10, the lightning activity level increased in the vicinity of the aircraft's lightning strike point, making it most likely that the possibility of a lightning strike was rapidly increasing (see Figure 5).

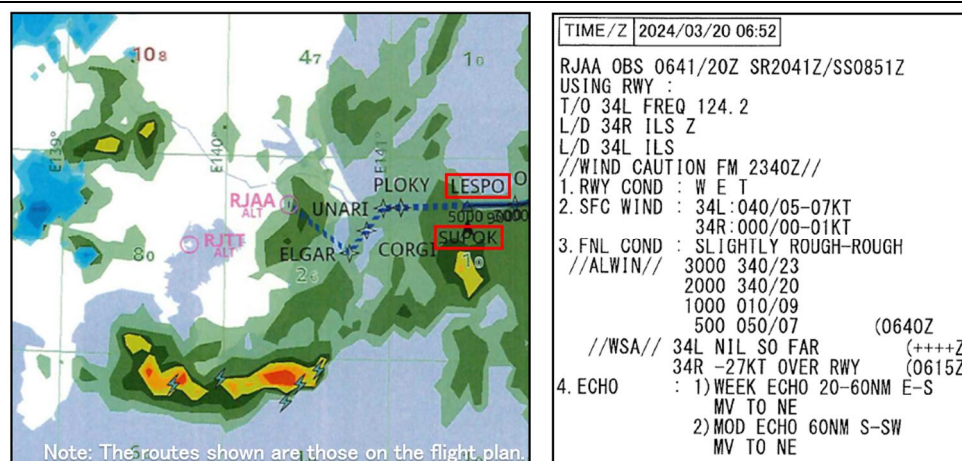
Figure 6: Information Obtained during Flight

According to the information confirmed by the flight crew members at about 15:40 using the application on the tablet provided by the company, there was a slightly strong echo to the south of the waypoint (LESPO, SUPOK) located on the aircraft's approach path and a strong echo off the Boso Peninsula (Figure 6, left).

According to the information obtained by the flight crew members by ACARS at 15:52, a weak echo located 20 to 60 nm east to south of Narita International Airport and a moderate echo located south to southwest of the airport, both moving northeast (Figure 6, right).
