AIRCRAFT SERIOUS INCIDENT INVESTIGATION REPORT

DEVIATION FROM A RUNWAY (LIMITED TO WHEN AN

HONDA AIRWAYS CO., LTD.

HONDA AIRCRAFT HA-420, JA924H

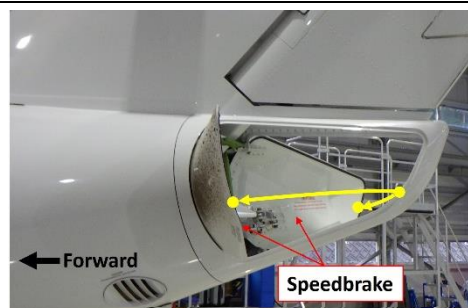
Figure 5: Speedbrake when deployed

the left, the captain monitored the situation as judging that the trainee's correction would be possible. The changes to the left and right in the roll angle and the sideslip angle were continuously recorded on the CVFDR. Afterward, the trainee deployed the speedbrakes installed on the aircraft's tail when judging the aircraft was beginning to run almost parallel to the runway center line. The speedbrake deployment was recorded on the CVFDR at 14:10:56 just after the observer's voice saying, "Go straight, go straight," when sensing the aircraft meandering began to be recorded on the CVFDR (see Figure 4, Figure 6 ①.).
