# AIRCRAFT ACCIDENT INVESTIGATION REPORT

## AIRCRAFT DAMAGE DURING LANDING

FUJI-BELL 204 B-2 (ROTORCRAFT), JA9383

Adopted by the Japan Transport Safety Board

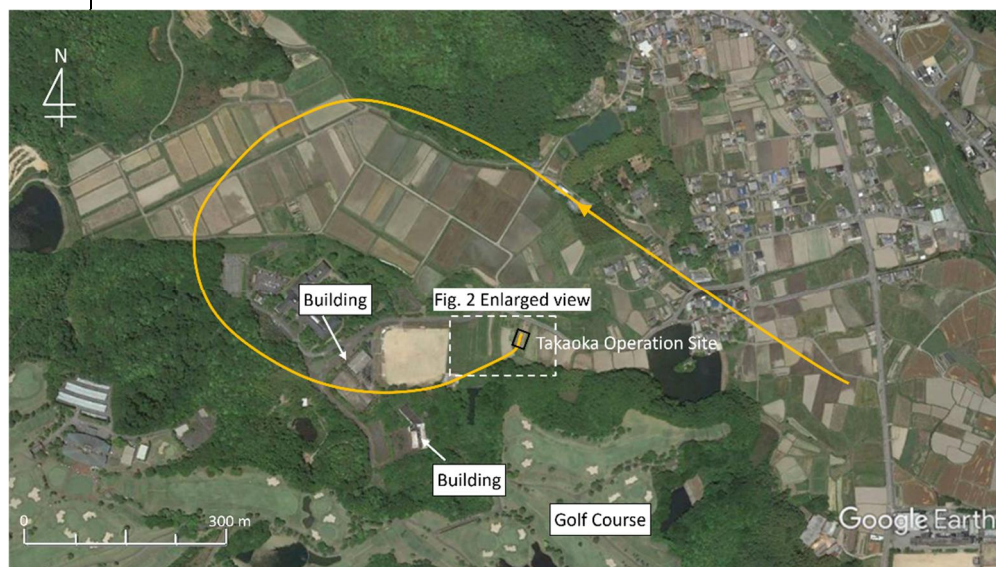
Figure 1: Estimated approach route of the helicopter

The helicopter passed 9 nm north of Osaka International Airport at a pressure altitude of about 2,000 ft, and as shown in Figure 1, gradually descended from the east side of the Operation Site to the north side, made a left turn, and approached from the west side. As shown in Figure 2, while approaching the Operation Site from the southwest at an altitude of about 40 ft above ground level, an engine abnormality was confirmed and a prompt landing attempt was made, resulting in a hard landing and damage to the aircraft.
