**AIRCRAFT ACCIDENT  
INVESTIGATION REPORT**

**OGAWA AIR INC.**

**J A 9 7 5 5**

OGAWA AIR INC.  
AEROSPATIALE AS350B (ROTORCRAFT), JA9755  
SEA SURFACE OFF CAPE OMASAKI  
OMA-CHO, SHIMOKITA-GUN, AOMORI PREFECTURE  
AT ABOUT 11:45 JST, JULY 6, 2008

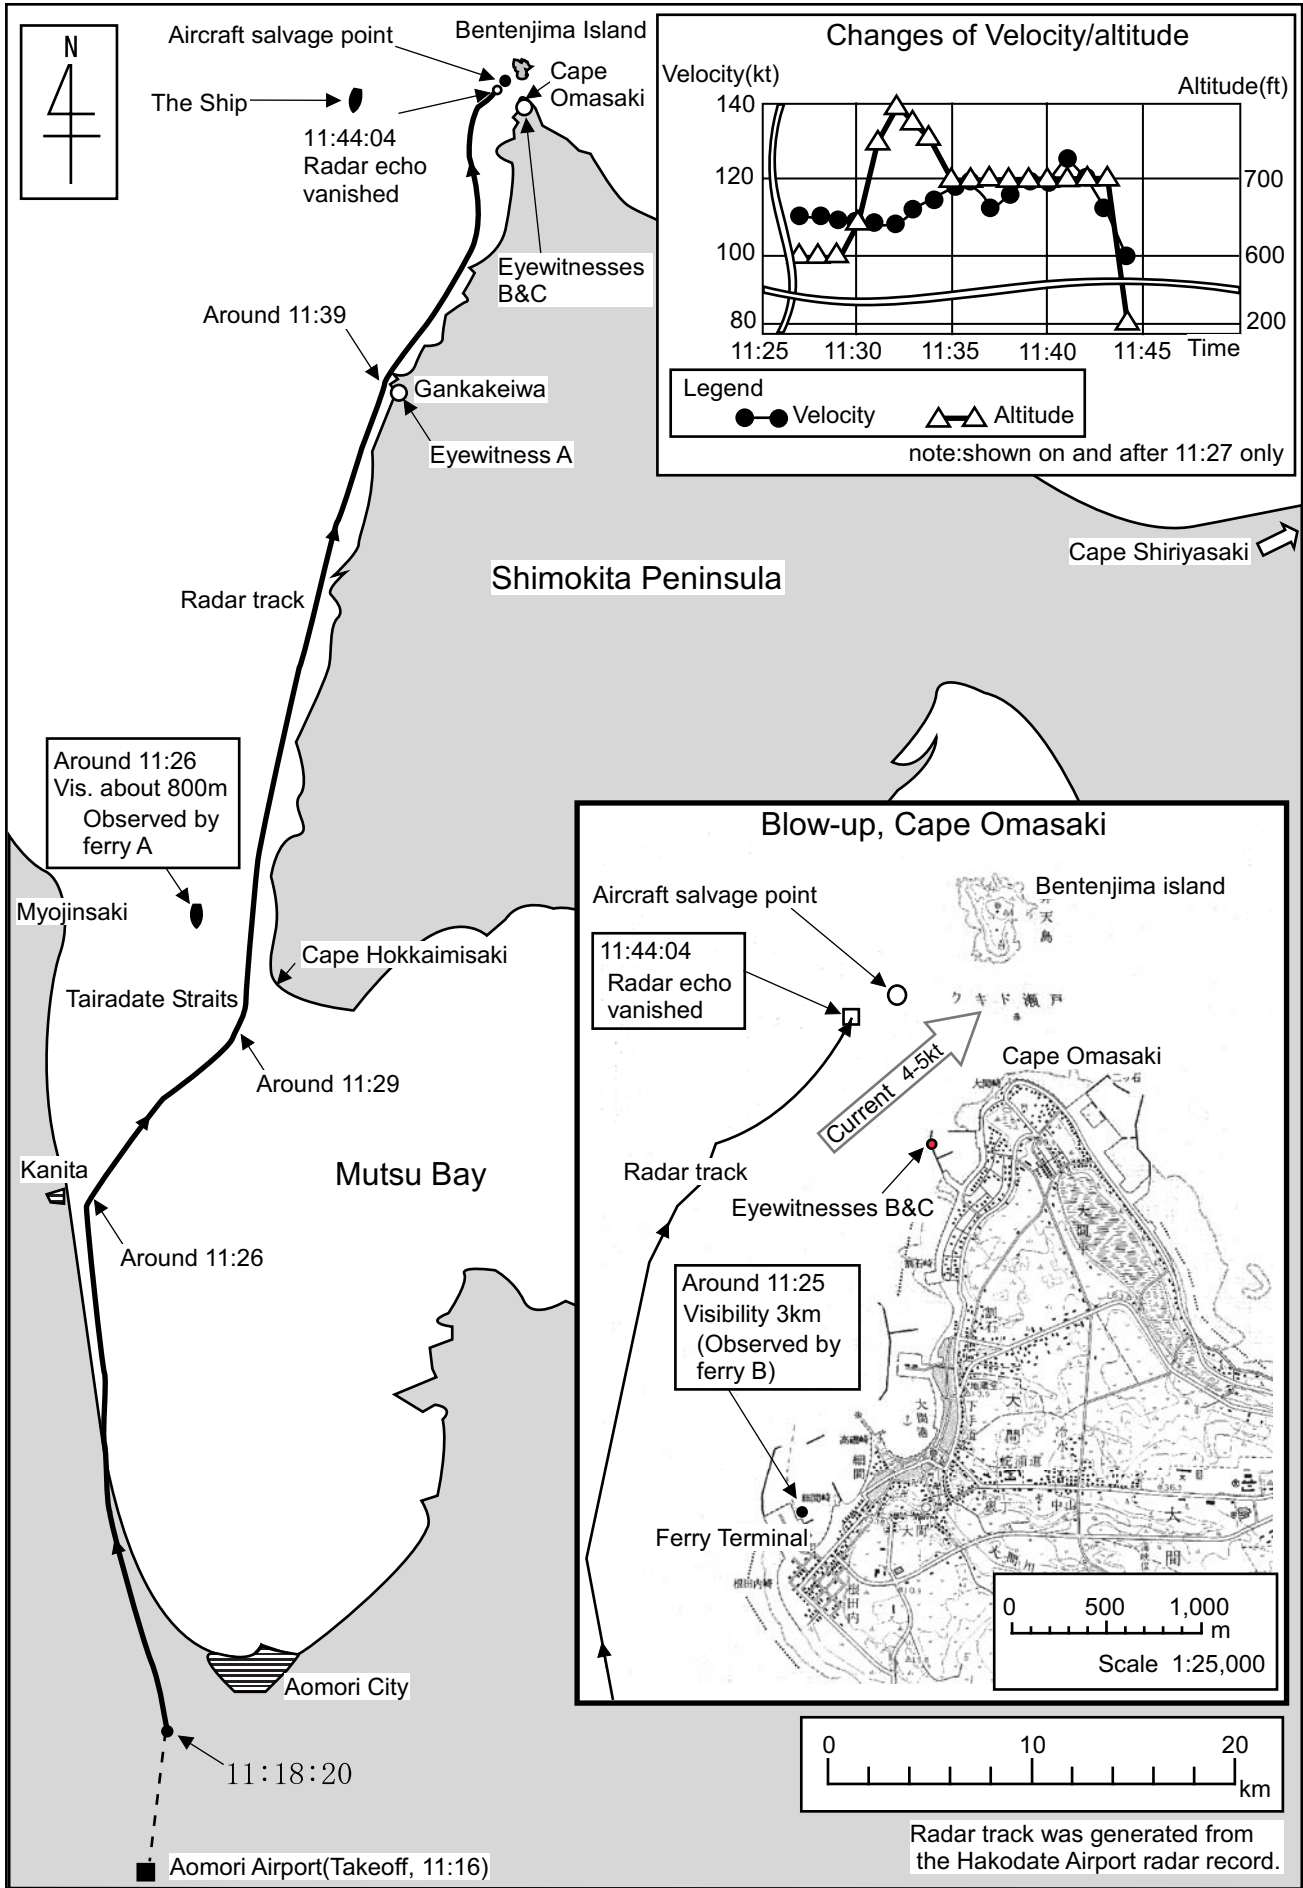
Figure 1 Estimated Flight Route

The accident occurred around 11:45 July 6, 2008, on the sea surface (41°33.11'N, 140° 54.23'E) about 700 m south-west from the Omasaki-Bentenjima light house. (See figure 1 "Estimated Flight Route")

As shown in Figure 1, the Aircraft's speed calculated from the radar track exceeds 100 kt. This speed, contrary to the speed described in 2.14.6, cannot be considered to be slow enough to avoid objects while flying.

The statements by the eyewitnesses described in 2.7.1 and the person who heard the boom on Bentenjima Island, it is considered probable that in the vicinity of Cape Omasaki, visibility to the south-west of Bentenjima Island was about 2 km, however, the area east of Bentenjima Island (the island inclusive) was covered by fog, and the sea surface was very calm with no wind. Under this weather condition, it is considered probable that visual altitude judgment was difficult with the obscured horizon by fog, making the Aircraft attitude establishment difficult. It is considered probable that while the weather condition east of Bentenjima Island did not satisfy the VMC requirements and the PIC was able to confirm this situation upon reaching Oma port, he should have abandoned proceeding further east beyond Cape Omasaki.
