**AIRCRAFT ACCIDENT  
INVESTIGATION REPORT**

**NAGANO FIRE AND DISASTER  
PREVENTION AVIATION CENTER  
JA97NA**

COLLISION WITH TREES AND CRASH  
MT. HACHIBUSE, MATSUMOTO CITY,  
NAGANO PREFECTURE  
AT AROUND 13:41 JST, MARCH 5, 2017

NAGANO FIRE AND DISASTER PREVENTION AVIATION CENTER  
BELL 412EP (ROTORCRAFT), JA97NA

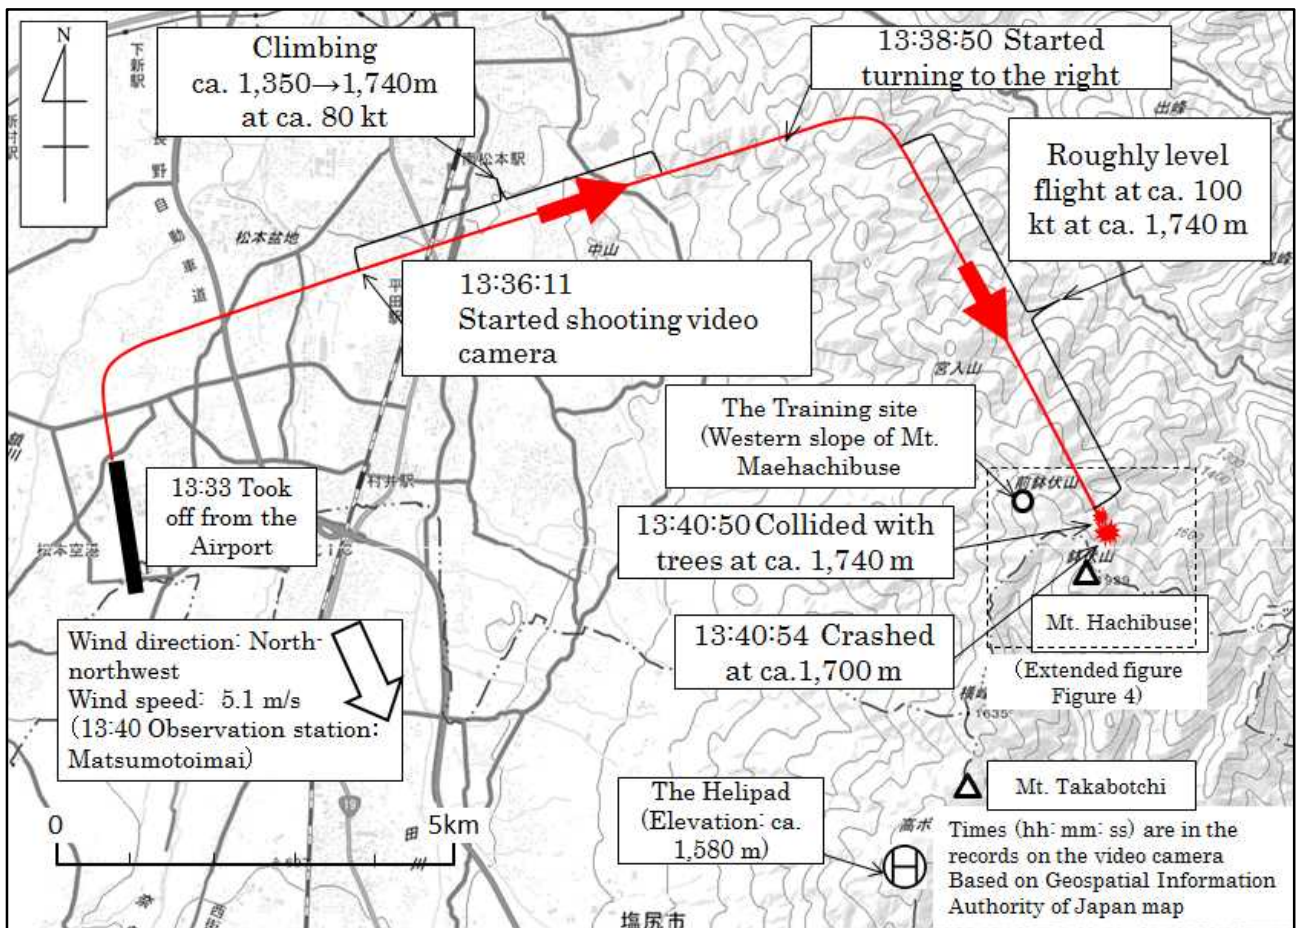
Figure 1: estimated flight route

The helicopter's flight route, estimated from the images showing the outside the helicopter and the operating engine data table (to be described in 2.7 and 2.12.2), is as shown in Figure 1 and Figure 2. After taking off from the Airport, the helicopter climbed at a speed of approximately 80 kt while heading northeast from the area above the city to over the mountains located about 9 km northeast of the Airport. The helicopter leveled off at about 1,740 m (5,700 ft), then turned right over the mountains and headed toward Mt. Hachibuse, continuing roughly level flight at a speed of about 100 kt and at an altitude of about 1,740 m. The higher the mountains' elevation got, the lower the helicopter's altitude above ground level (AGL) became, despite the tree-covered mountainside that was looming ahead, the helicopter collided with trees while maintaining attitude and speed. Branches and leaves scattered throughout the interior and about four seconds later, recording the video images stopped.

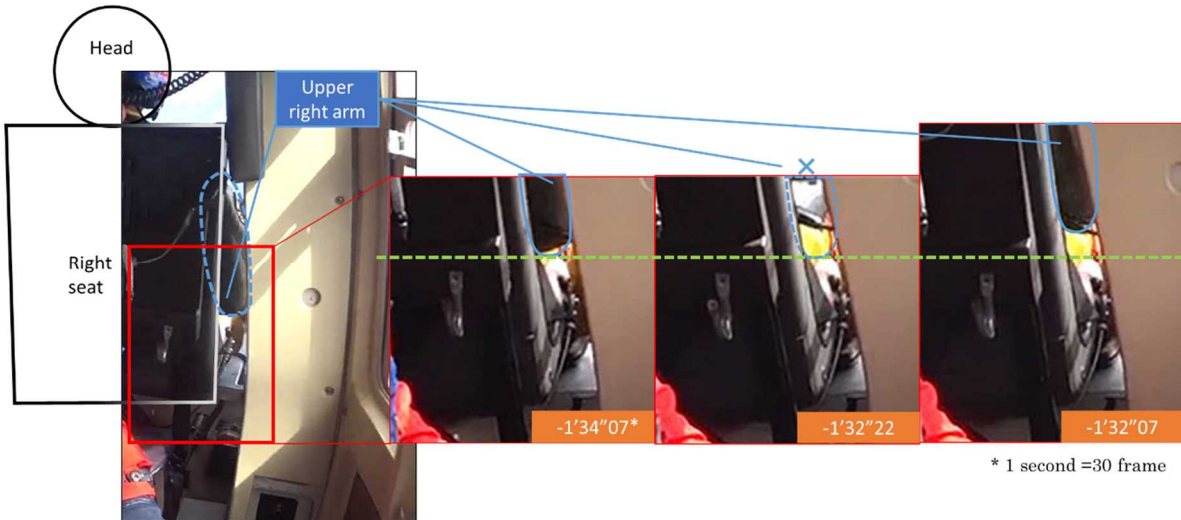
Photo 5: movement of captain's upper right arm (-1'30")

13:36:52 -3'58"	Captain: <u>Split</u> is much.	Climbing above the city
13:37:09 -3'41"	Mechanic A: I return it.	Climbing above the city
13:38:50 -2'00"	Rescuer B: Right rear clear.	Just commenced turning right above the mountains
13:39:20 -1'30"	The captain right upper arm moved.	Almost level flight above the mountains
13:40:50~54 0'00" to 0'04"	(Violent noises)	After collision with trees

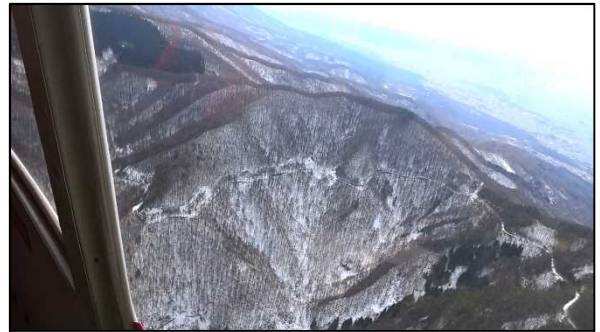
Photo 7: video camera image (-0'50")

The ridgeline of the mountains near the flight route is visible in the images of the video camera worn by rescuer B that was described in 2.1.1 (1), and visibility was good without any phenomena that impeded visibility nearby.

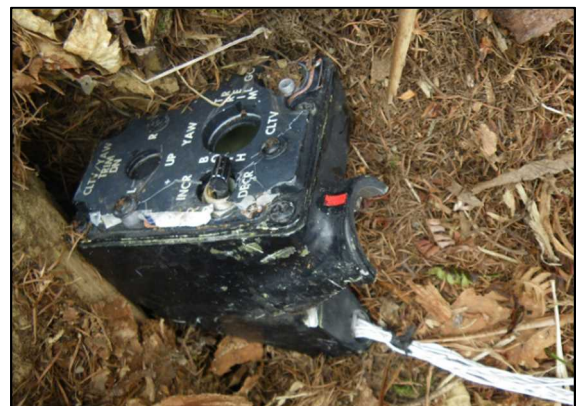
Photo 9: the left pilot seat's CP lever head

As described in 2.7, from the fractured circumstances of the trees and nearby scattered circumstances of the left cockpit door, the lower fuselage parts, the CP lever head, and the part of the damaged MRB, it is highly probable that the helicopter crashed its fuselage and MRB into trees over a distance of approximately 40 m as shown in Figure 5. It is highly probable that the helicopter received massive damage to its fuselage's nose and the MRB at that point, and it is also highly probable that, as the helicopter subsequently passed through the air above the valley, it had temporarily separated from the tree but had already fallen into an uncontrollable condition.

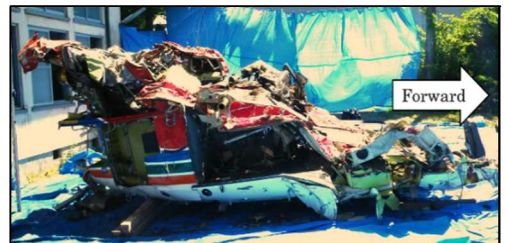
Photo 11: cabin

Much of the cabin was damaged by the force of impact from the front and above. Most of the aft fuselage was severely damaged with the engine attached to the engine deck. All of the windows and doors were severely damaged by the force of impact. The landing gear was relatively undamaged.

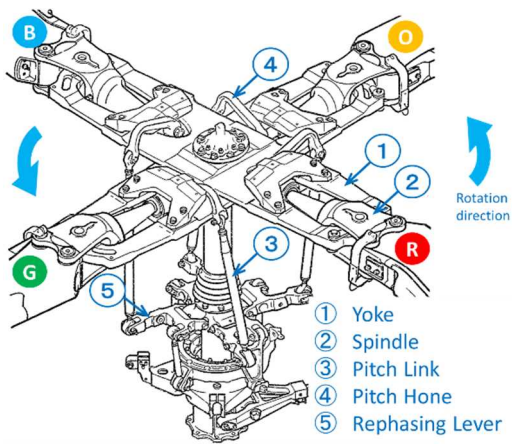
Figure 6: MR hub

The four MRBs, which rotate counterclockwise when viewed from above, are identified by the colors of green, blue, orange and red. The yokes of the green MRB and blue MRB were bent downward and were fractured near the spindle. The yokes of the orange and red MRBs were bent upward. The pitch link of the green MRB was fractured at the end of the pitch horn but joined at the rephasing lever. The pitch link of the blue MRB was joined with the pitch horn but fractured at the end of the rephasing lever. The pitch link of the orange MRB was fractured at both ends. The pitch link of the red MRB was fractured at the end of the pitch horn but joined at the rephasing lever.

All of the MRBs were severely damaged overall.

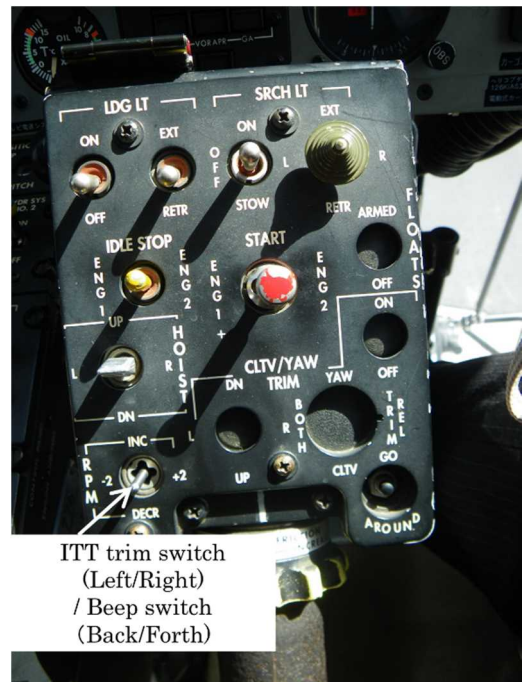
Photo 20: the right pilot seat's CP lever head

The "range check" means the engine data check that is conducted to obtain the data used for N2 (power turbine RPM) control adjustment. During the range check, a pilot flew the helicopter by mainly watching outside, but a mechanic is not able to watch outside because he or she has to concentrate on checking flight instruments while extending the right hand to the right pilot seat and operating the

ITT trim switch on the CP lever head in the right pilot seat. When a mechanic conducts a range check after telling a pilot that he would do it, however as data are usually obtained en route on the flight route, it's not necessary to specifically give an instruction on the flight route. Besides, the range check would not be conducted in every flight, let alone on mountain flights.

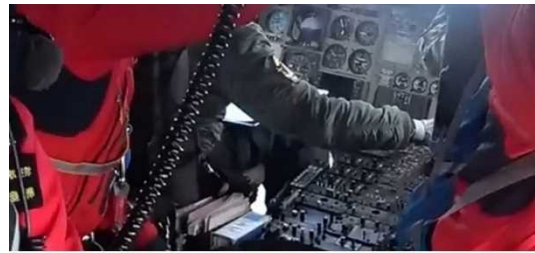
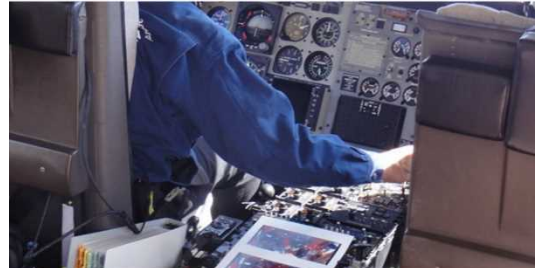
Photo 21: right arm of mechanic A

As shown in Photo 21, when the CP Lever was moved up to the same position as at the time of climbing, and the right hand was extended to the ITT trim switch, almost the same composition as in the image of video camera (-4'01") was reproduced.

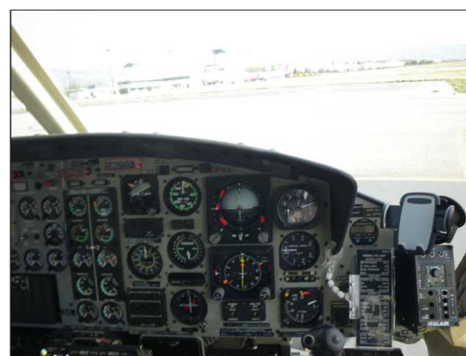
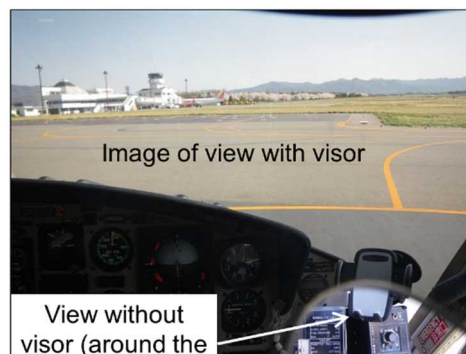
Photo 22: eye level in the cockpit

With two side mirrors installed around the foot part of the outside of the helicopter's window, the view could be limited. When looking at the pilot's face with the visor lowered, the opening state of eyes and his facial expressions were not recognized.

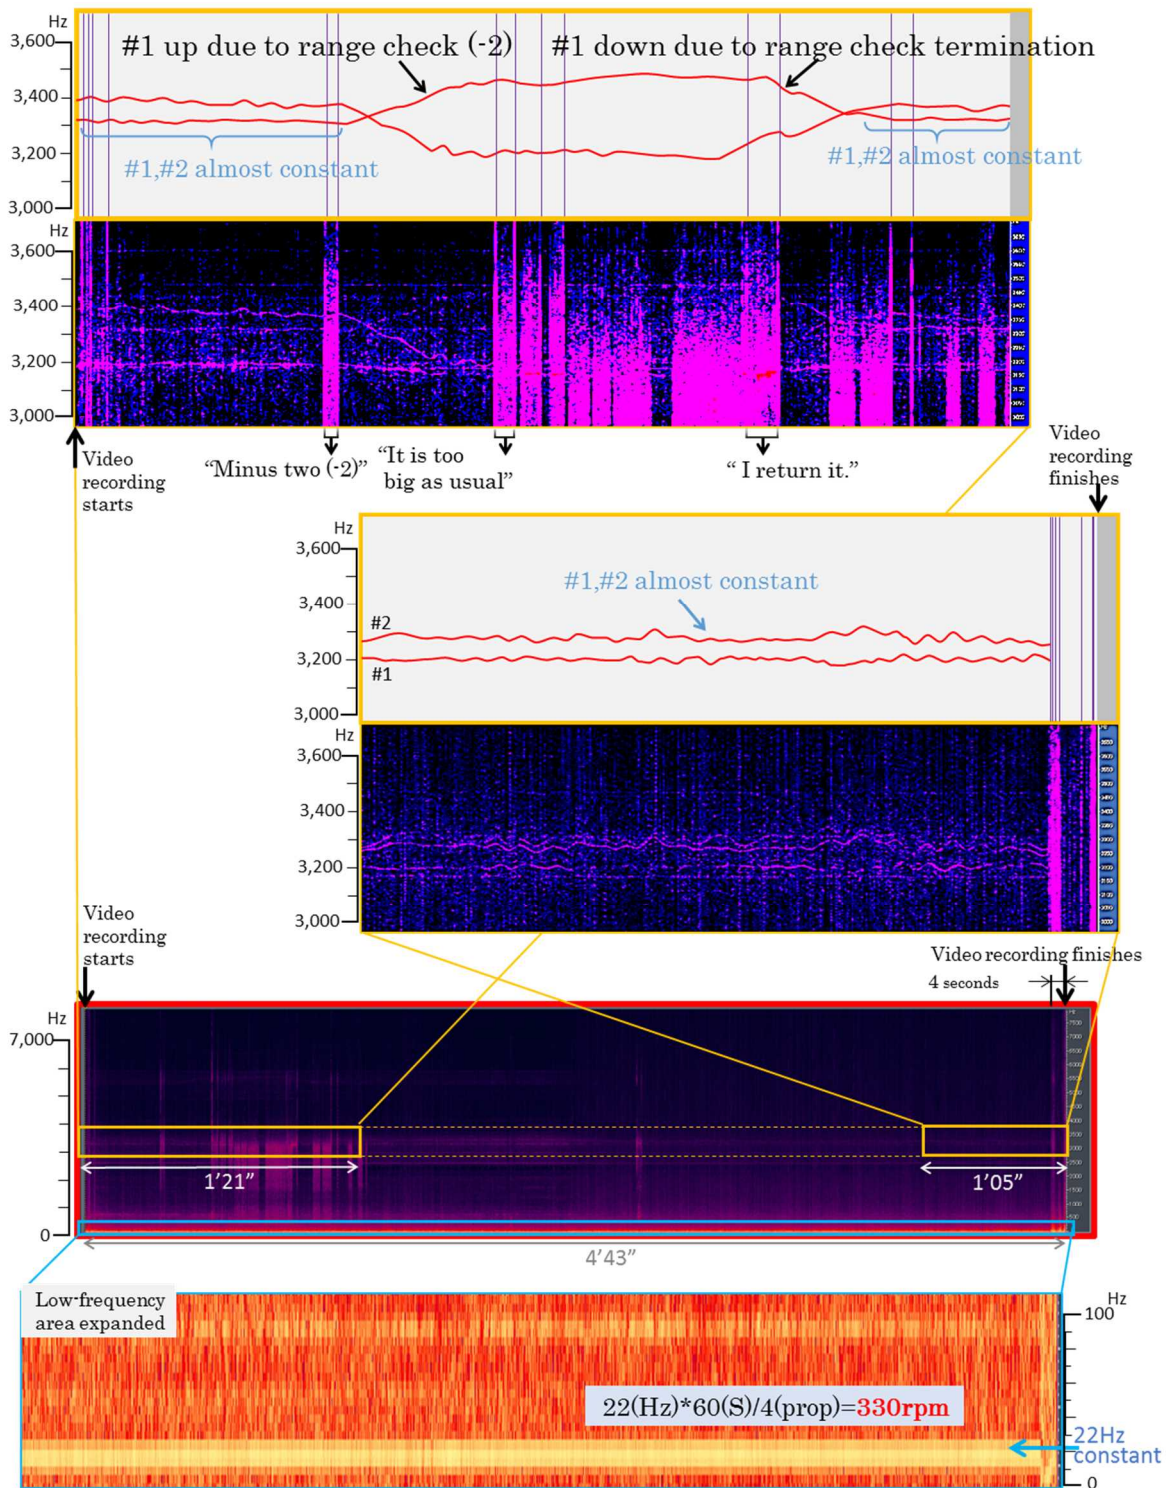
Figure 7: audio spectrum inside the helicopter

An audio spectrum of approximately 3,300 Hz and an audio spectrum of approximately 3,400 Hz, which were transmitted at a constant frequency respectively. However, immediately after the voice of “minus two”, in the former case, the frequency increased by approximately 200 Hz, while in the latter, the frequency decreased by approximately 200 Hz. Those frequencies returned to original frequencies and they were constantly transmitted again, immediately after the voice saying “I return it.”

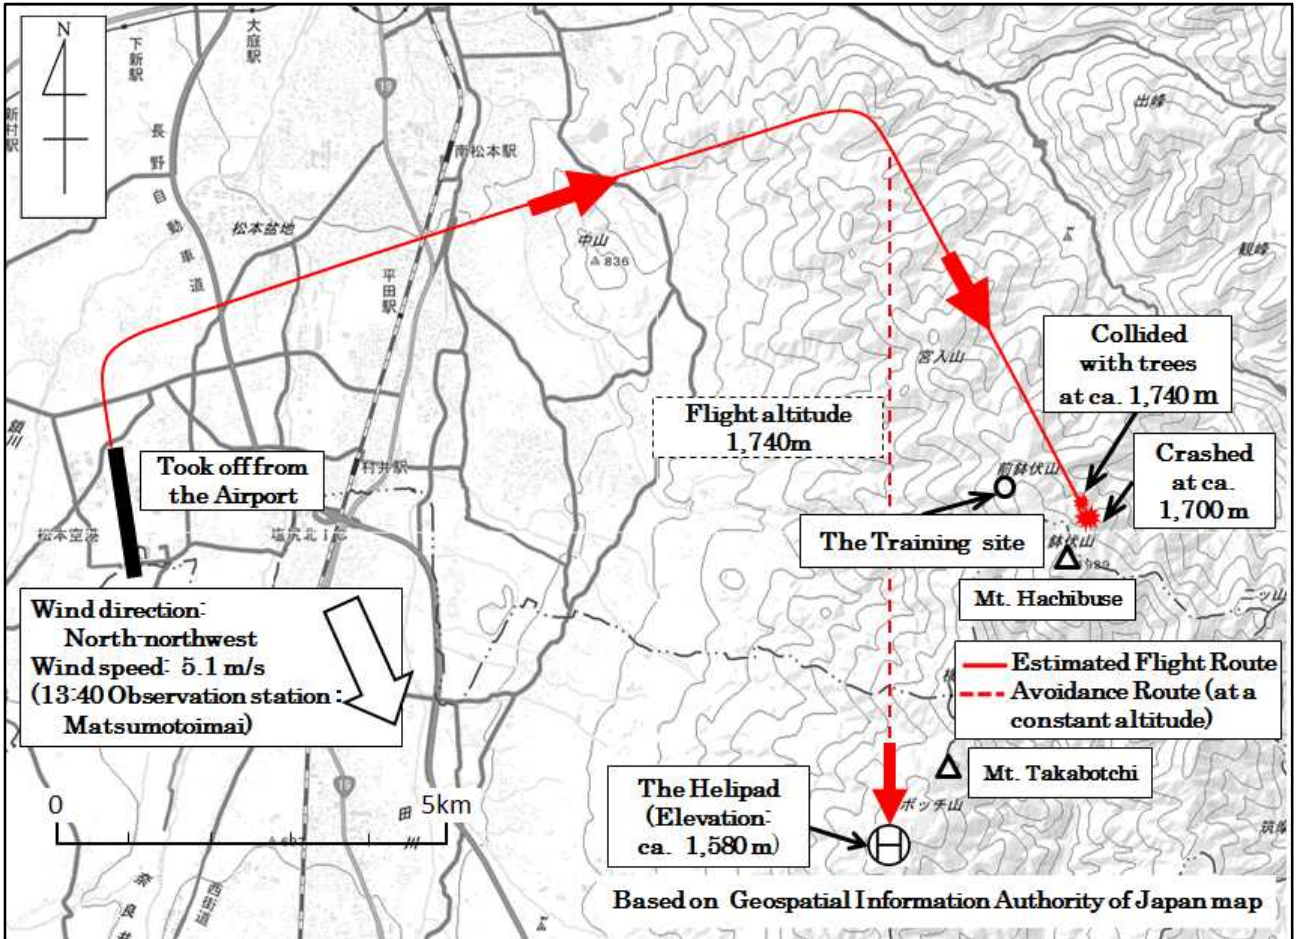
Figure 10: avoidance route (at a constant altitude)

It is probable that the helicopter should have gone directly to the Helipad after turning right by taking the avoidance route (at a constant altitude) as shown in Figure 10 in order to continue flying with the maximum safe altitude from the ground (150 m) without changing flight altitude.

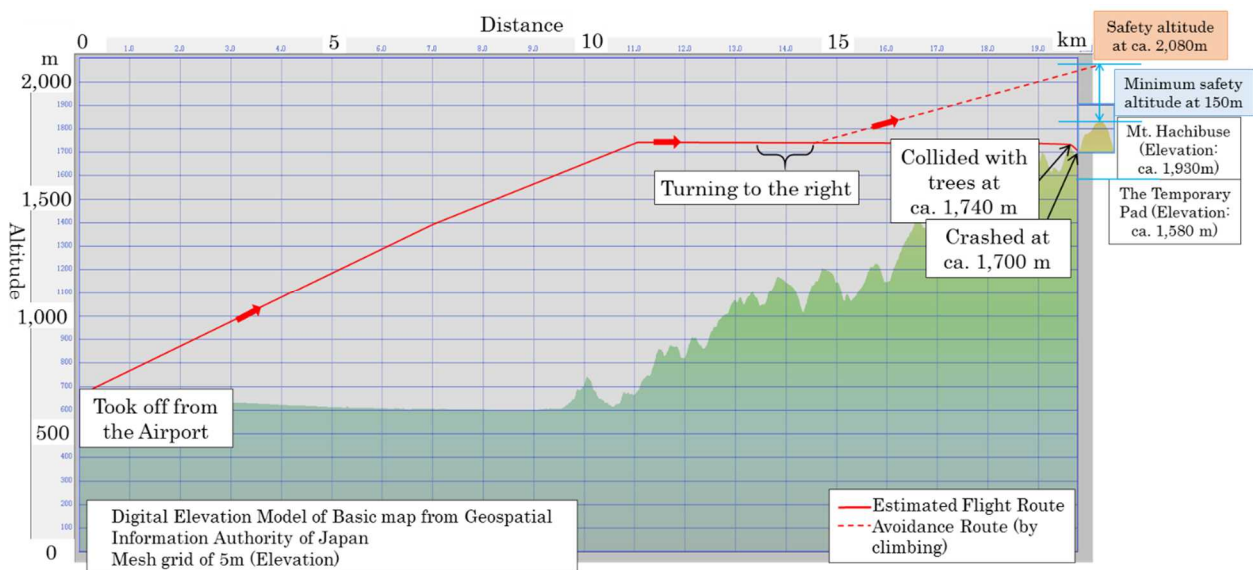
Figure 11: avoidance route (by climbing)

It is highly probable that, in order to pass on the beam of the Training site maintaining the maximum safe altitude of 150 m above Mt. Hachibuse, which was the highest mountain in the vicinity, it was necessary for the helicopter to climb about 340 m after turning right by taking the avoidance route (by climbing) as shown in Figure 11.

However, it is somewhat likely that while maintaining the maximum safe altitude, the helicopter took neither the avoidance route at a constant altitude by directly heading for the Helipad nor the avoidance route by climbing, instead, it continued to fly toward Mt. Hachibuse at a constant altitude after turning right, its AGL became lower as flying into over the mountains region, and the helicopter approached the ground.
