# AIRCRAFT SERIOUS INCIDENT INVESTIGATION REPORT

MULTIPLE MALFUNCTIONS  
IMPEDING THE SAFE FLIGHT OF AIRCRAFT,  
GULFSTREAM AEROSPACE G-IV, N146BG  
PRIME JET, LLC  
AT AN ALTITUDE OF ABOUT 13,200 m  
ABOUT 300 km SOUTHWEST OF  
TOKYO INTERNATIONAL AIRPORT  
AT AROUND 19:58 JST, MAY 22, 2020

Adopted by the Japan Transport Safety Board

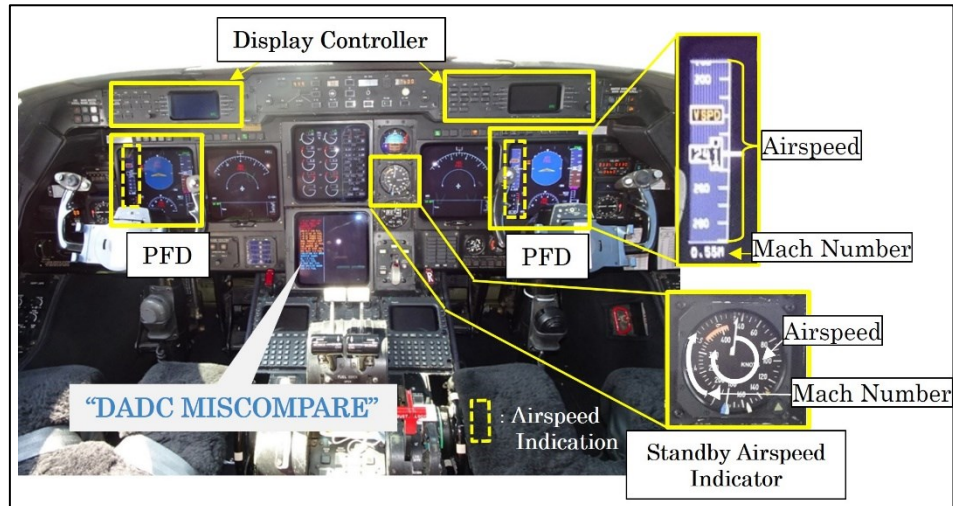
Figure 2 Cockpit

Approximately one hour before landing at Tokyo International Airport, the message “DADC MISCOMPARE” indicating a mismatch between two DADCs was displayed on the Engine Indication and Crew Alerting System (EICAS). At this time, the PFD in the left seat displayed the data calculated by No. 1 DADC and the PFD in the right seat by No. 2 DADC (until (a) in Figure 4), and each PFD did not display a flag (Red X mark) indicating a DADC failure.

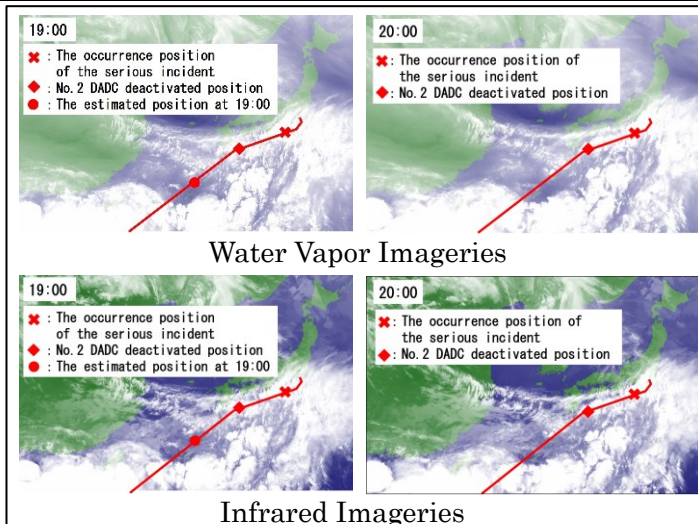
Figure 6 Weather Satellite Imageries (Excerpt)

In addition, according to the infrared image, the area around the flight route of the aircraft during the time of the serious incident was shown in white, and high cloud top height clouds were observed.

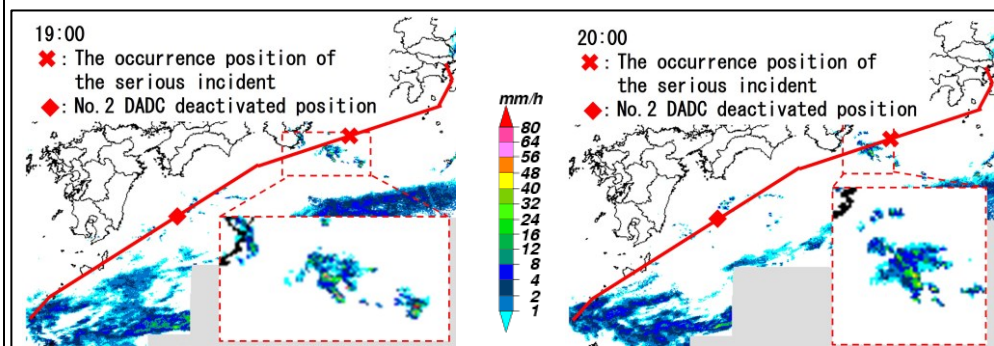
Figure 8 Radar Composite Chart (Echo Intensity) (Excerpt)

In addition, it was analyzed that the maximum echo intensity in the echo area at each cloud top height was 4 to 8 mm/h and 40 to 48 mm/h, respectively.

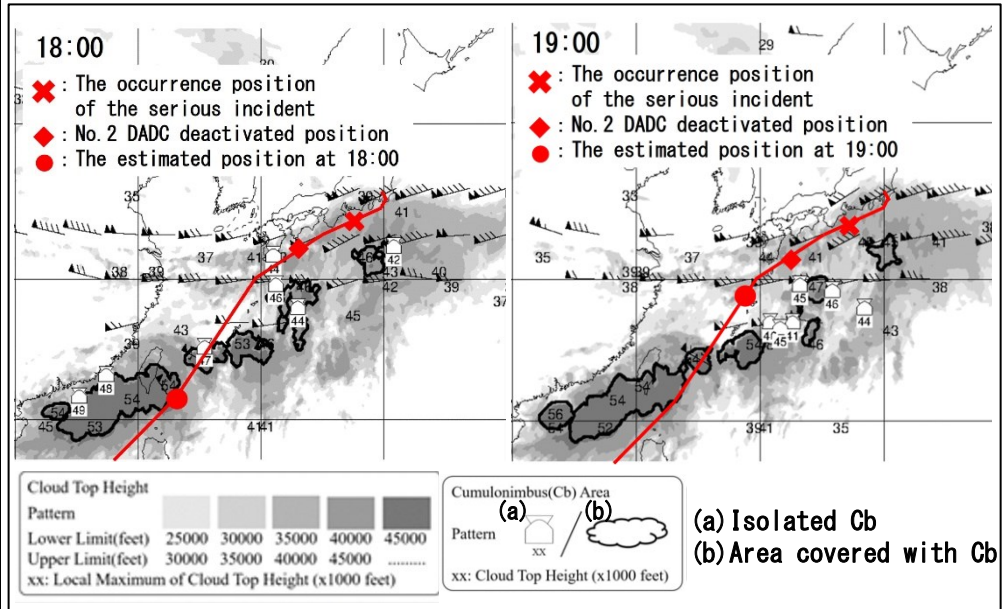
Figure 9 Wide area cloud imagery information (TSAS1 Excerpt)

According to the wide-area satellite imagery information analyzed automatically based on the information from the weather satellite every hour, it was analyzed as of 18:00 that the cumulonimbus cloud area with the maximum cloud top height of 54,000 ft south of Taiwan, the isolated cumulonimbus cloud with the cloud top height of 47,000 ft and the cumulonimbus cloud area with the maximum cloud top height of 53,000 ft south of Okinawa.
