AIRCRAFT ACCIDENT INVESTIGATION REPORT

AIRCRAFT DAMAGE DURING TAKE-OFF

BOEING 747-400F, N404KZ (USA REGISTRY)

NARITA INTERNATIONAL AIRPORT

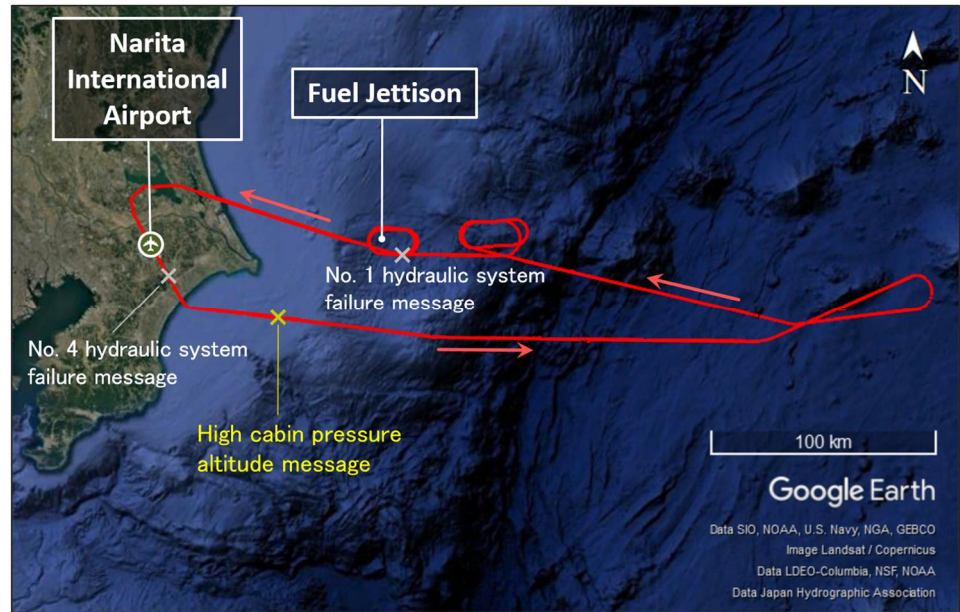
Figure 2: Estimated Flight Route and Location of Each Event

While the aircraft was climbing, at an altitude of about 12,000 ft, the EICAS displayed the “CABIN ALTITUDE” (Warning) message at 21:52, indicating the high cabin pressure altitude. The flight crew members therefore checked the cabin pressure altitude and found that it was indicating 10,300 ft.

Due to the loss of multiple hydraulic systems, the flight crew were unable to use the steering function and automatic brakes, therefore, they reduced the speed using the manual brakes during landing.
