AIRCRAFT ACCIDENT INVESTIGATION REPORT

Northwest Airlines
Boeing 747-251B N637US
New Tokyo International Airport
March 1, 1994

November 29, 1996

AIRCRAFT ACCIDENT INVESTIGATION COMMISSION

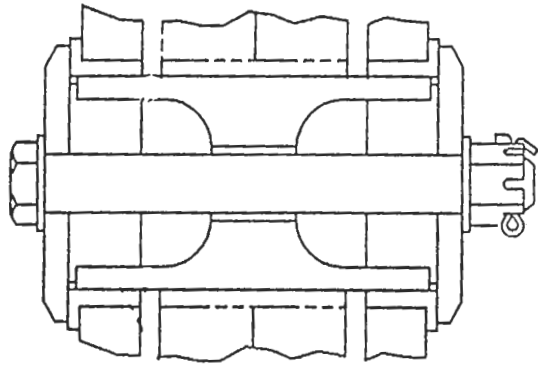
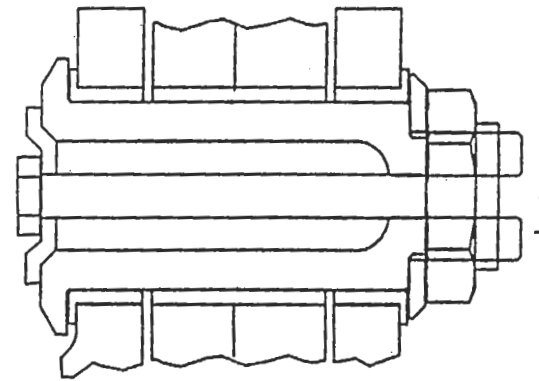
Figure 7 Shapes of Fuse Pins

At the time of the accident, the fuse pin of the aircraft was undergoing a modification, from the bulkhead type fuse pin of high tension steel to the third generation bore type fuse pin of stainless steel with modified shape and increased strength. (See Figure 7)

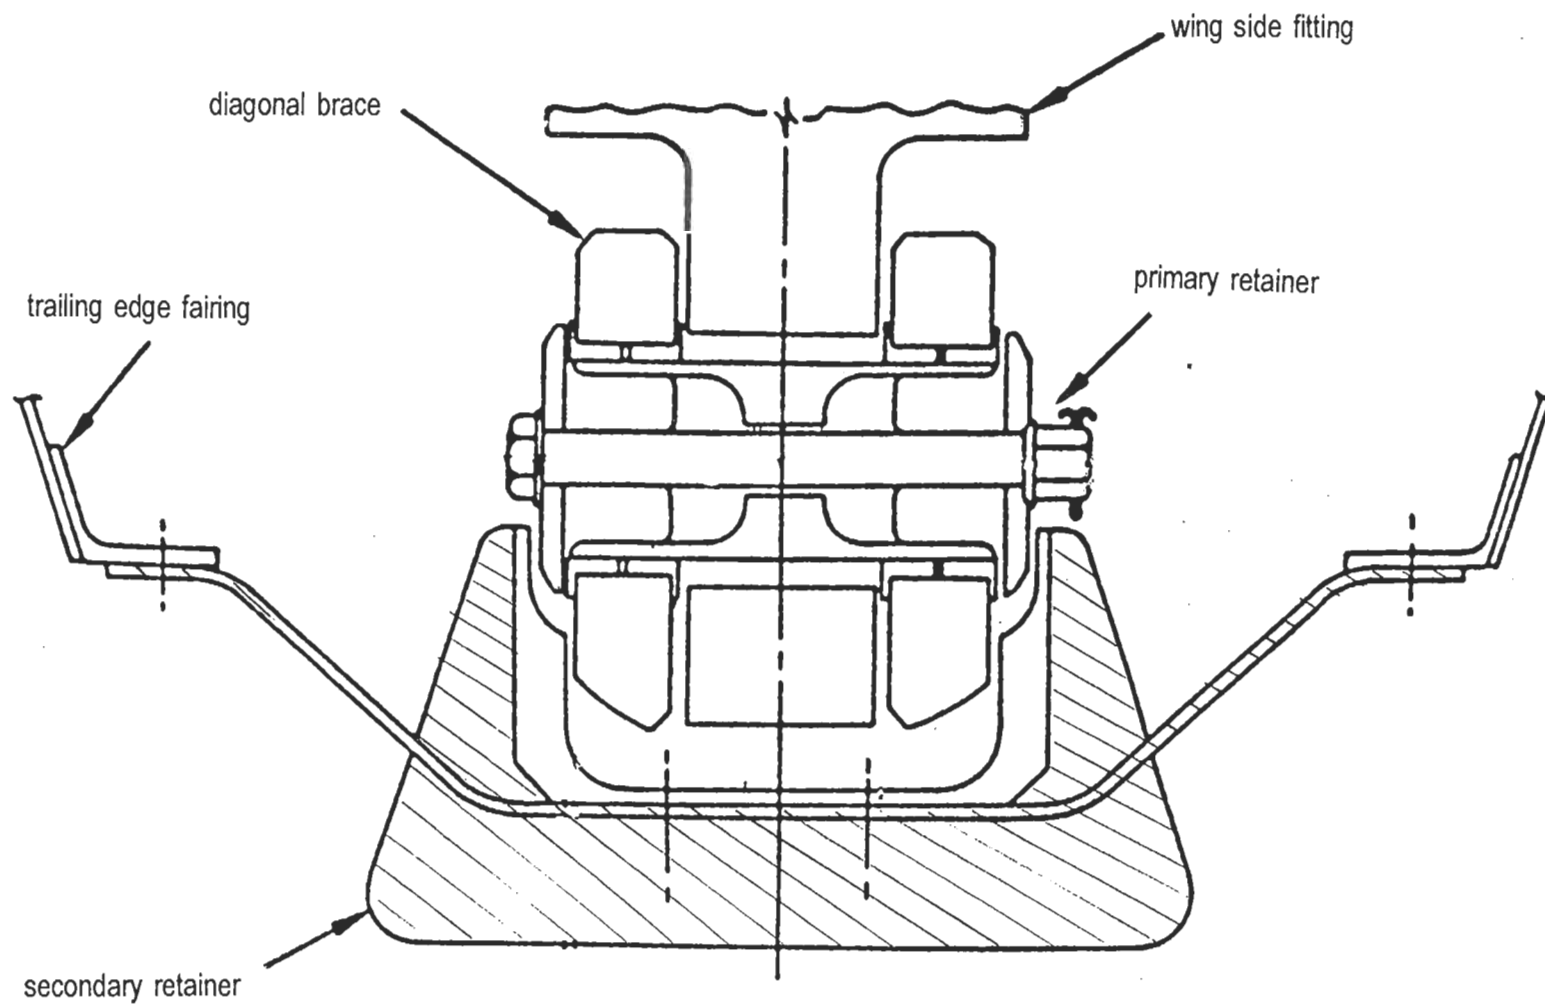
Figure 8 Schematic of Secondary Retainer of Diagonal Brace Aft Fuse Pin

Fuse pins are equipped with retainers for the purpose of preventing them from coming out. The bulkhead type fuse pins are provided with primary retainers and secondary retainers. The primary retainer is a set of 2 caps, 1 bolt, 1 nut and 2 washers and the secondary retainer is used to attach the C shaped bracket. (See Figure 8 and Photo 8)

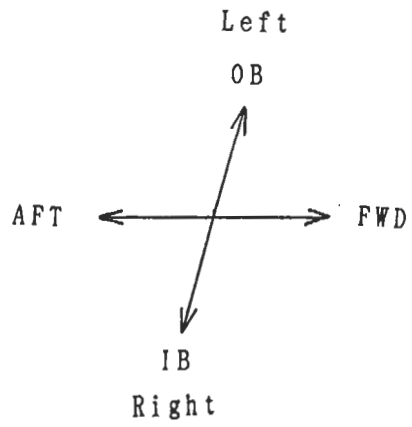
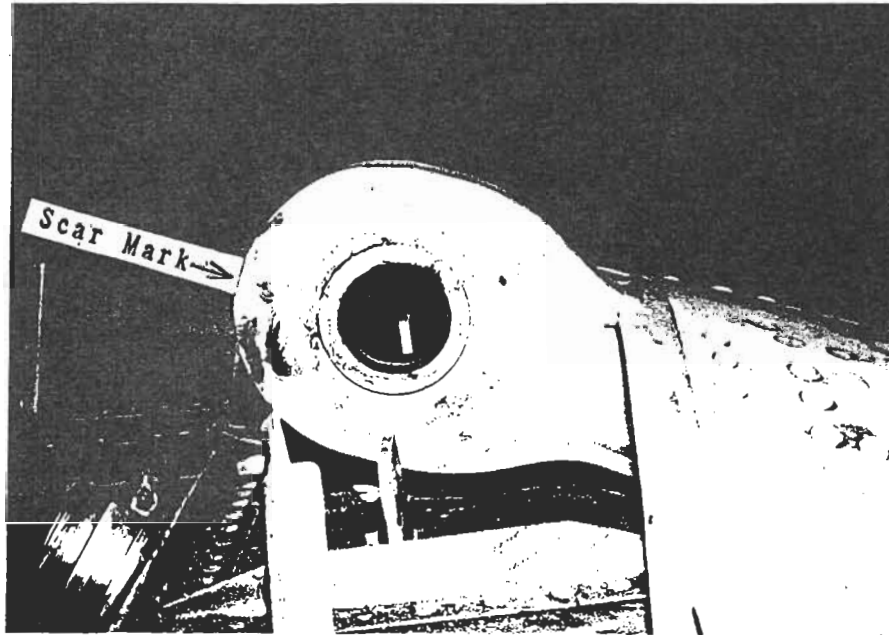
Fig.4 Photo of Pylon Rear Mount Bulkhead Fitting from IB or Right Side

5 The strut rear mount bulkhead fitting made of aluminum alloy is designed to hold the pin through a bushing made of beryllium-copper alloy. The hole into which the bushing of the fitting is inserted, has a diameter of approximately 54 mm and is approximately 38 mm long and the thickness of the wall which supports the load is approximately 37 mm. The measurement of the deformation of the hole disclosed that the hole had been slightly deformed into an oval shape, with the inner diameter in the $90^\circ \sim 270^\circ$ direction being approximately 0.4 ~ 0.8 mm greater than that in $0^\circ \sim 180^\circ$ direction.

Assuming that this deformation was caused by an excessive load, it can be deduced to approximately 1003 kN from the yield stress of Boeing materials specification and the dimensions of the fitting. When this load is converted to the shearing load applied to the pin, it becomes 857 MPa which exceeds the shearing strength of 788 MPa calculated from the tensile strength of 1365 MPa obtained from the Vickers hardness measured on the fractured fuse pin using the Mises equation (shearing stress $\tau = \text{tensile stress } \sigma / \sqrt{3}$) and it also exceeds the shearing strength of the fuse pin calculated using the Mises equation from the value of the tensile strength given in Boeing materials specification.

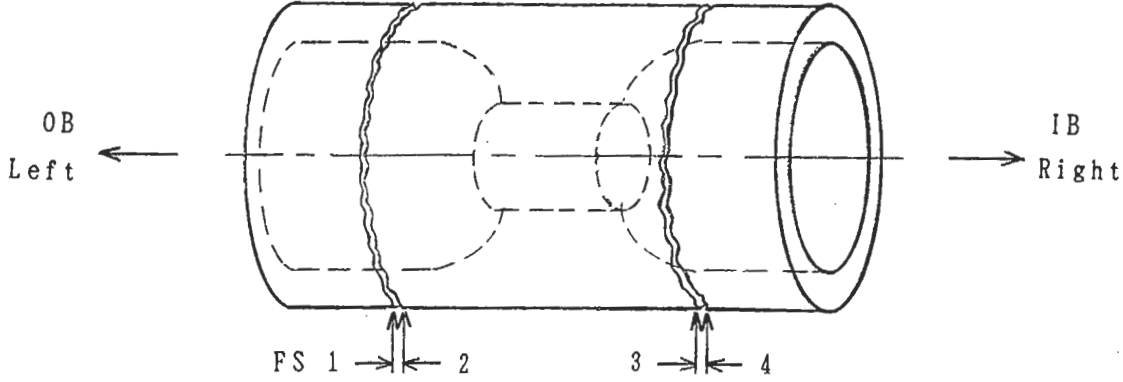
Fig.5 Macro-photo and Schematic of Upper Link FWD Fuse Pin

1 The fuse pin is a pillar with the total length of approximately 82 mm and the diameter of approximately 48 mm, with Cr-plated outside and Cd-plated inside, of tempered steel. Portions approximately 30 mm from both ends are of a cylindrical shape, approximately 5 mm thick, the center portion approximately 42mm are fitted into the bulkhead and both left and right ends approximately 20 mm long are fitted into the upper link forward fork. The fuse pin had been broken into 3 fragments.

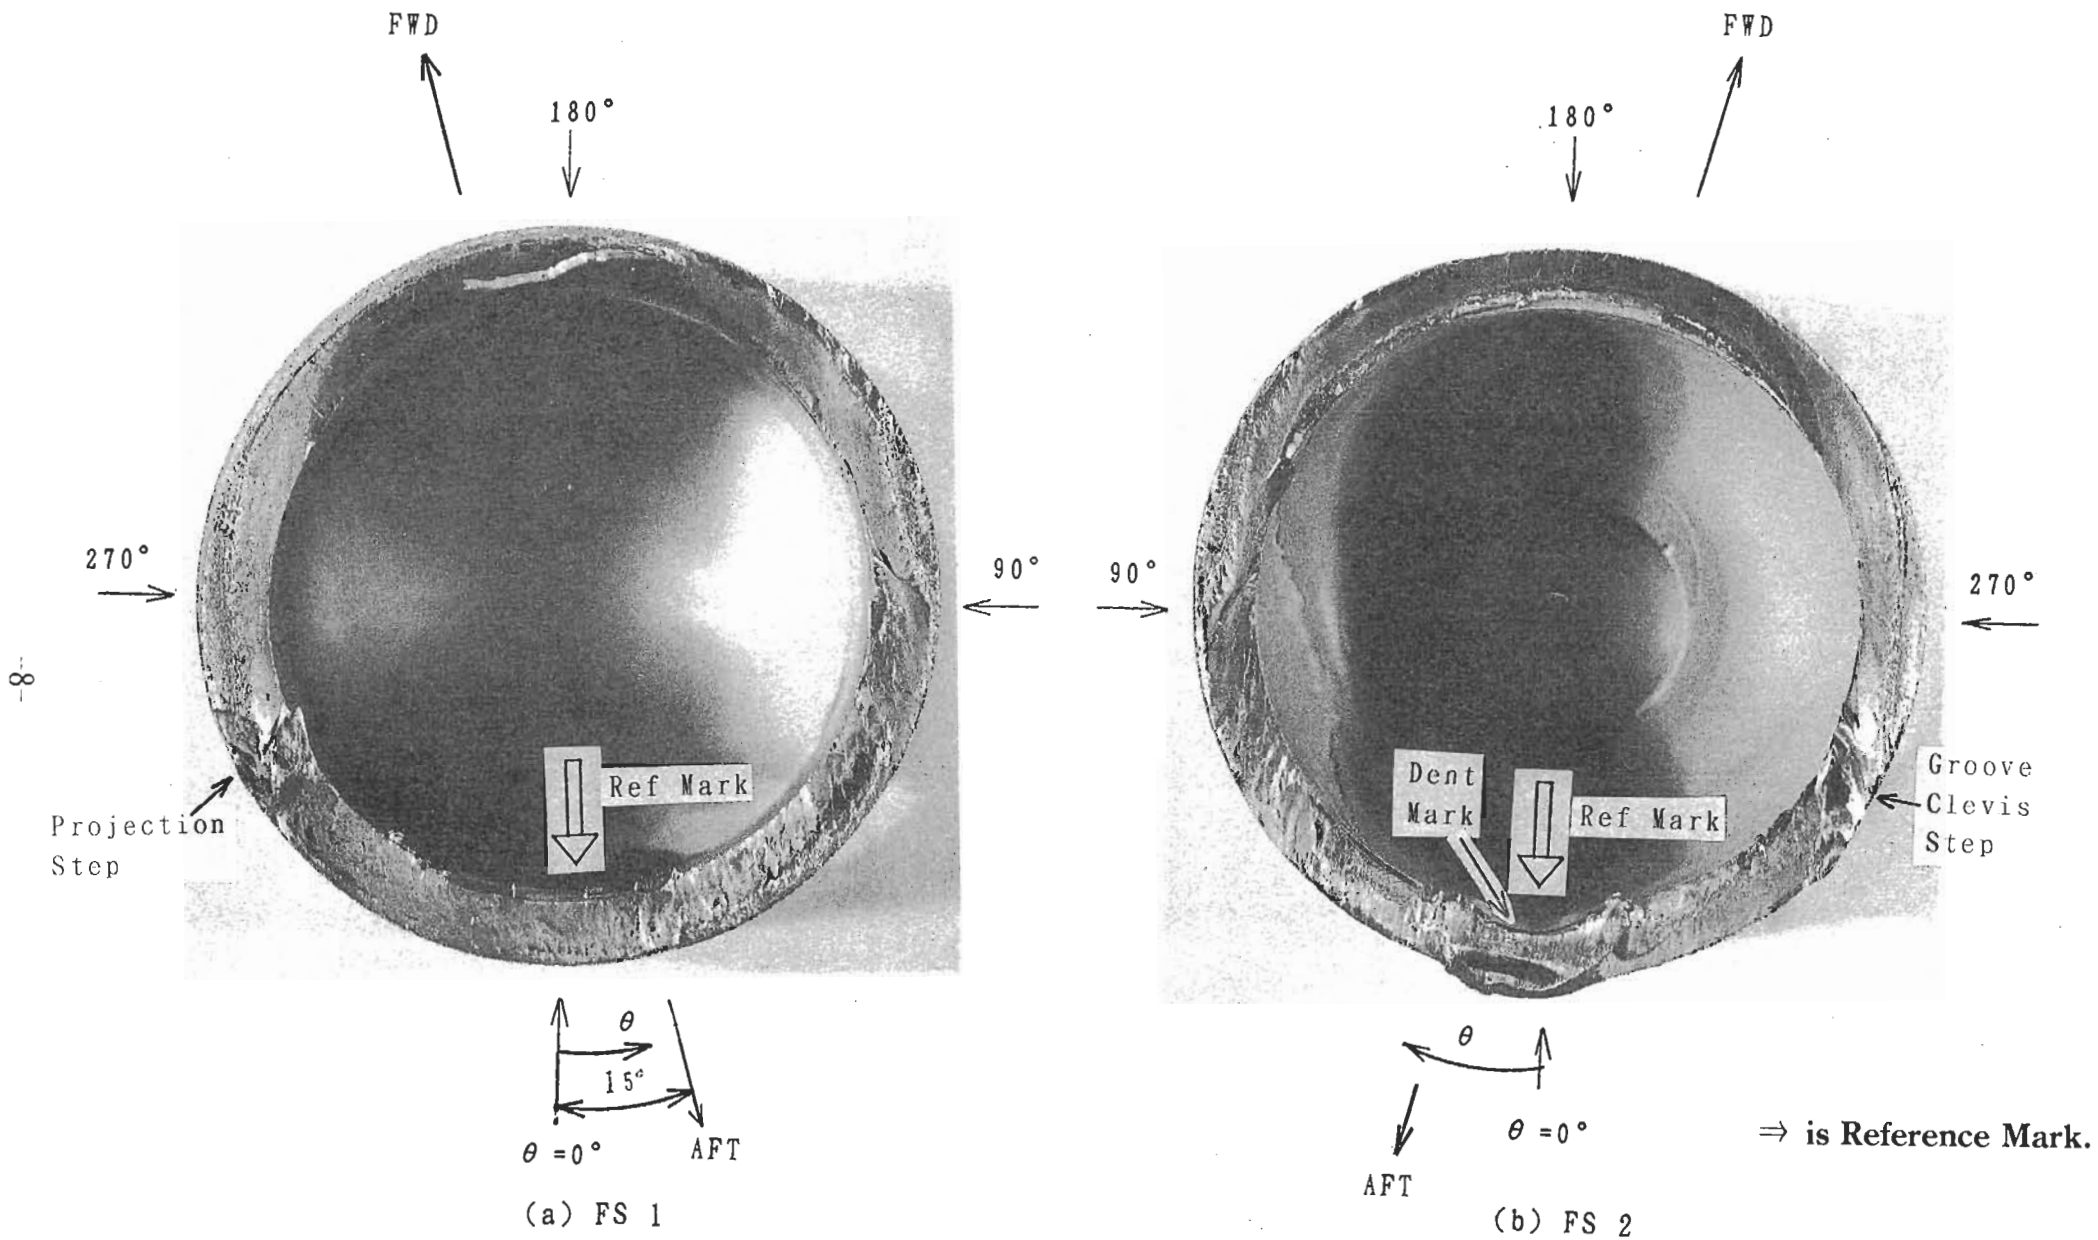
Fig.6-1 Macro-photos (part 1, FS 1 and 2) of Fractured Surfaces of Upper Link FWD Fuse Pin

First of all, the pair of the fractured surfaces 1-2, and the pair of 3-4 were found matching well and no significant differences between the pairs of fractured surfaces 1-2, and 3-4 were noted.

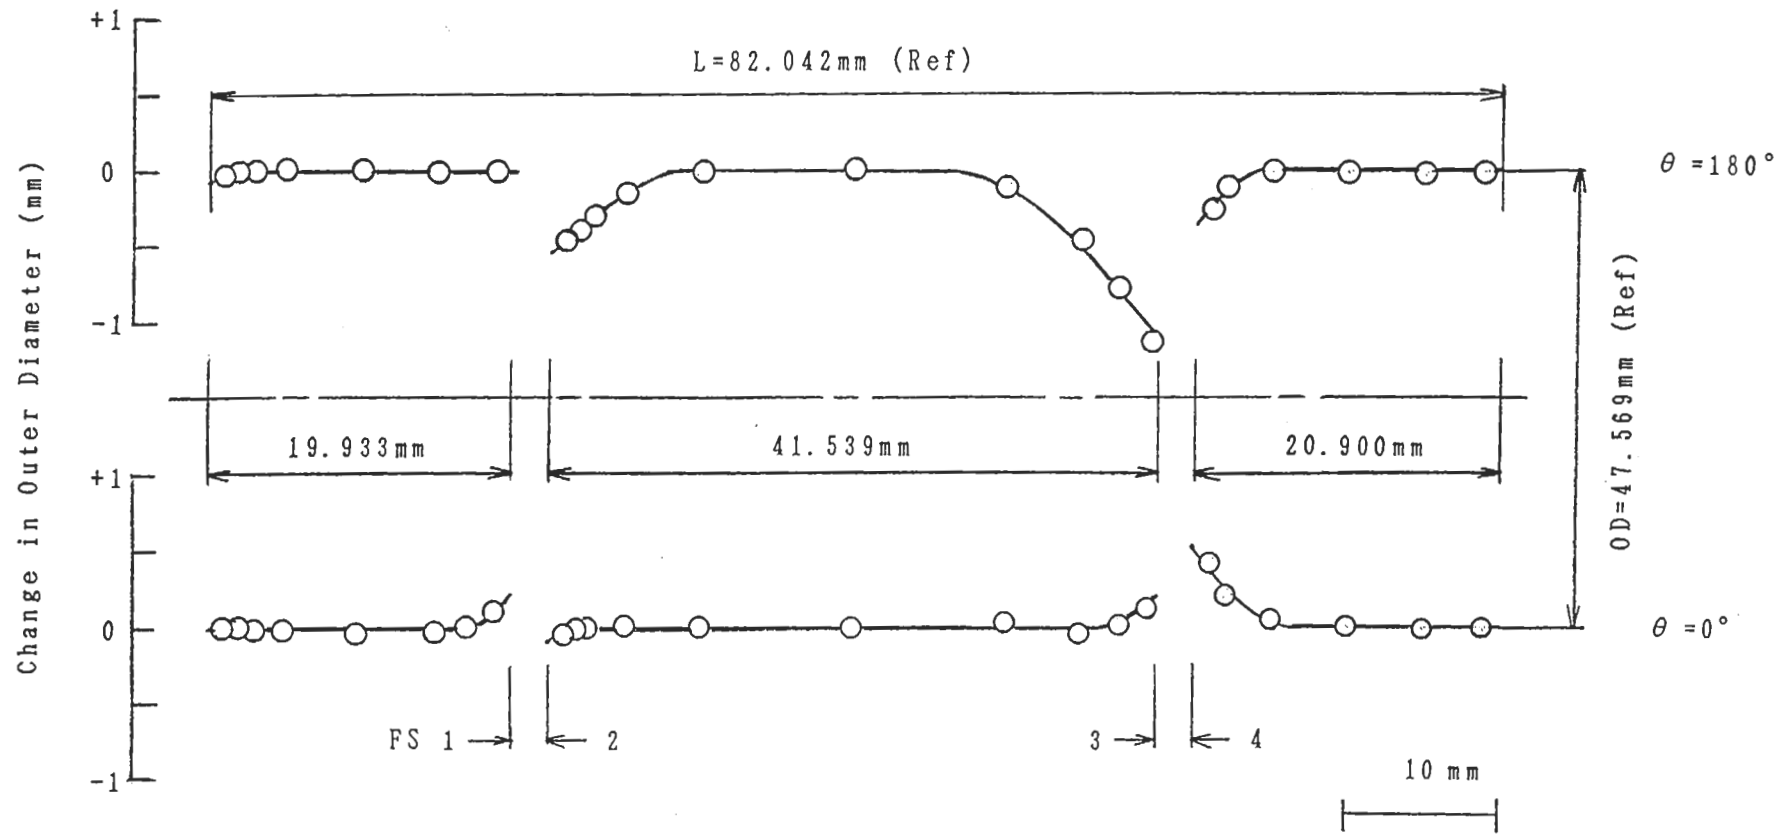
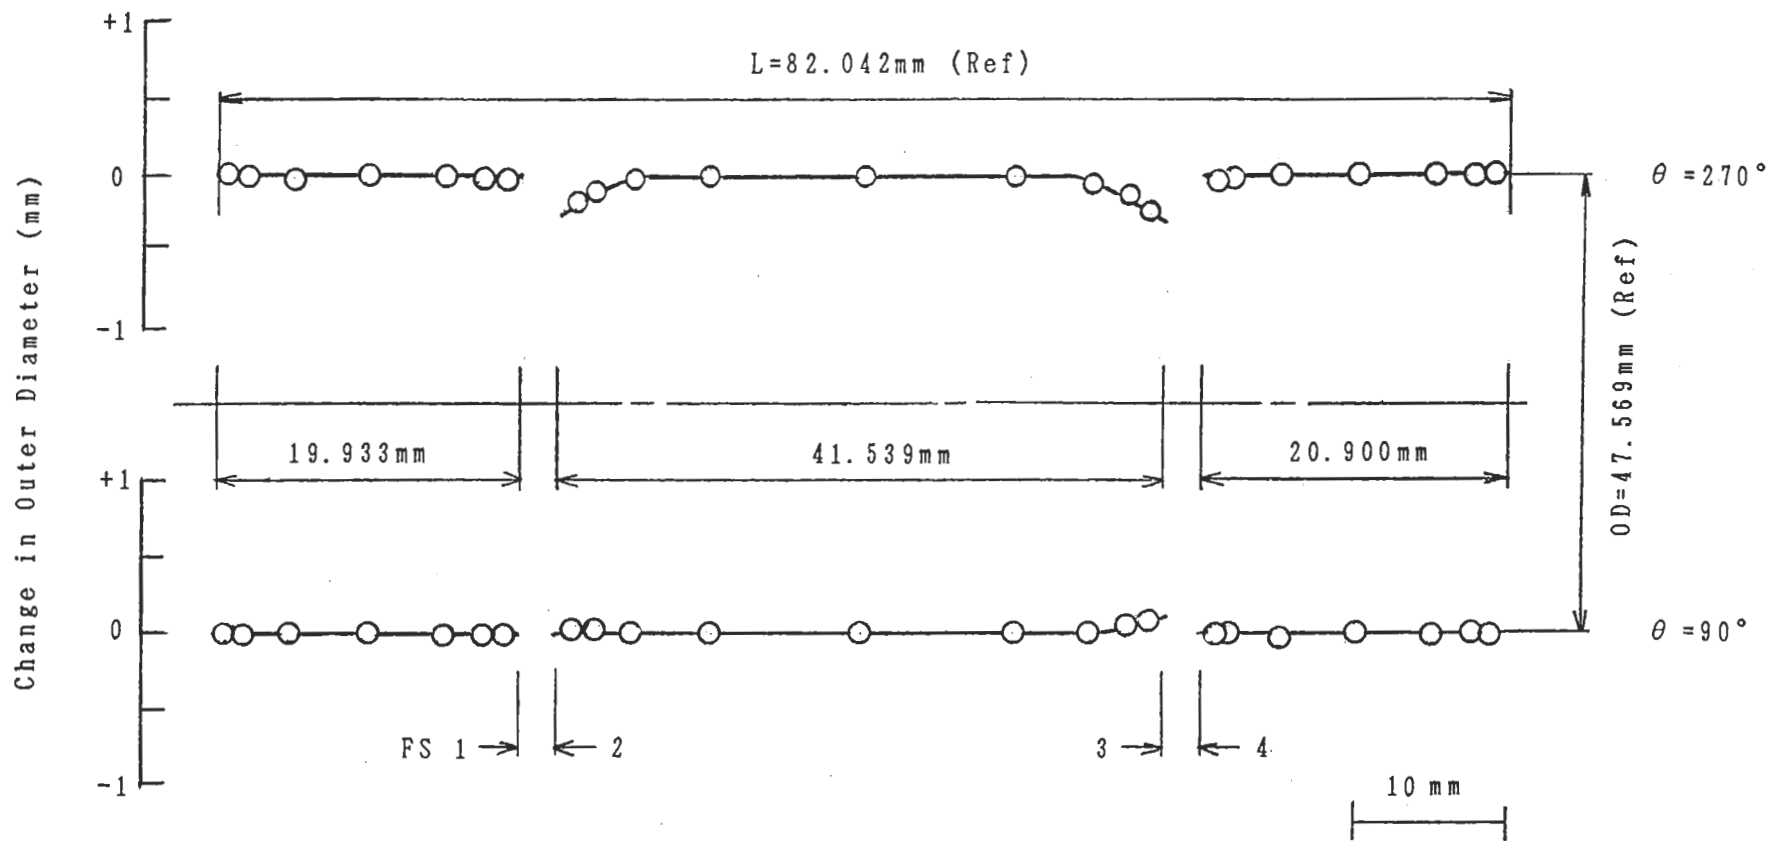
Fig.14 Change of Outside Diameter of Upper Link FWD Fuse Pin in Axial Direction (Part 1, Positions at $\theta = 0^\circ$ and 180° from Reference Mark)

Fig.14 Change of Outside Diameter of Upper Link FWD Fuse Pin in Axial Direction (Part 2, Positions at $\theta = 90^\circ$ and 270° from Reference Mark)

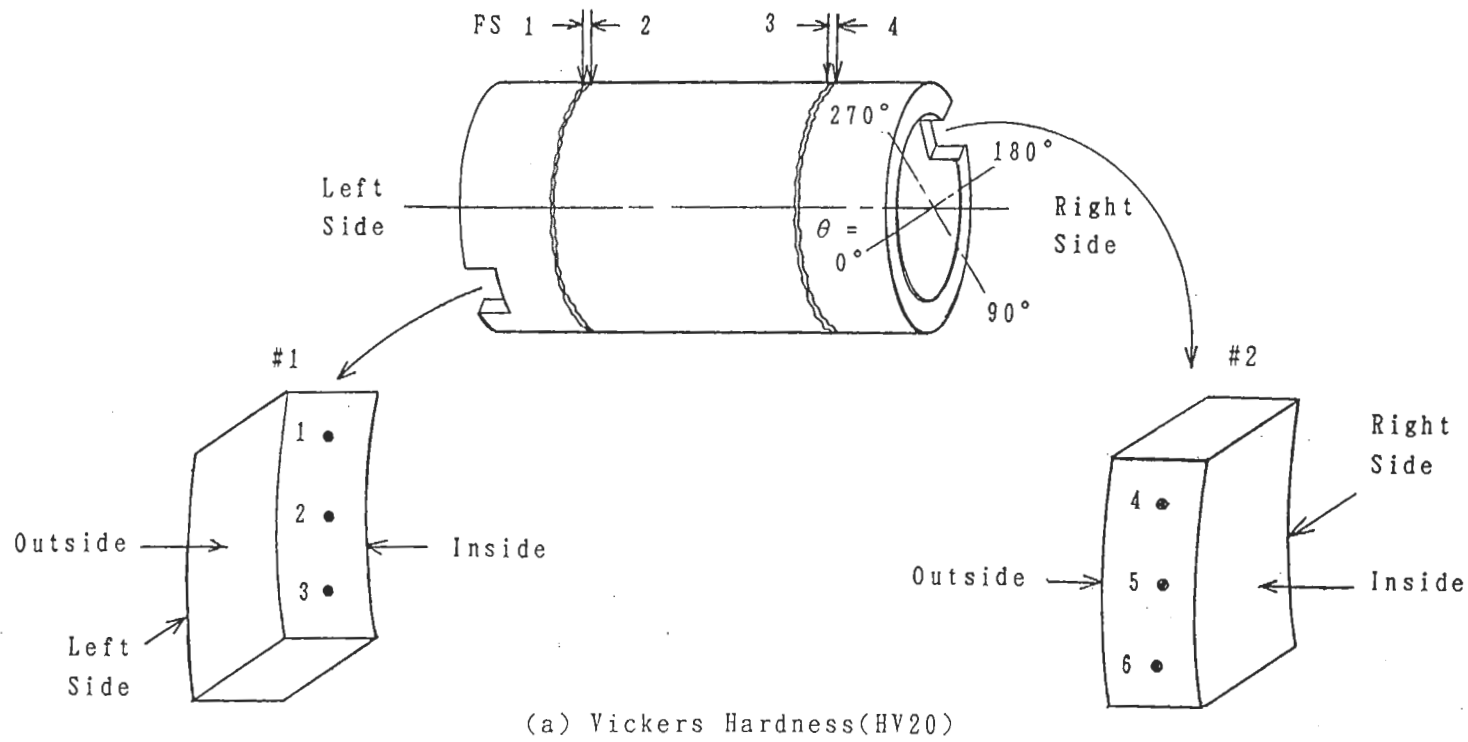
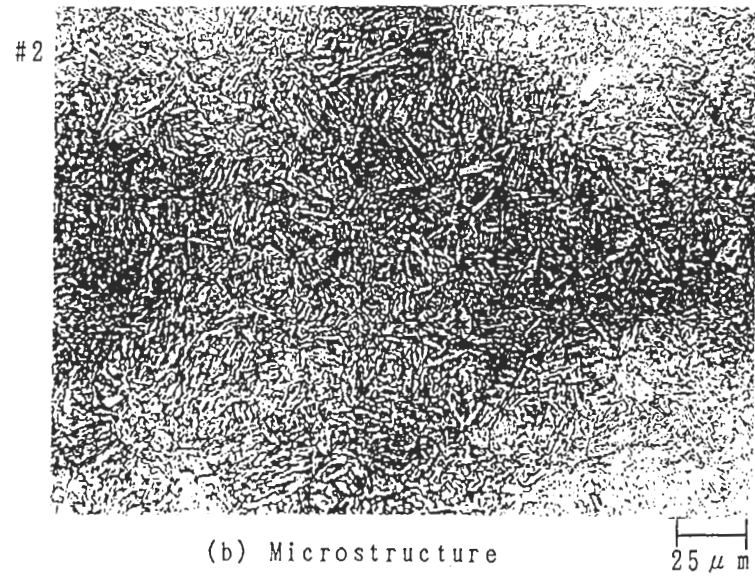
Fig.17 Hardness Measurement and Photo of Micro-structure of Upper Link FWD Fuse Pin

- (1) The deformation of the outside diameter of the fuse pin is small on No.1 and 4 fracture surfaces, and big on No.2 and 3 fracture surfaces. It is estimated that this difference was due to the fact that although the outside and the inside of No.1 and 4 fractured surfaces were restrained by the upper link and the insert, respectively, the inside of No.2 and 3 fractured surfaces was exposed to a cavity.

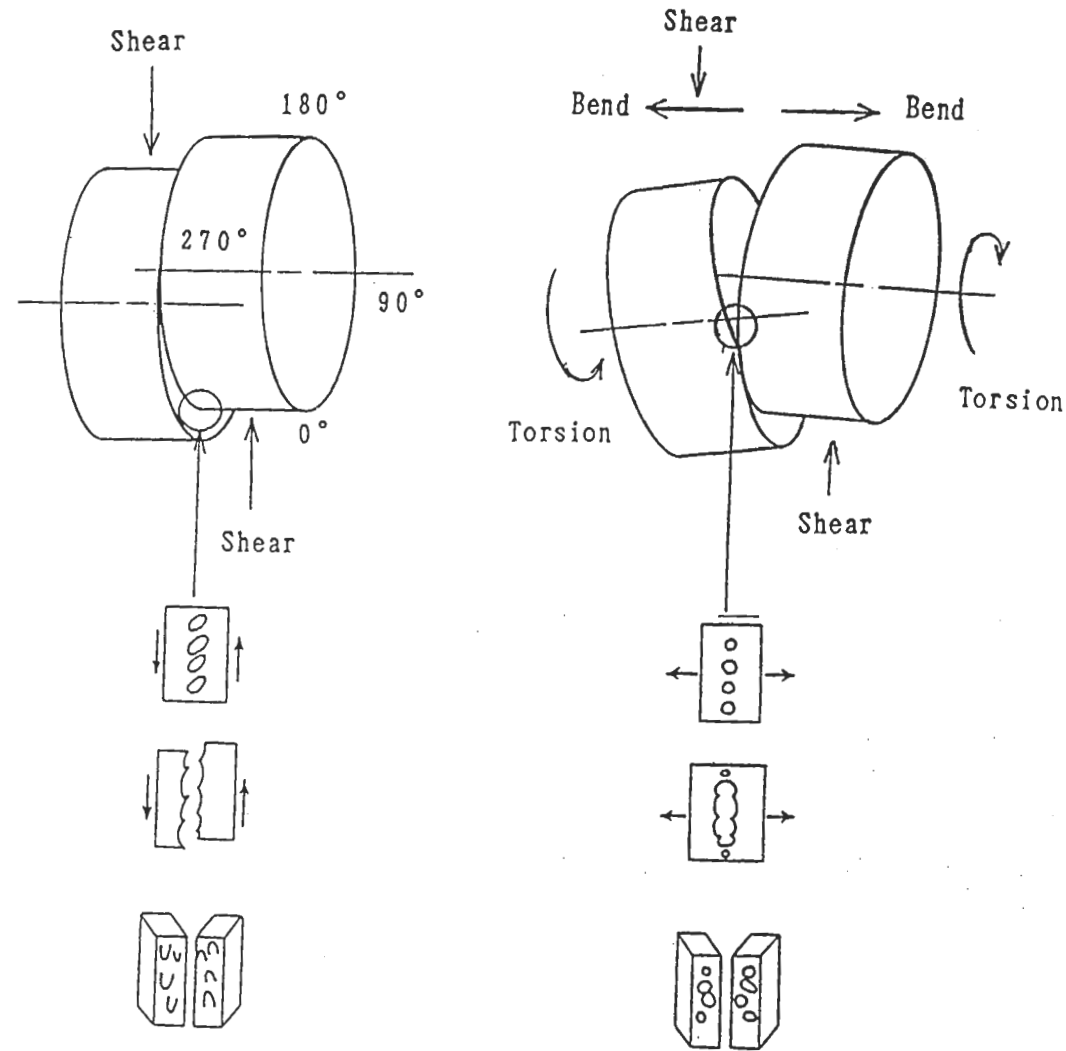
Figure 18 Summary of Destruction and Deformation

- b As a bending load is generated in the vicinities of remaining 90° and 270° portions, the co-axial dimples begin to appear, and the rupture takes place first in the vicinity of 90° portion.

- c Finally, the rupture is completed in the vicinity of 270° portion, but at this point of time, a torsion load is also applied, reversing the dimples on the outside and the inside.

(a) Early phase ... Elongated dimples (b) Later phase ... Co-axial dimple

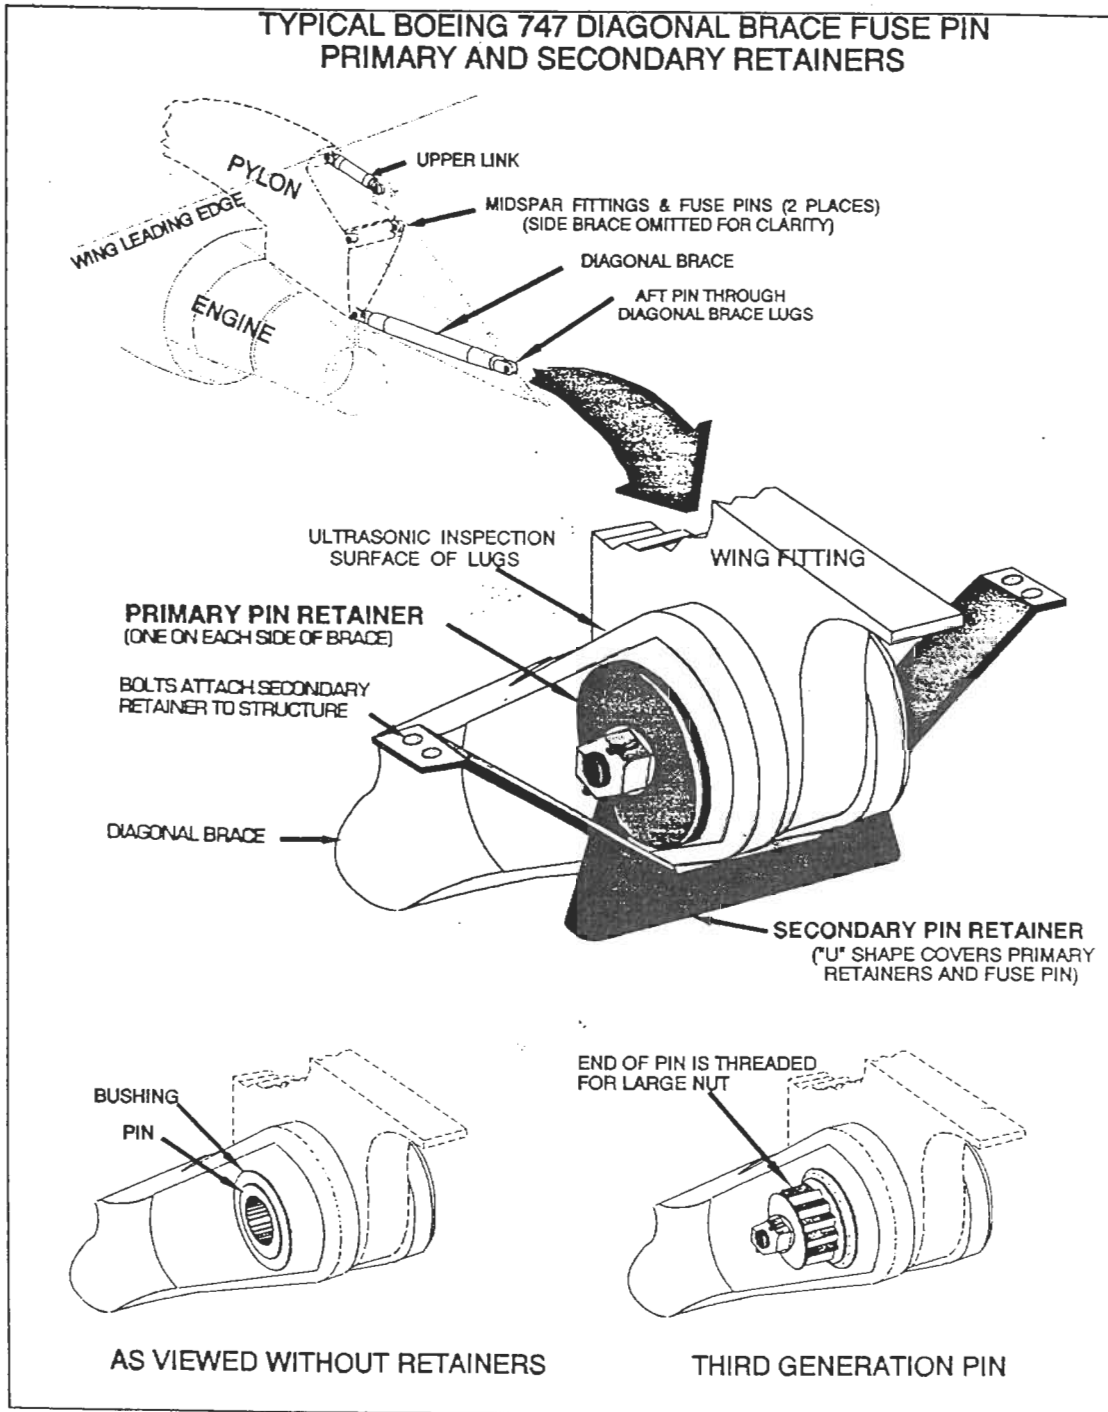
Figure 2.--Diagonal brace attachment details.

Prior to this landing, at some unknown time, the aft fuse pin on the pylon diagonal brace had migrated out of its fitting. The pin was found loose in the pylon structure. It was intact, undamaged, and had no evidence of preexisting defects. The aft diagonal brace fuse pin is normally retained by both a primary retainer (two washer-like retainer caps and a through bolt) and a secondary retention clip (a bolt-on C-shaped bracket). (See figure 2). However, a search of the airplane pylon and engine area, as well as the runway surface at Narita, revealed neither the aft diagonal brace fuse pin primary nor secondary retaining devices.

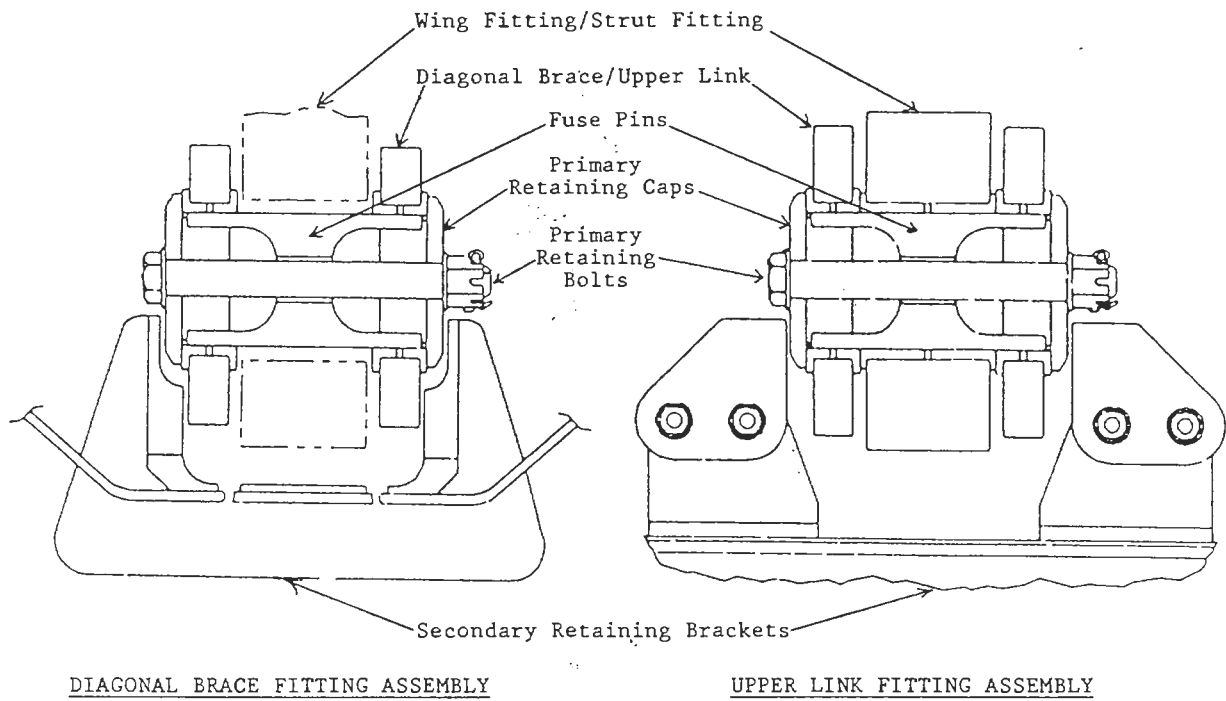
Figure 3.--Diagonal brace and upper link fitting assemblies.

The fractured forward upper link fuse pin from the No. 1 pylon was recovered in three pieces and was retained by the JAAIC for metallurgical examination. Examination of the pin revealed that it fractured in static overload and that there was no evidence of preexisting fatigue.
