AA2011-12

**AIRCRAFT ACCIDENT  
INVESTIGATION REPORT**

**Japan Transport Safety Board**

**NORTHWEST AIRLINES INCORPORATED  
BOEING 747-400, N676NW (THE UNITED STATES OF AMERICA)  
IN THE AIR ABOUT 174 KM SOUTH-SOUTHWEST OF NARITA  
INTERNATIONAL AIRPORT  
AROUND 11:45 JST, FEBRUARY 20, 2009**

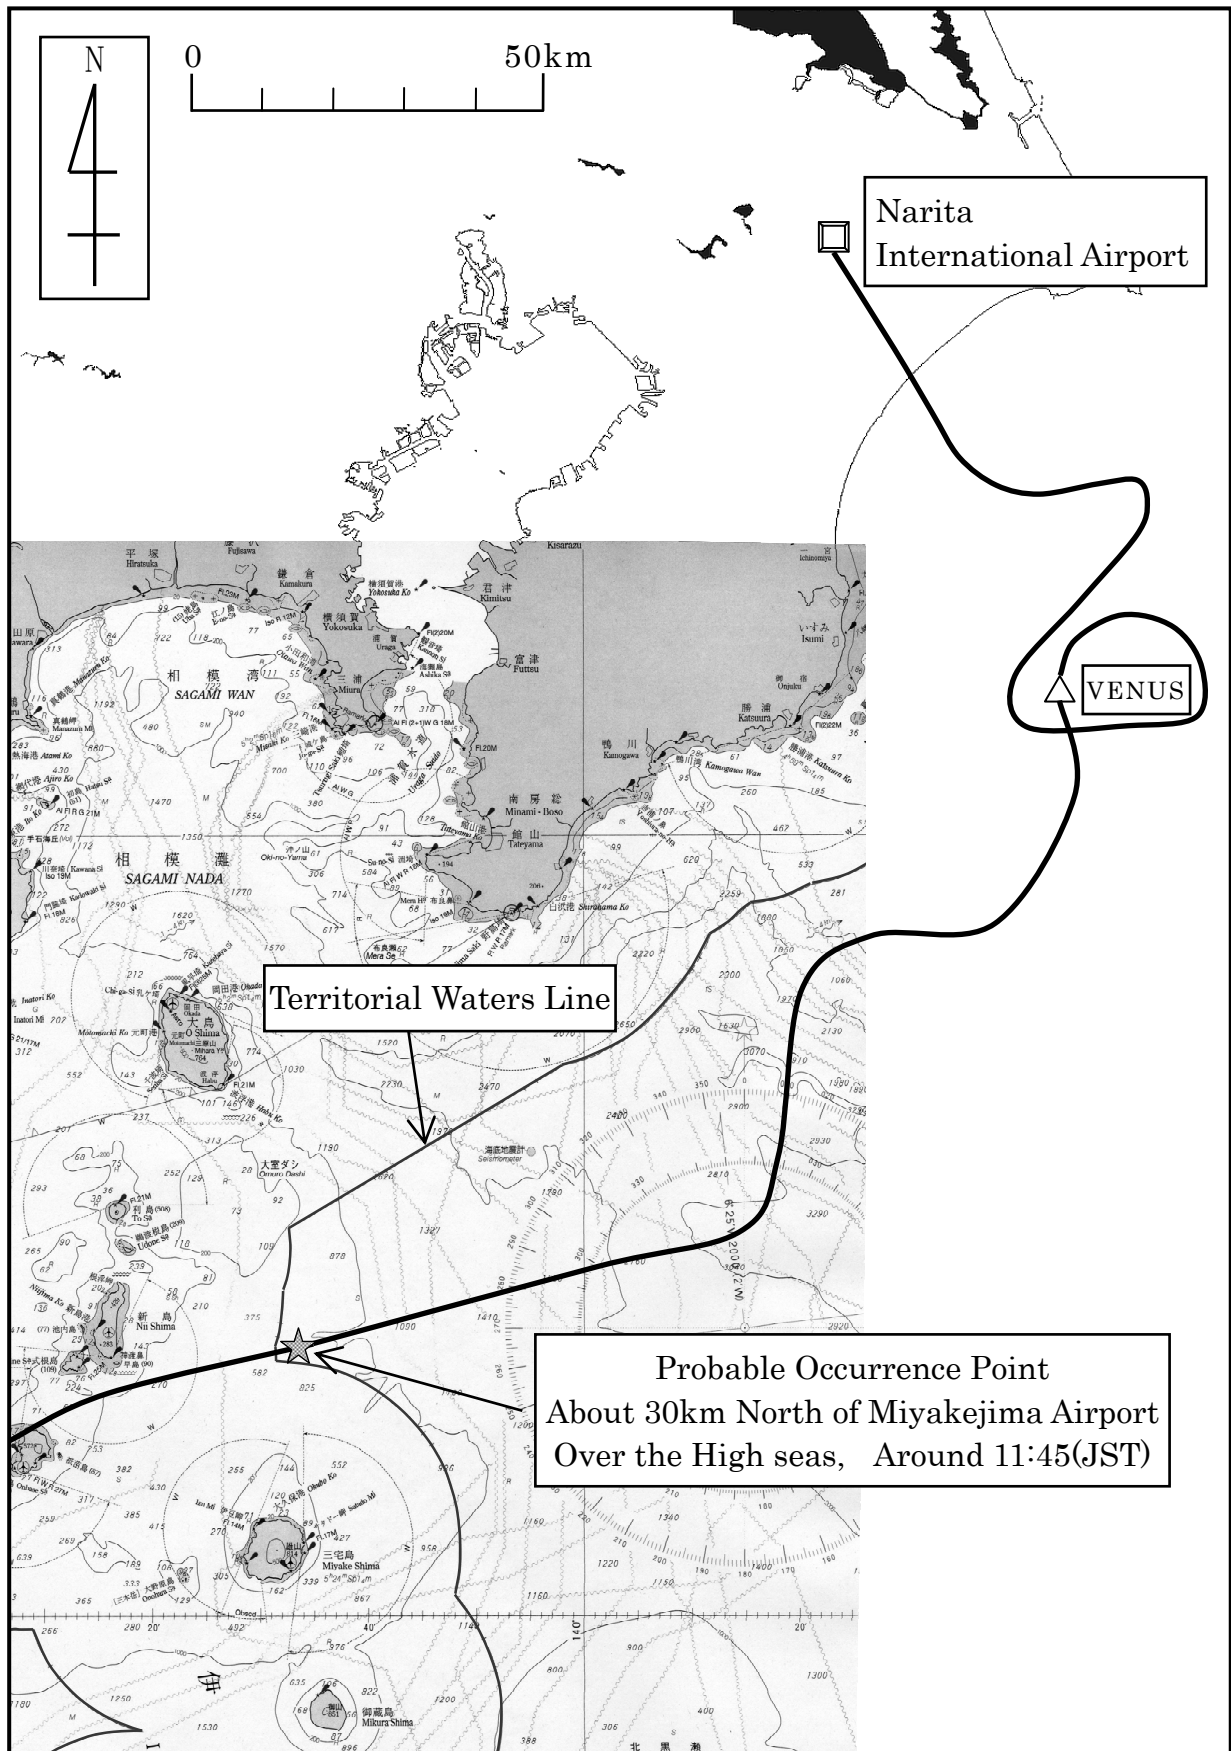
Figure 1 Estimated Flight Route

This accident occurred around 11:45, at an altitude of about 30,300 ft about 174 km south-southwest of Narita Airport (34°20'55" N, 139°33'32" E). (See Figure 1 Estimated Flight Route, Figure 2-1 DFDR Records (1), Figure 2-2 DFDR Records (2), Figure 3 Seat Locations of Injured Persons, Photo 1 The

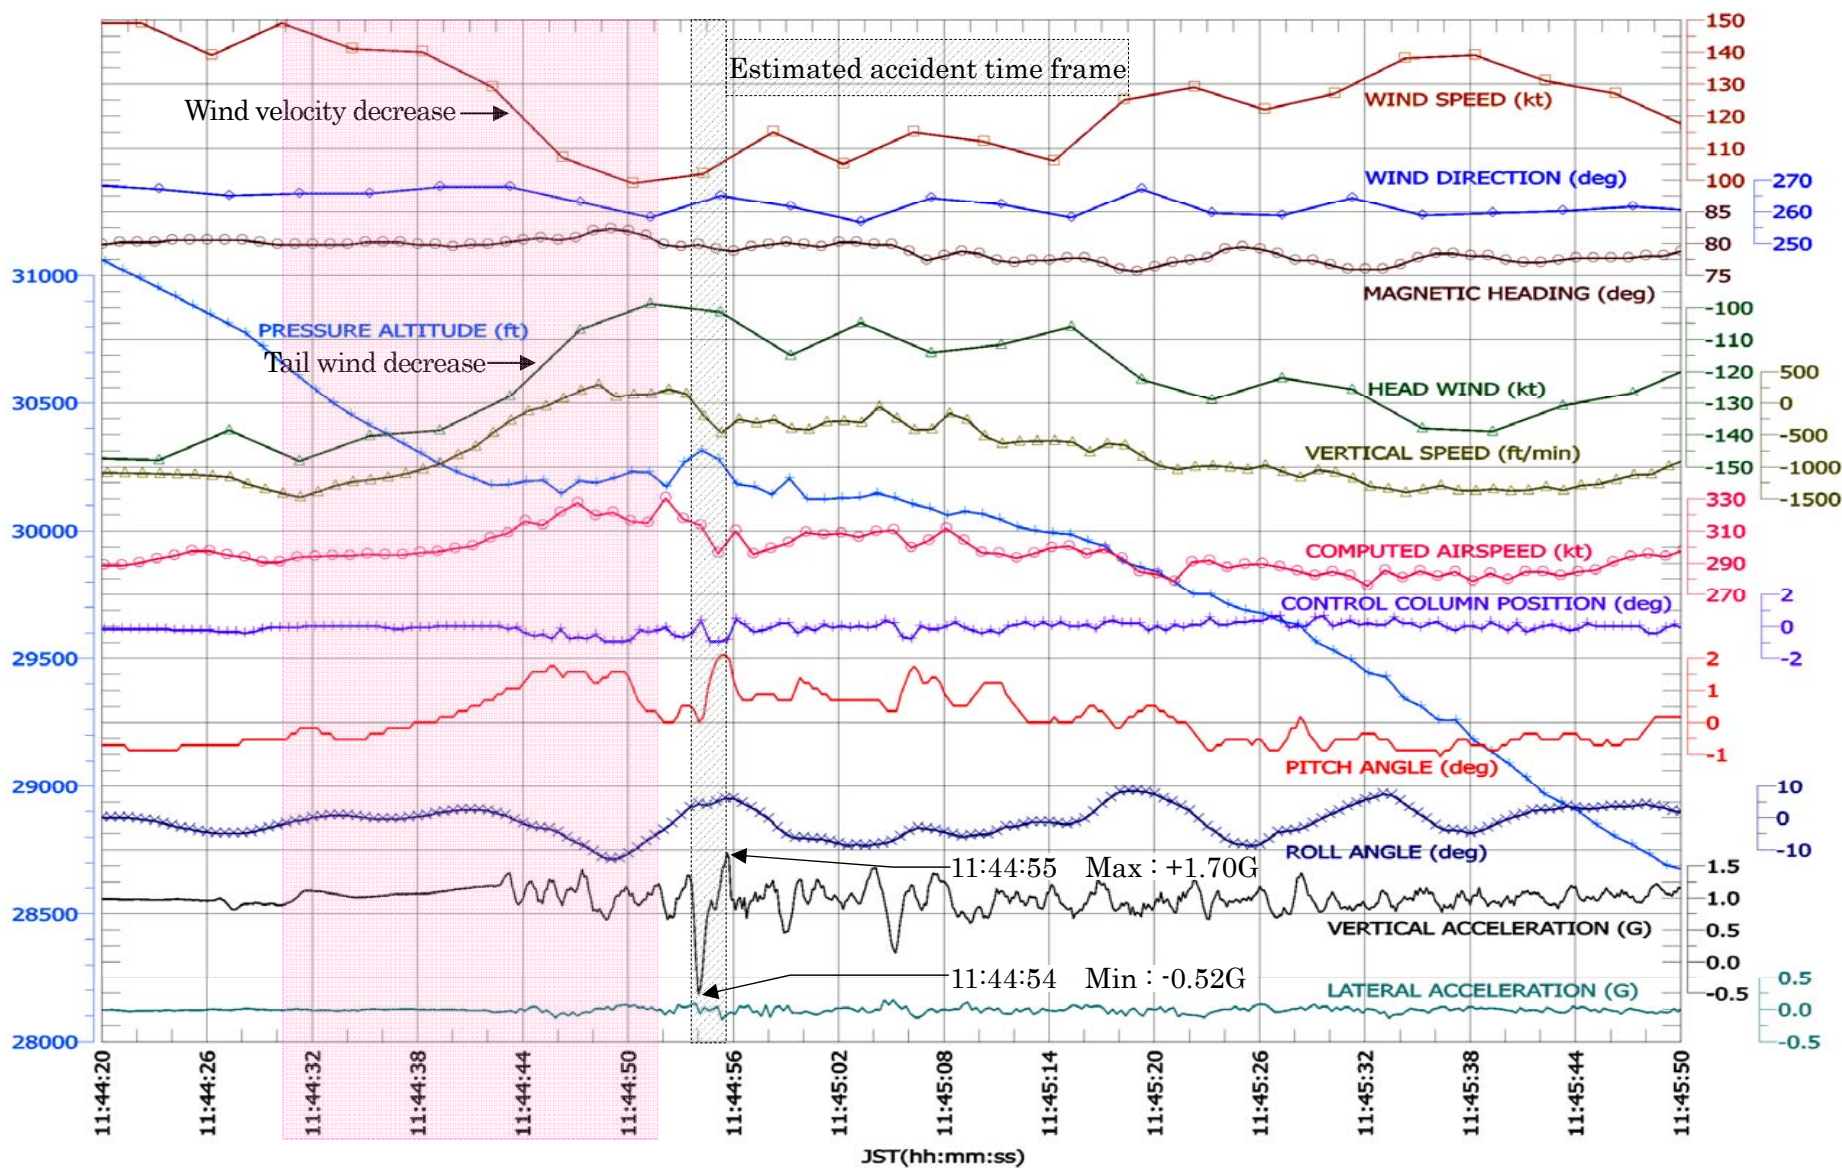
Figure 2-2 DFDR Records (2)

According to the history of the flight as described in 2.1.1 and Figure 2-2, the Aircraft encountered big bumpiness around 11:44:54, and a vertical acceleration of -0.52G was registered concurrently the pitch angle decreased followed by quick increase. It is considered probable that the aft section of the Aircraft sank suddenly corresponding to this pitch change and as a result it was subjected to a large negative vertical acceleration than in the forward.

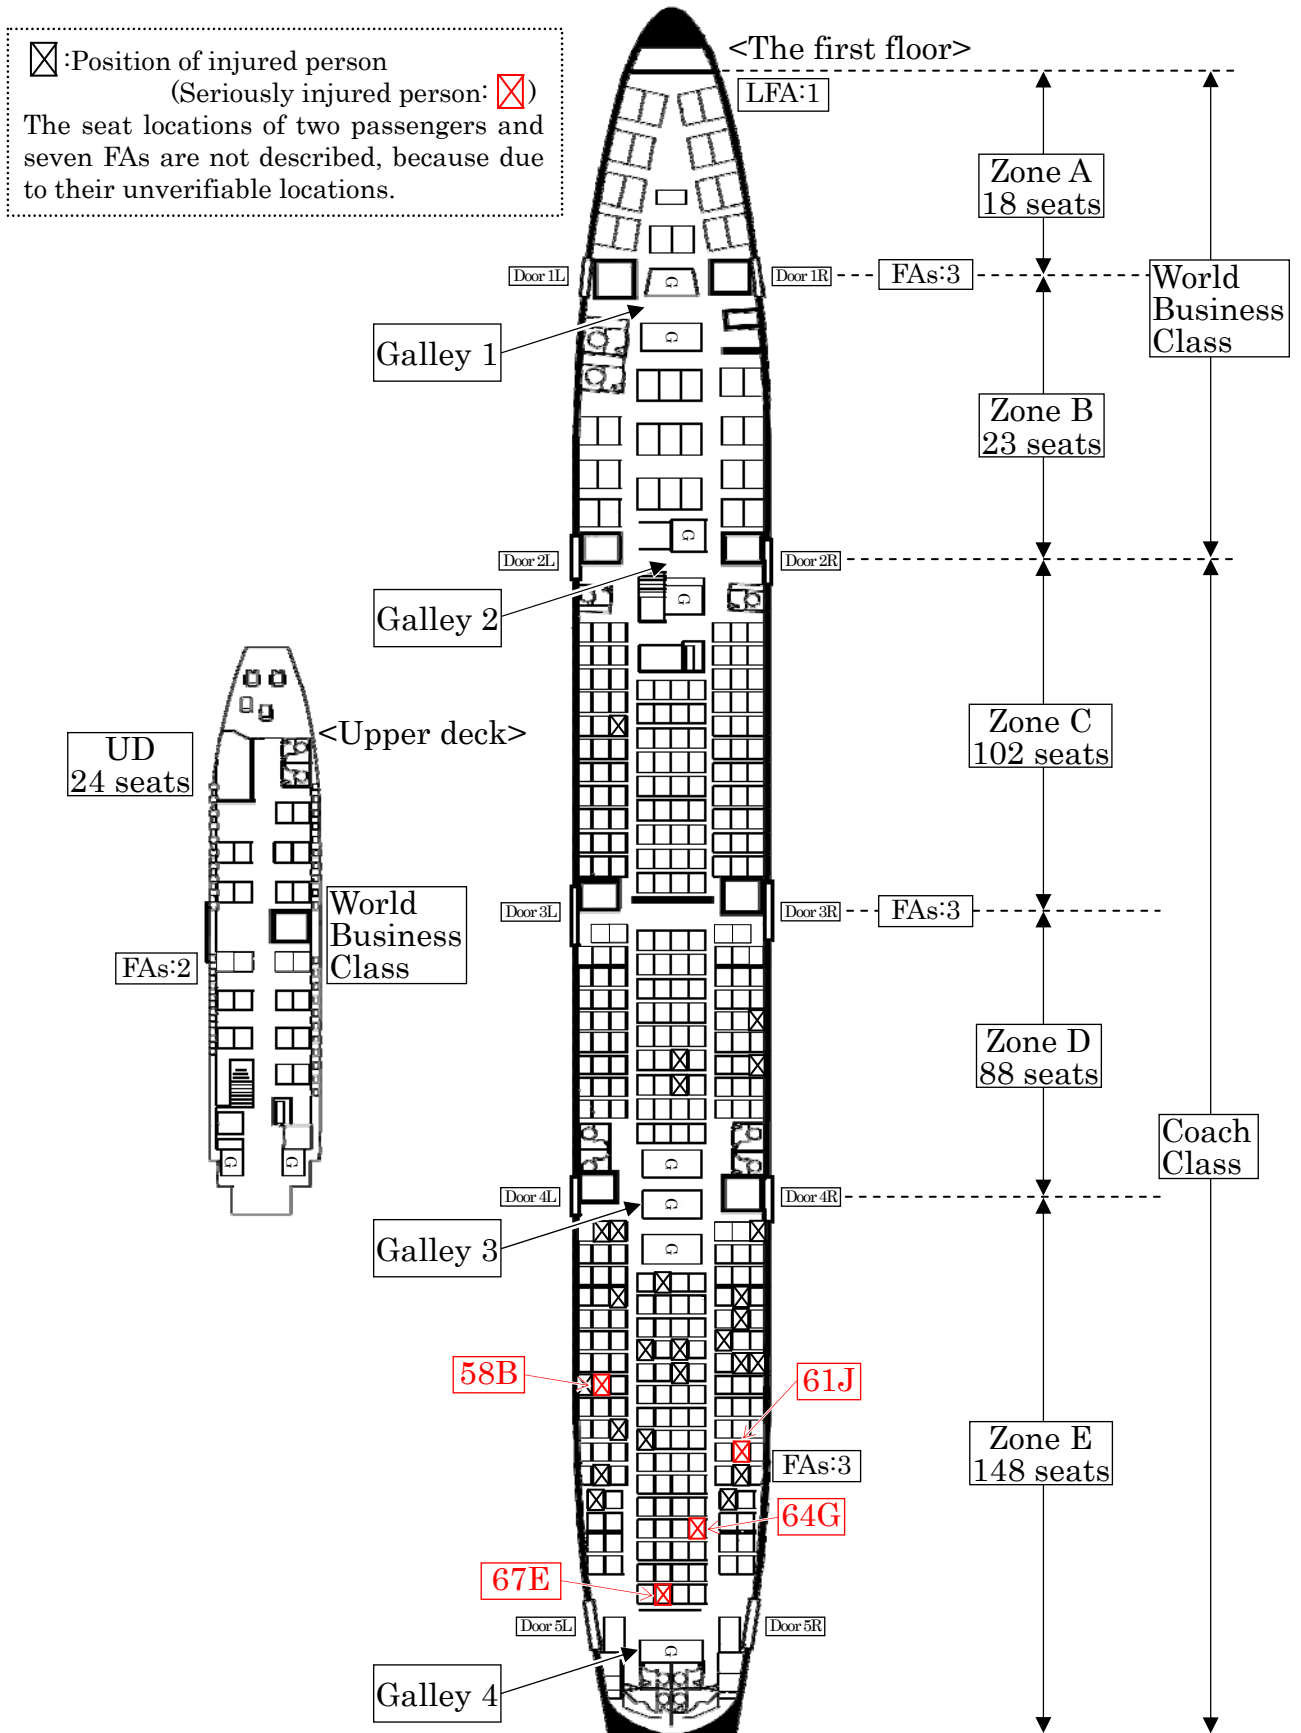
Figure 3 Seat Locations of Injured Persons

According to 2.9.3, the seats on the Aircraft were almost fully occupied. As drawn in Figure 3, passenger density was higher in the middle and aft cabin sections compared to the forward and upper deck sections. The number of passengers per one FA was about 13 persons for the World Business Class in the forward and upper deck sections, while the number was far higher at about 56 for the Coach Class seats in the middle and aft cabin sections. It is considered probable that although the contents of services differed from class to class, it took longer to finalize post-service duties and confirm the safety of passengers in the middle and aft cabin sections.

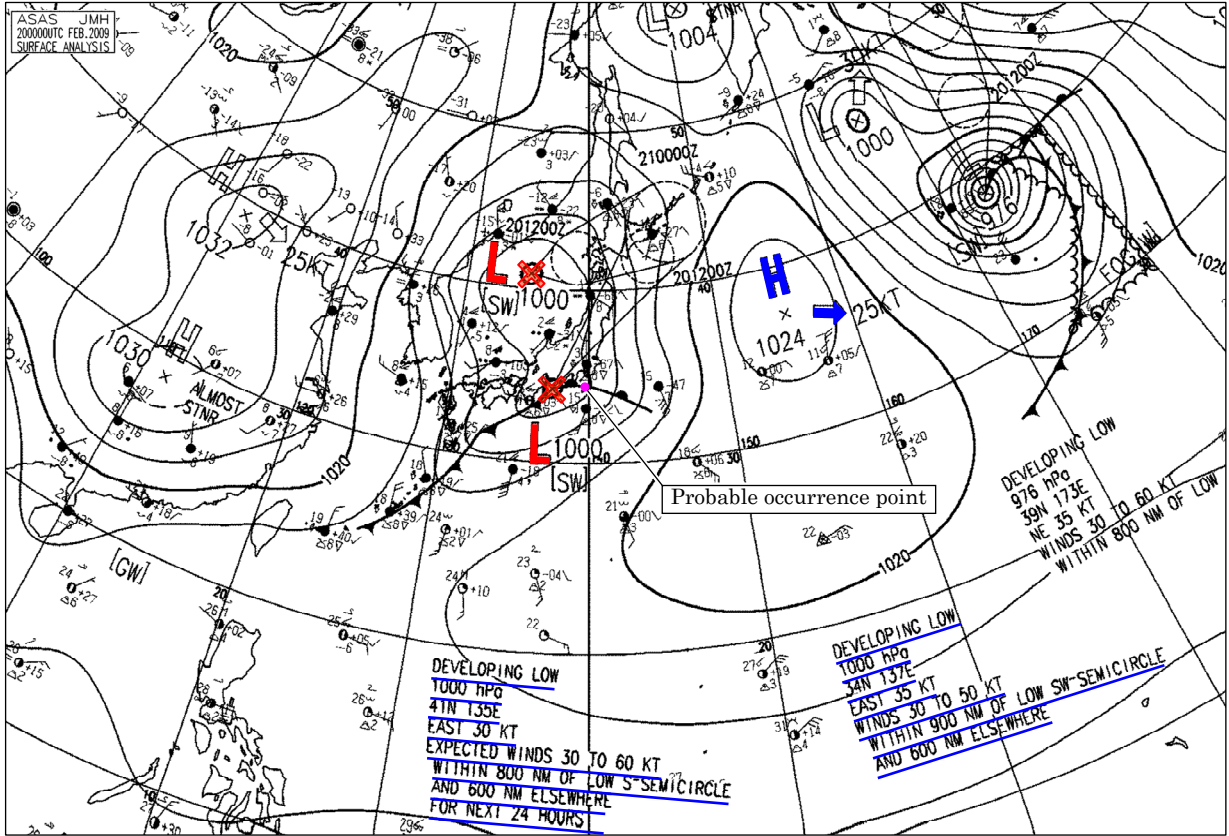
# Figure 5 Asia-Pacific Surface Analysis

As described in 2.6.1, because warm and damp winds were blowing from the south into the low pressure near the Tokai region, generating unstable atmospheric condition. As a result, as described in 2.6.2, it is considered highly probable that clumpy convective clouds were developing there. As described in 2.6.3, a vertical wind shear of 6 kt per 1,000 ft was observed amid jet stream near Latitude 35° N at an altitude of 26,000 to 30,000 ft. Therefore, it is considered highly probable that turbulent air was generated in the airspace near the place where the accident occurred.
