**AIRCRAFT ACCIDENT
INVESTIGATION REPORT**

**American Airlines, Inc.
N 7 5 1 A N**

AMERICAN AIRLINES, INC., BOEING 777-200, N751AN
PASSENGER AND CABIN ATTENDANT INJURY
BY THE SHAKING OF THE AIRCRAFT
AT AN ALTITUDE OF APPROXIMATELY 27,000 FT
OVER NORTHERN KANTO, JAPAN
AT ABOUT 19:35 JST, DECEMBER 16, 2014

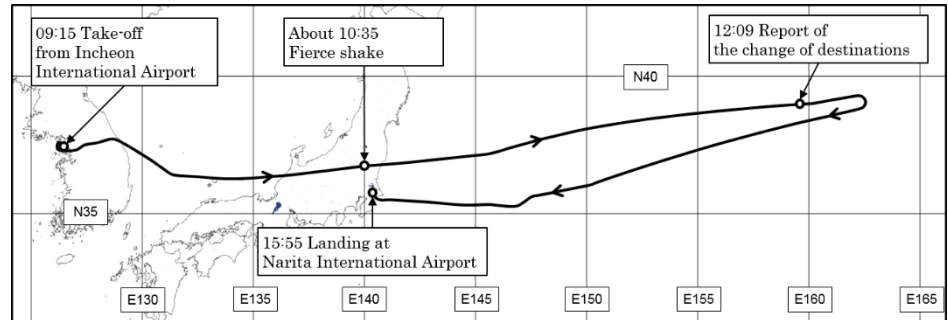
Fig. 2 Estimated flight profile map of the aircraft

The accident occurred at about 10:35-38 on December 16, 2014, at about 27,000-29,000 ft over Northern Kanto (36°43'-46'N, 139°58'-140°33'E).
