**AIRCRAFT SERIOUS INCIDENT  
INVESTIGATION REPORT**

**JETSTAR AIRWAYS PTY LTD.  
V H V K J**

## CASE EQUIVALENT TO CONTINUED LOSS OF THRUST OF ENGINES IN FLIGHT JETSTAR AIRWAYS PTY LTD.

BOEING 787-8, VHVKJ

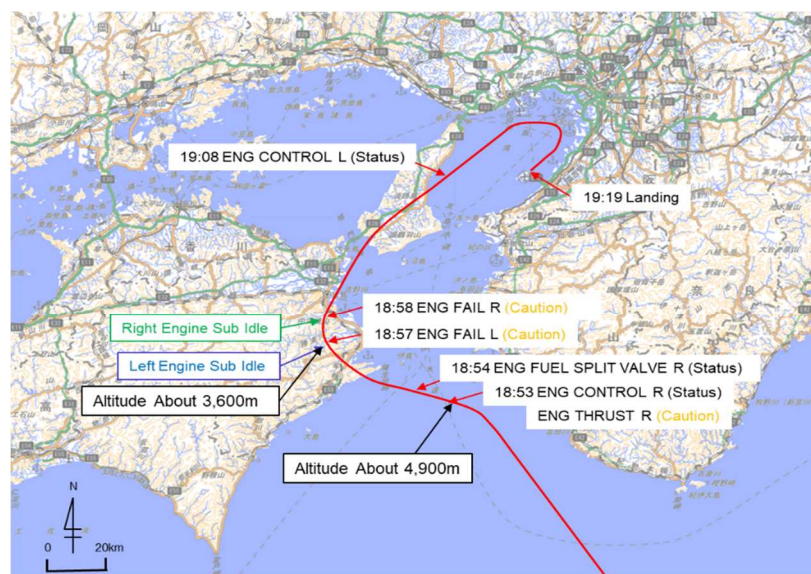
Figure 1: Estimated flight route and

At 18:53 JST (unless otherwise noted, all times are indicated in JST in this report on a 24-hour clock), during the descent at an altitude of about 4,900 m (about 16,000 ft) to Kansai International Airport, the right engine instrument display became unstable with “ENG THRUST R” and “ENG CONTROL R” EICAS\*2 messages appeared.

At 18:57, “ENG FAIL L” EICAS message appeared and disappeared shortly thereafter at an altitude of about 3,600 m (about 12,000 ft). The PIC did not feel malfunction in the left engine parameters at this time. CPL recorded a value below idle lasting for eight seconds in the left engine.

At 18:58, “ENG FAIL R” EICAS message appeared and disappeared after a while. The PIC disengaged the right auto throttle and set the right engine thrust lever to the idle position in accordance with check list because he confirmed unstable parameters of the right engine. The right engine parameters indicated unstable until landing. CPL recorded a value below idle lasting for 81 seconds in the right engine.
