**AIRCRAFT SERIOUS INCIDENT
INVESTIGATION REPORT**

VIETNAM AIRLINES

V N – A 1 4 6

**VIETNAM AIRLINES
BOEING 777-200, VN-A146 (VIET NAM)
ON B TAXIWAY AT NARITA INTERNATIONAL AIRPORT
AT ABOUT 07:44 JST, JULY 30, 2008**

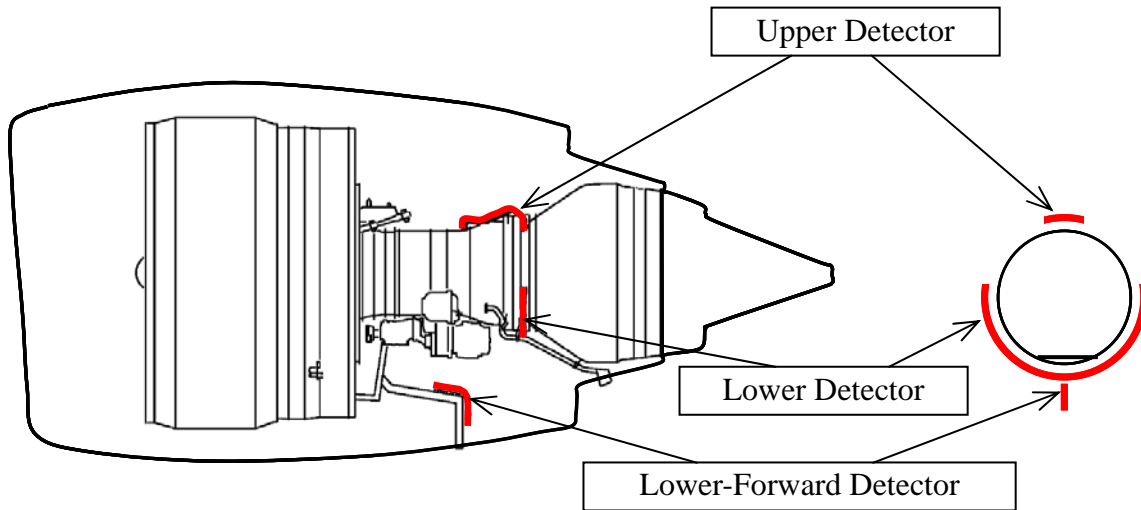
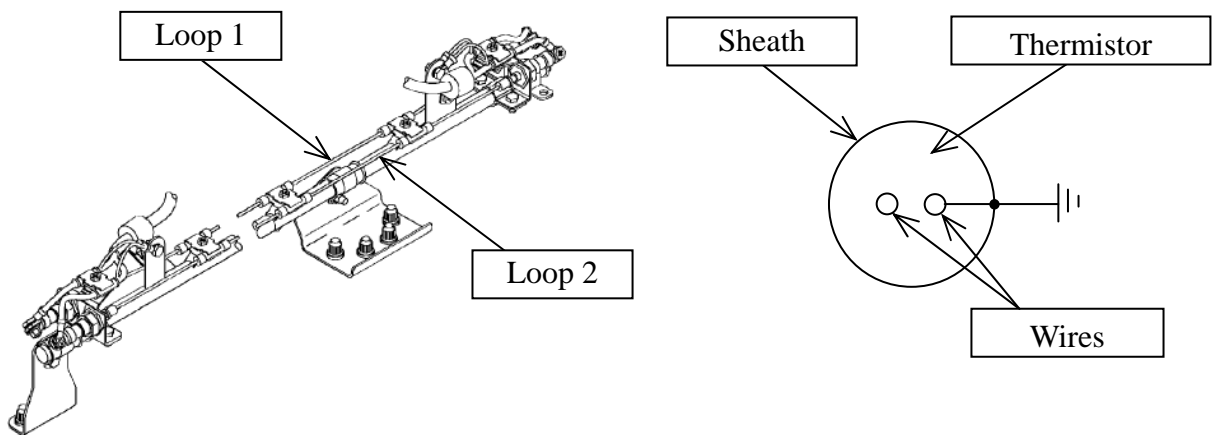
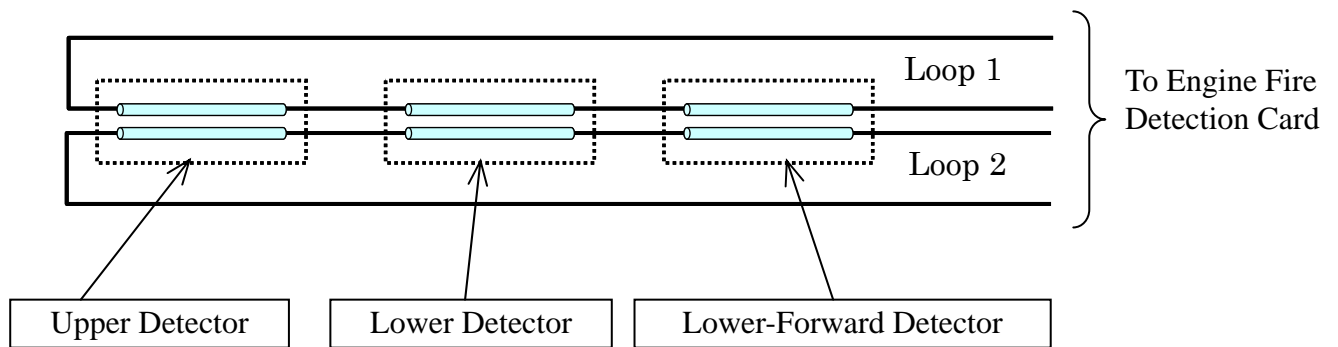
Figure 5 Engine Fire and Overheat Detection System

In addition, the exterior surfaces of the detectors had the signs that suggest damage resulting from exposure to high-temperature flames.
