AIRCRAFT ACCIDENT INVESTIGATION REPORT

**Cathay Pacific Airways
Lockheed L 1011-385-1, VR-HOC
New Tokyo International Airport
March 24, 1990**

**Aircraft Accident Investigation Commission
Ministry of Transport**

March 27, 1992

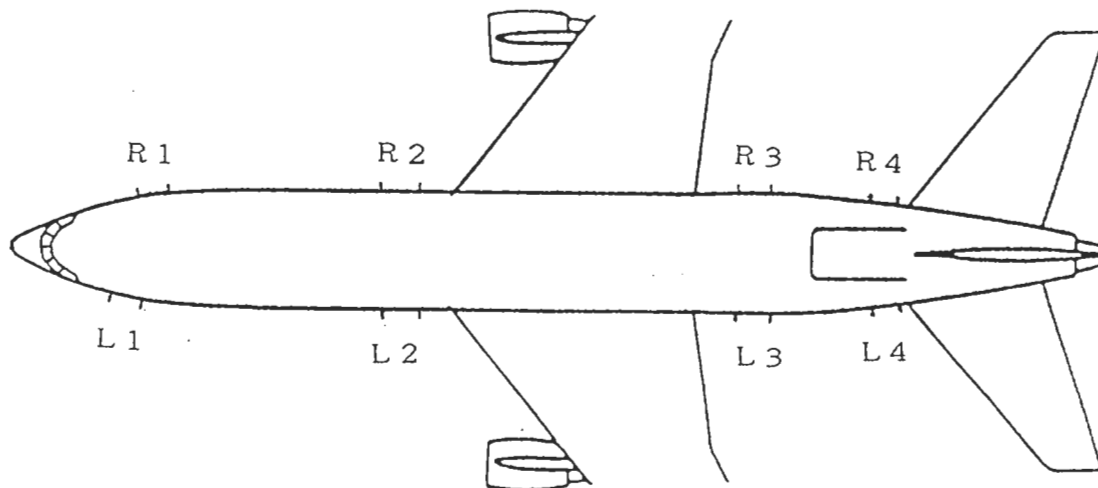
Location of Emergency Doors

The chief purser, who heard the captain's instruction "Emergency evacuation from the right side" only as "Emergency evacuation", opened immediately L1 door. The escape slide, however, was unusable being flapped by wind. Then she hooked the door with the safety strap, and guided passengers to R1 door.

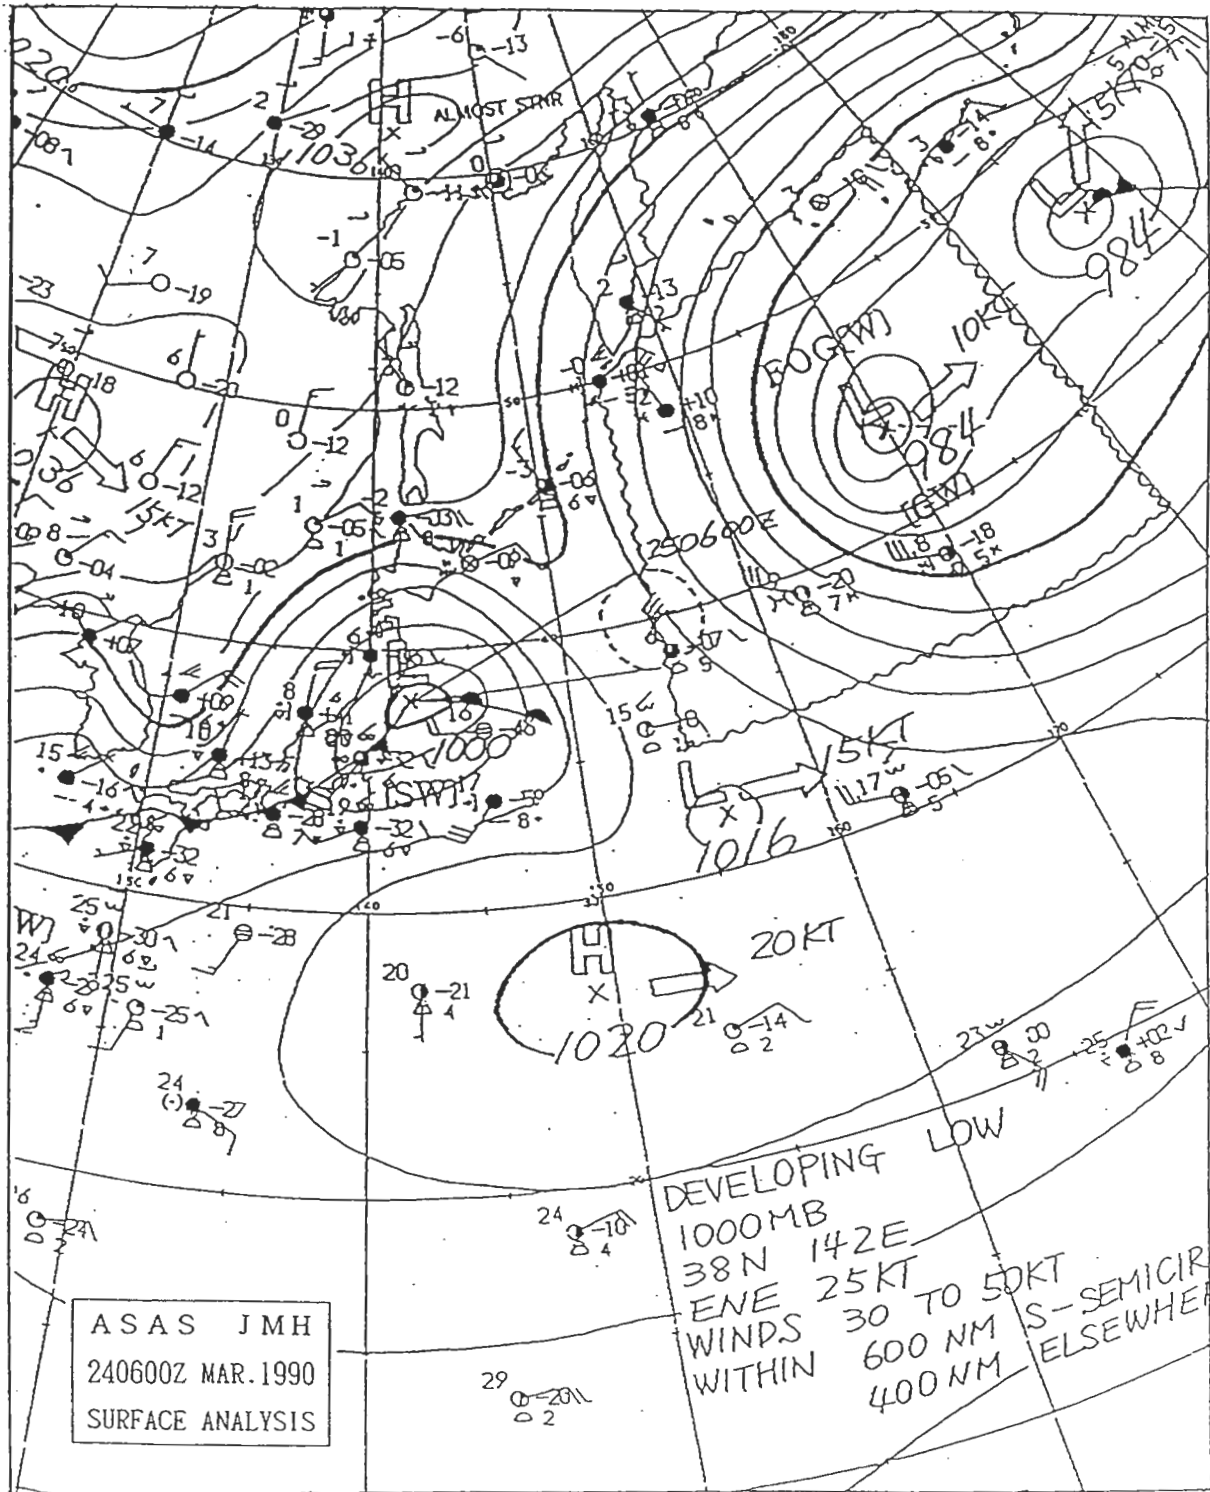
Attached Fig. 6 Surface Chart
0600 Hours (UTC), March 24, 1990

At 0600 UTC of the 24th day, near the time the accident occurred (0512 UTC:1412 JST), a Low of 1000 hPa was located on the ocean east of the Honshuu, from where a cold front was extending as far to the Kyuushuu Island passing through a northern part of the Kanto Area. (see Attached Fig. 6) The cold front passed Narita Airport about 1140 UTC of the 24th day, until which the wind had been from SSW~SW with a significant intensity for the period of 0030 UTC to about 0830 UTC. (see Attached Fig. 8) In front of the cold front is recognized a strong wind belt extending from the Izu Peninsula and reaching near Narita Airport through Tokyo Bay, in accordance with data of the Automated Meteorological Data Acquisition System at 0500 UTC, the nearest to the time of accident. (see Attached Fig. 9)

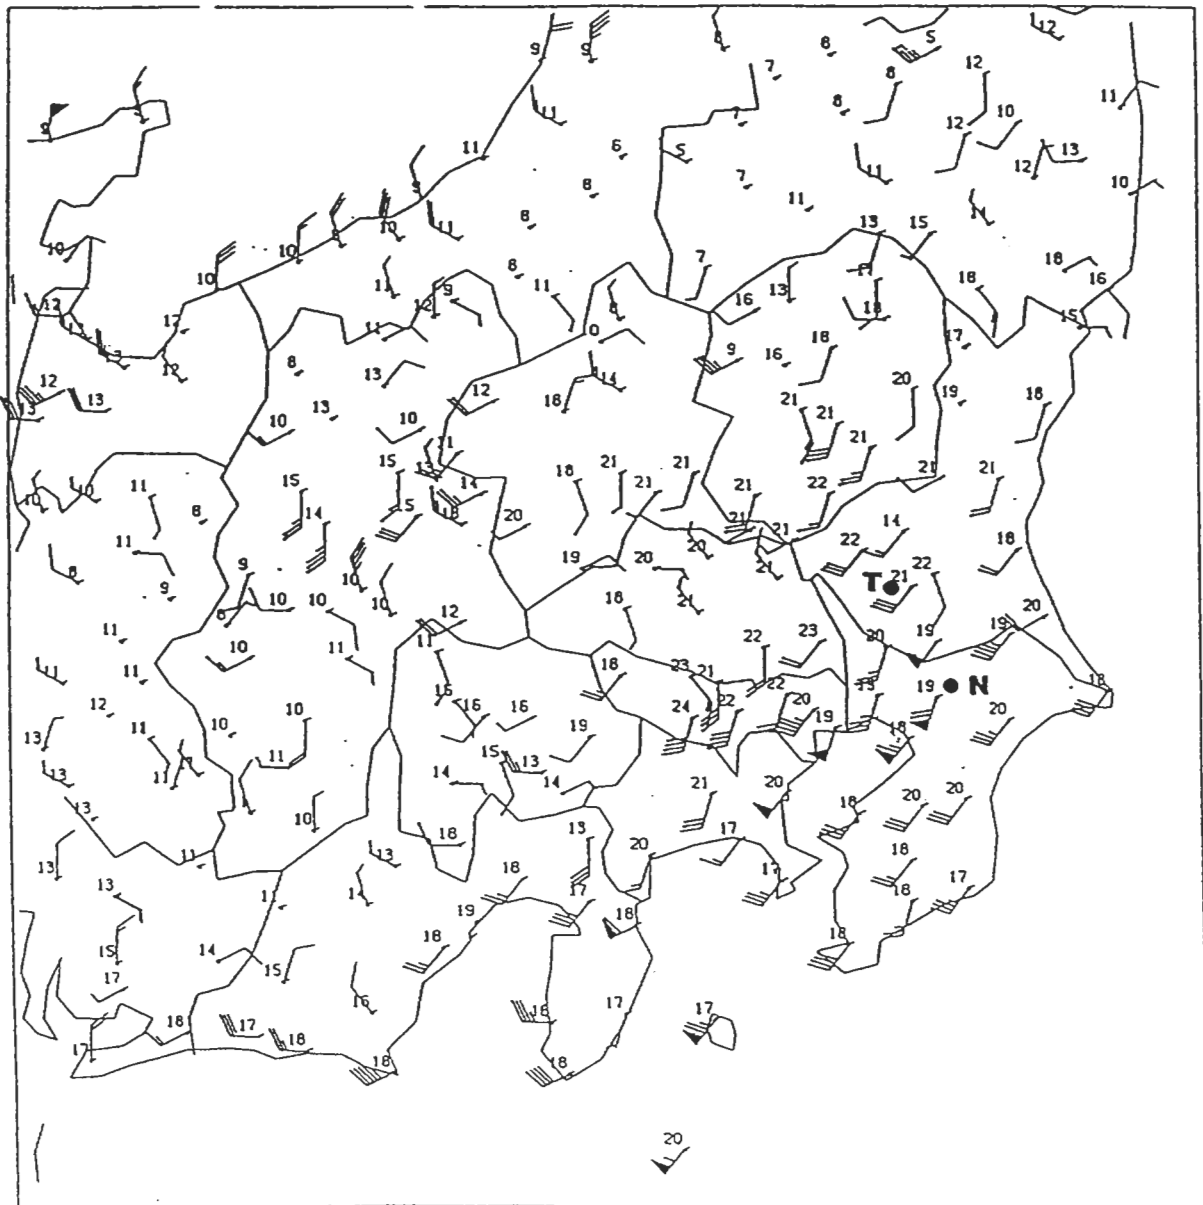
Attached Fig. 9

Since, as shown in Attached Fig. 9, Narita Airport was in the same area of strong wind as the Aerological Observatory at Tateno in Tukuba City (located approximately 40 km NW of Narita Airport), the data of upper air currents observed at the observatory were used to estimate its vertical structure at Narita Airport. (see Attached Fig. 10) According to this, there was an inversion layer at height of 960~900 hPa at 0000 UTC with the maximum wind speed of 15.9 m/s (31 kt) from 218° at 944 hPa (a height of 580 meters).

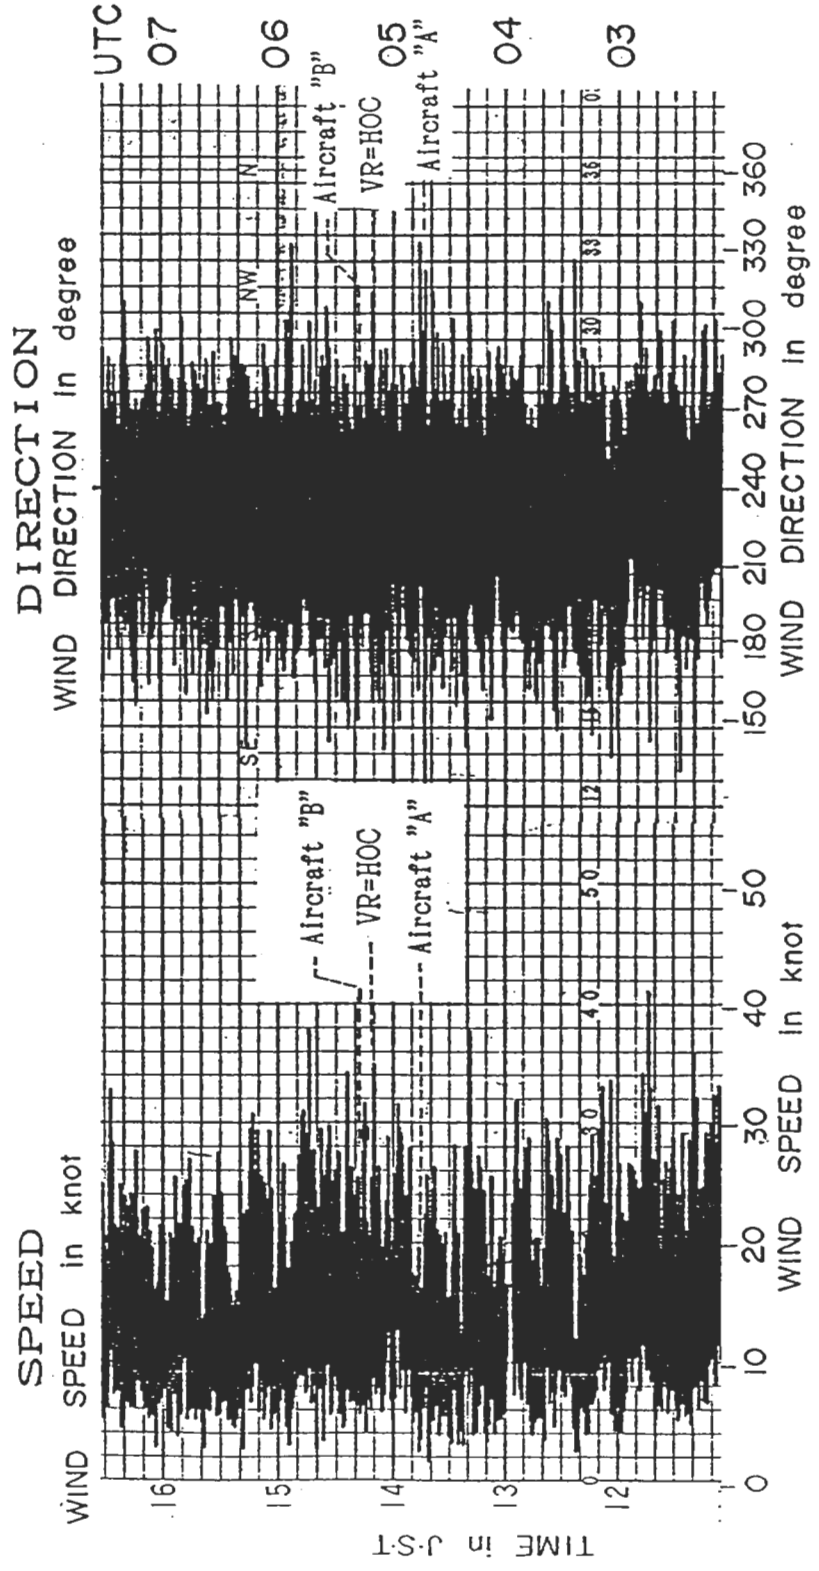
Attached Fig. 11
 Records of Wind Direction/Speed at Runway 16
 0200 - 0700 hours, March 24, 1990

(4) In records of the wind direction and the wind speed, there are variations in the wind speed and direction having a period longer than the gust, ranging from several minutes to slightly more than 10 minutes. (see Attached Fig. 11)

3.2.4.2 According to records of the 2-minute wind sensor, it was about from 0430 to 0600 UTC that the variation in wind direction on the Runway 16 side was remarkable, and about from 0500 to 0540 UTC that the maximum in wind speed was large; and the accident occurred in this time zone in which the gustiness was significant. (see Attached Fig. 11)

The recording paper (see Attached Fig. 11 of the Text) of the runway 16 wind sensor is unable to read the average wind because the recording paper is saturated with recording ink. Therefore, the maximum value deviated to the north (not gust but an average for several minutes) was compared with the average wind recorded in the aircraft on the assumption that when the wind direction was deviated to the north, the average wind would also make a similar change. (see Attached Table 1) According to this,

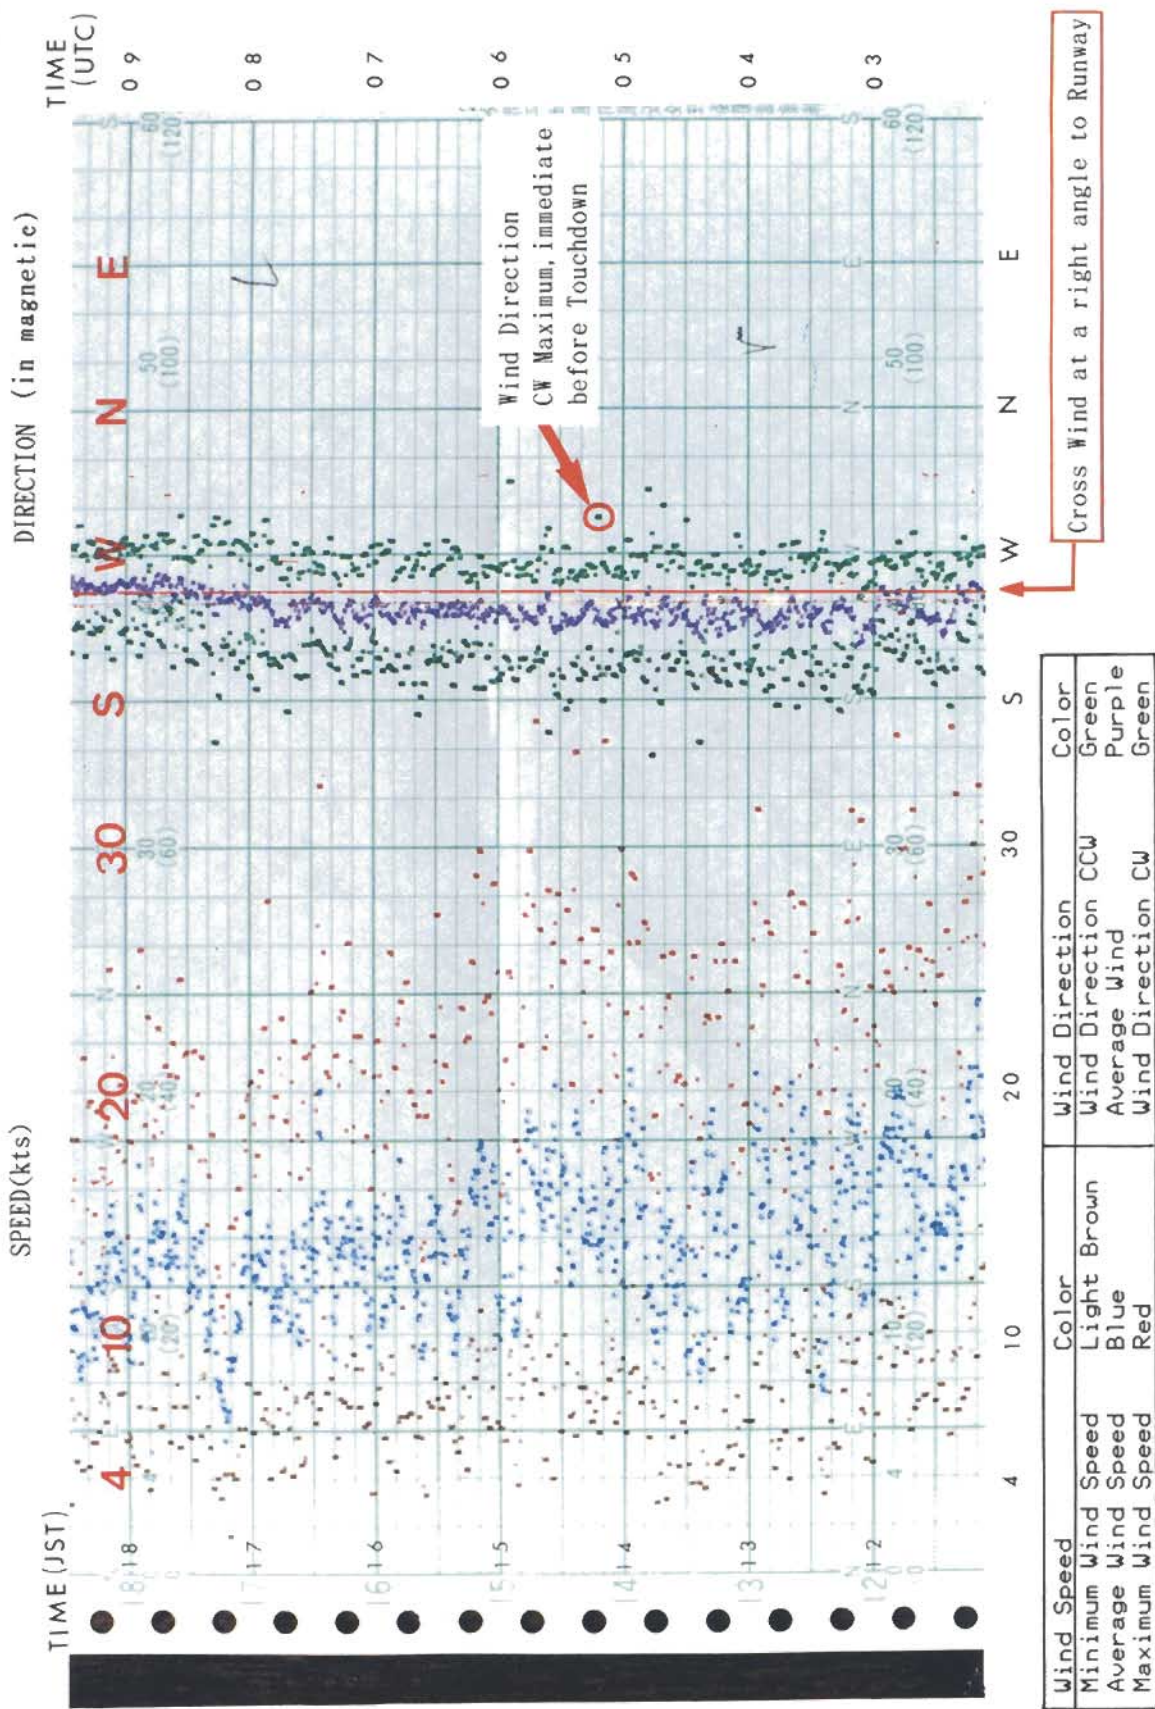
Attached Fig. 12
 Records of TWD(2) Minutes Average of Wind Direction/Speed at Runway 16
 March 24, 1990

(3) It is noted that the accident occurred in the time zone where the turbulence was significant, in view of the fact that, according to the 2-minute wind sensor (see Attached Fig. 12), remarkable changes in wind direction were during a period of 0430 UTC to 0600 UTC, and the maximum wind speeds were high during a period of 0500 UTC to about 0540 UTC. The right side of the red line in Attached Fig. 12 is a tailwind portion, as the tail wind frequently appeared as an instantaneous value on the day of the accident.

For this portion, however, a wind direction of 287 deg (red arrow mark in Attached Fig. 12) and a wind speed of 27 kt are recorded in the 2-minute wind sensor as 3-second average values, and when movement of an eddy is taken into account, a chronological consistence could exist. From this, it is conjecturable that the aircraft would have temporarily been subjected to a tailwind although its absolute value is unknown.

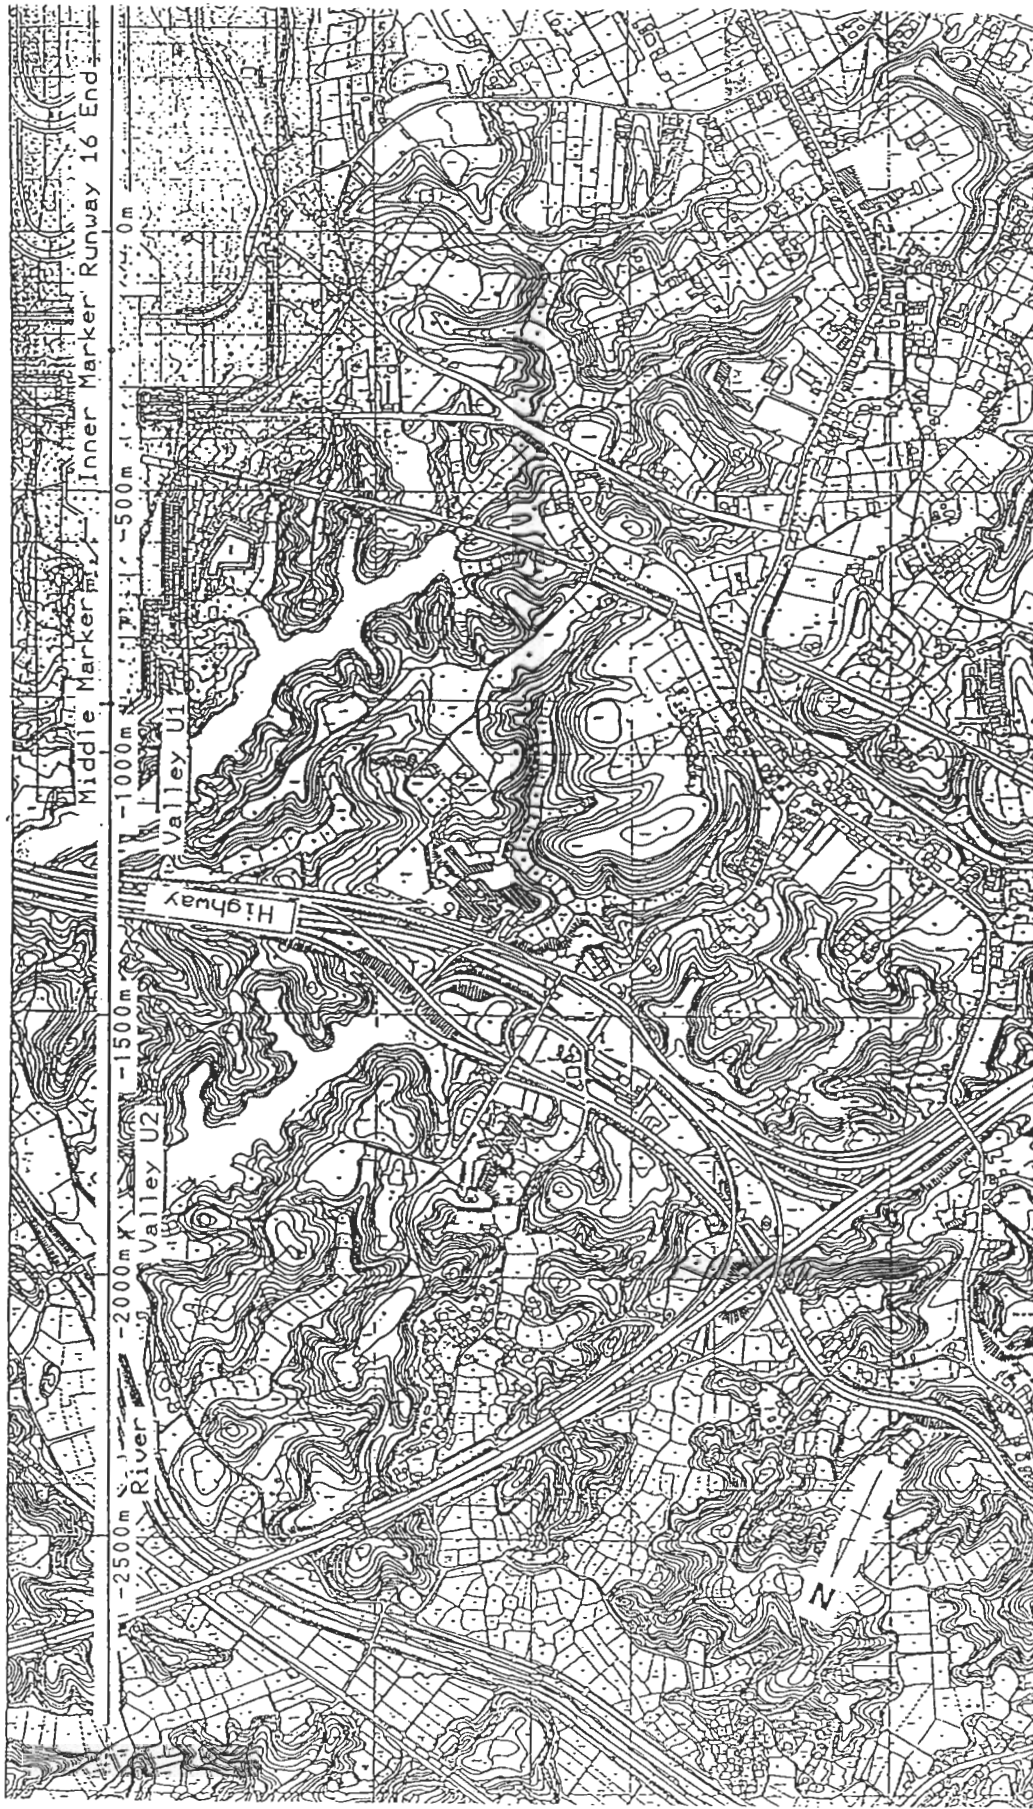
Attached Fig. 13

(2) The wind the aircraft 'A' and 'B' encountered on their approach varied in its direction and speed with the height. The variation in the wind speed would have been a horizontal variation due to the topography, for a reason that if the variation in the wind speed had been caused by a vertical wind shear, its scale must have been 34 - 38 meters/second per 100 meters for aircraft 'A', and a vertical wind shear of such an extent should be unconceivable. (see Attached Fig. 13)

The CAS of the aircraft suddenly increased to a maximum of 172.6 kt near about 1.9 km short of the approach end of runway. This location is near the place where the flight course crosses a valley (Valley U2 in Attached Fig. 13) running at a bearing of about 200 degrees. Since the prevailing wind around there is 225 deg/35 kt for Aircraft 'A', and 210 deg/45 kt for Aircraft 'B', the headwind component to the direction of the approach course is 9 kt for Aircraft 'A', and 22 kt for Aircraft 'B'.

The area where variation in CAS was intense is of such complicated topography that from 200 meters ahead on the upstream side is lying the outside of the airport where sunken places and hills are abound and a valley (Valley U1 in Attached Fig. 13) running on a bearing of about 200 degrees is crossing. The plateau on which the middle marker is

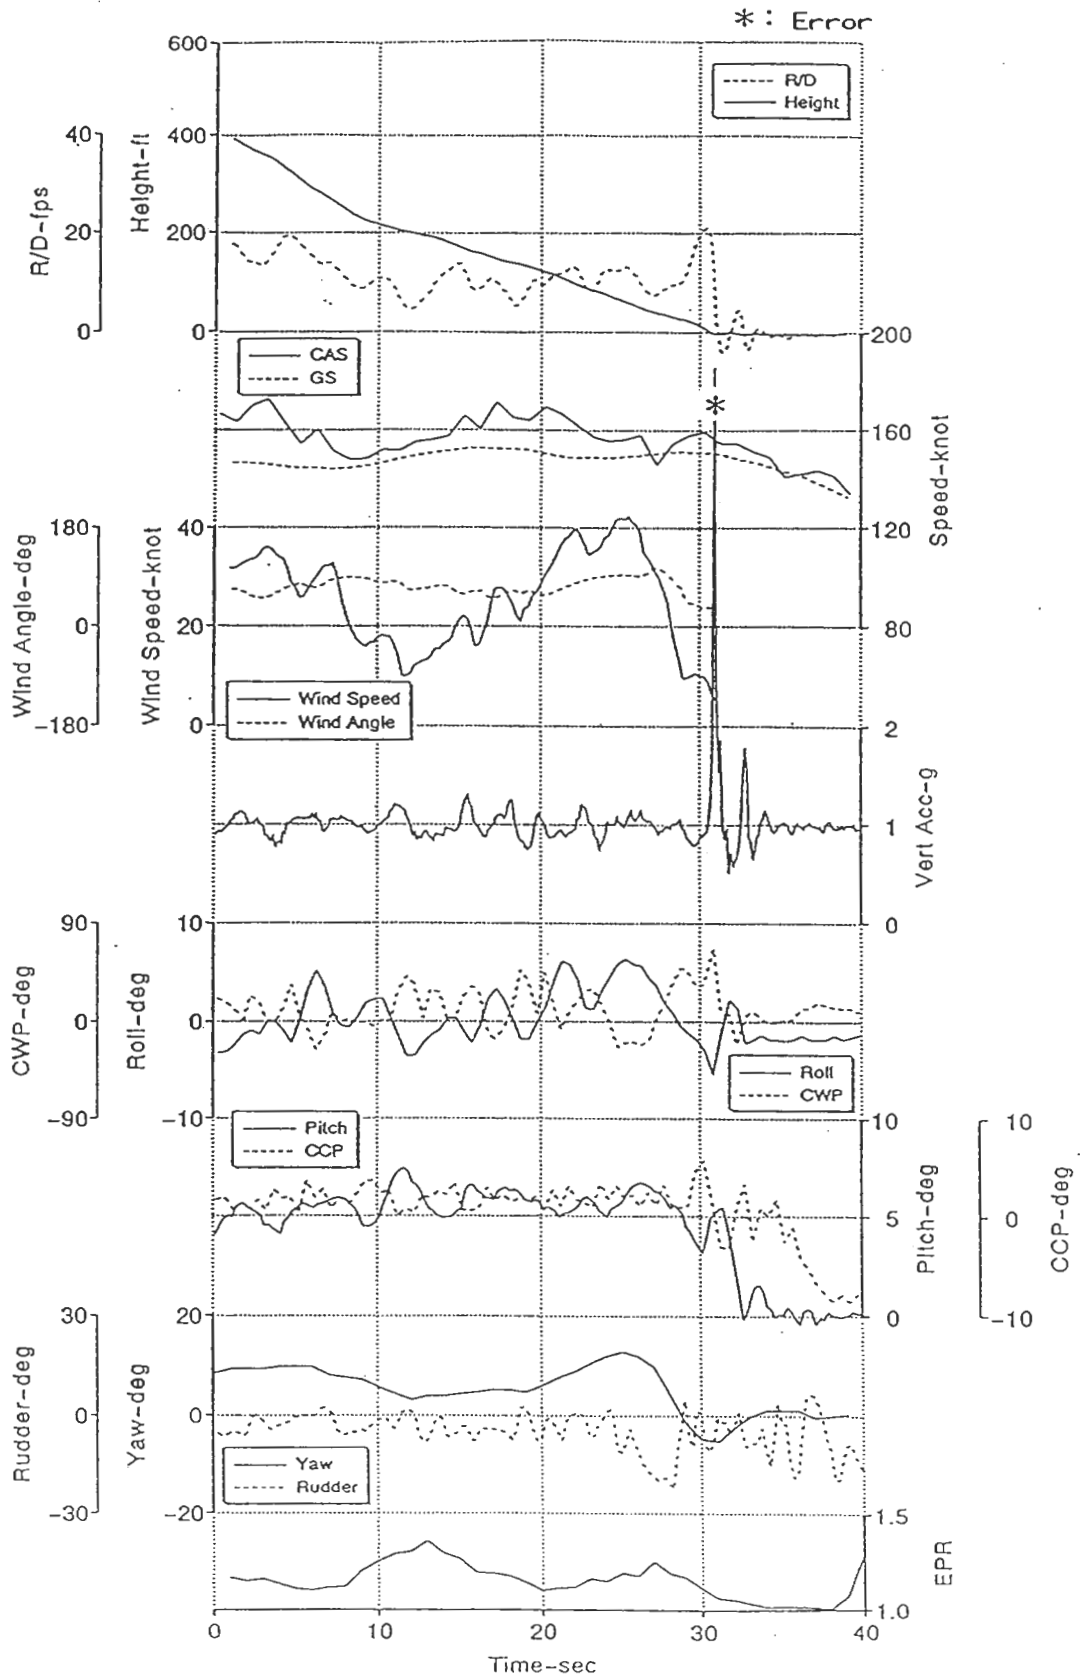
Attached Fig. 19 Chronological Records

In Attached Fig. 19 is shown the chronological sequence up to touch-down of the aircraft from the height of 400 ft, while in Attached Figs. 20 and 21 are shown details of the longitudinal and the lateral motion from 6 seconds prior to touch-down. In these figures, the height, rate of descent, ground speed, and wind direction and speed are values which were estimated in para. 3.1.4, and others are readouts of DSDR.
