(AIRCRAFT ACCIDENT INVESTIGATION INTERIM REPORT)

BOMBARDIER DHC-8-315, JA722A

AIRBUS A350-941, JA13XJ

December 25, 2024

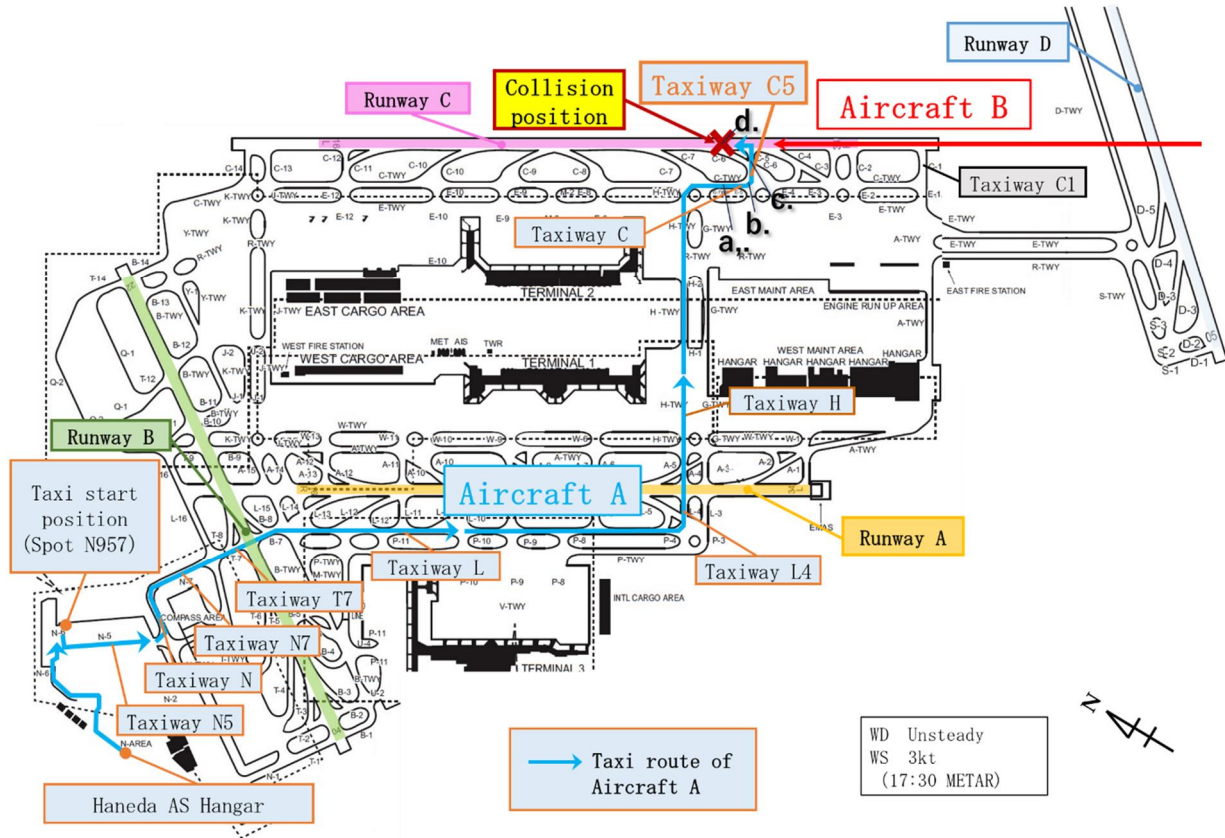
Figure. 1 Taxi Route of Aircraft A

At 17:46:46, Aircraft A lined up to the centerline of Runway 34R in take-off direction (northwest) (approximately 560 m from the southeast end of Runway C) in takeoff direction (northwest), and at 17:47:27, collided with Aircraft B, which landed on Runway 34R (Figure 1 d. and Figure 2-1 d.). (See Figure 1 d. and Figure 2-1 d.).

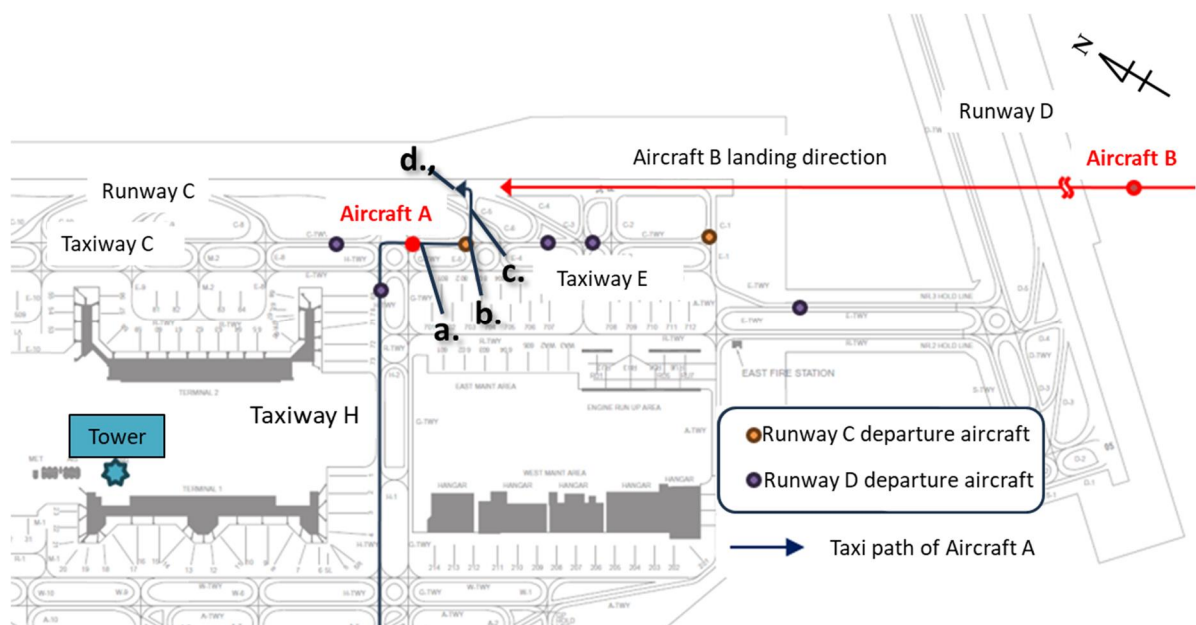
Figure 2-1 Situation when the Communication of Aircraft A was Transferred to Tower East

- (1) Aircraft A was taxiing northeast on Taxiway H when communications were transferred from the air traffic controller at the tower control position west of Tokyo Airport Traffic Control Tower (hereinafter referred to as “Tower West”) to the air traffic controller at the ground control position east of Tokyo Airport Traffic Control Tower (hereinafter referred to as “Ground East”). At 17:44:13, Aircraft A was instructed to route from Ground East to taxi to holding point*⁵, via Taxiway C. At this time, PIC A was aware that there were two or three preceding to the right of Aircraft A and one following aircraft to the left of Aircraft A on Taxiway C. Aircraft A turned right to enter Taxiway C from Taxiway H and its communication was transferred from Ground East to the air traffic controller at the tower control position east of Tokyo Airport Traffic Control Tower (hereinafter referred to as “Tower East”). At this point, PIC A thought that Aircraft A would take off after the preceding aircraft. At 17:45:14, Tower East instructed Aircraft A to taxi to holding point on Taxiway C5 and reported “Number one, taxi to holding point C5” , intending to report that Aircraft A was first in the departure order. Aircraft A read back the instructions from Tower East and continued to taxi to Taxiway C5 (see Figures 1 a. and 2-1 a.).

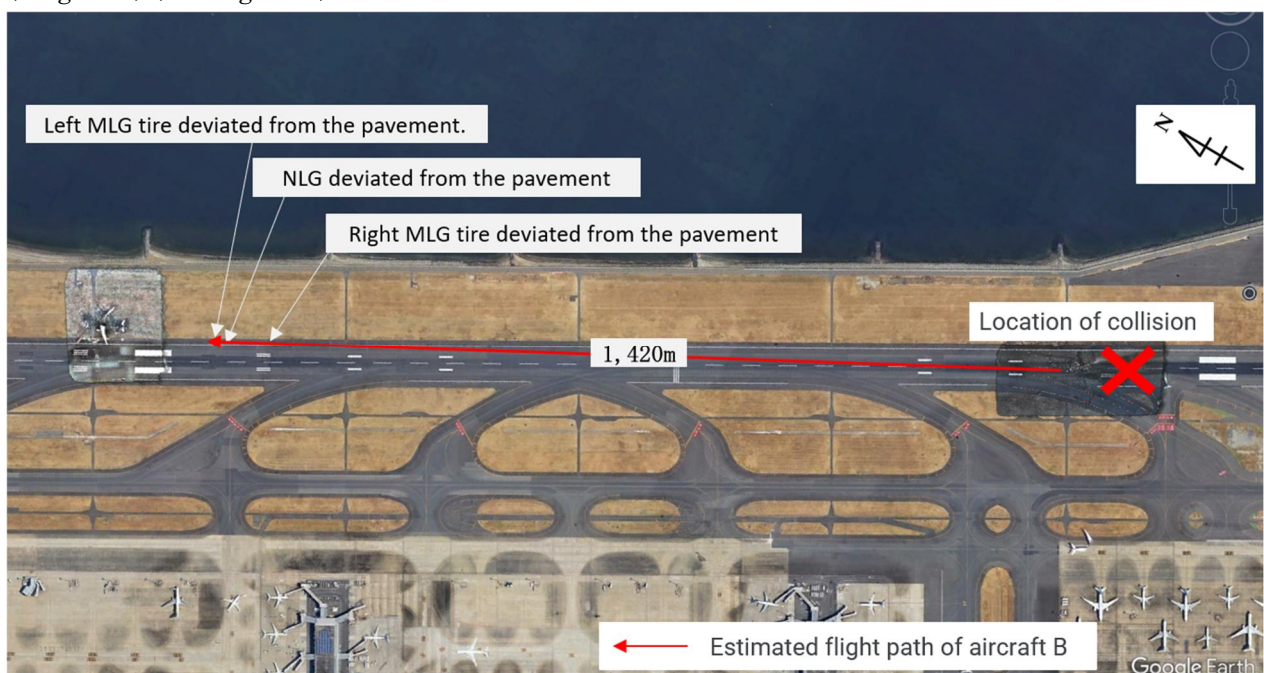
Figure 6 Flight Track of Aircraft B after the Collision

After that, Aircraft B deviated to the east of Runway 34R at approximately 2,118 m from the southeast end of Runway 34R, then traveled through the green area on the east side of the runway and struck the approach angle indicator (PAPI) installed for Runway 16L. The aircraft came to a stop at around 17:48:14, 2,298 m from the southeast end of Runway 34R and 56 m east of the runway center (26 m from the long side end) with a heading of approximately 345° (magnetic) (see Figure 6).

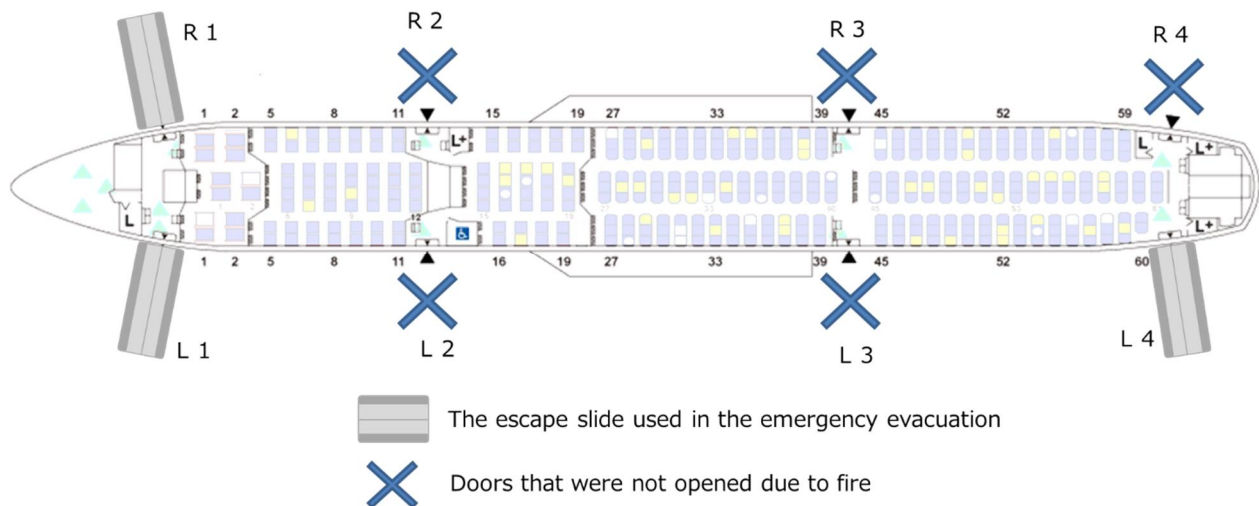
Figure 7 Exits Used for Emergency Evacuation

The chief flight attendant and the left-most forward exit flight attendant (hereafter referred to as "L1"), who noticed that the cockpit door had come loose, went to the cockpit, and reported the situation to the flight crew. The chief flight attendant and the L1 flight attendant, who had received emergency evacuation instructions from PIC B, shouted instructions to the right-most forward exit flight attendant (hereafter referred to as "R1"). Upon receiving this information, the flight attendant in charge of R1 and the chief flight attendant checked the situation outside the aircraft, then at approximately 17:51:30, opened the L1 and R1 doors, deployed the escape slides, and began the emergency evacuation of passengers (see Figure 7).

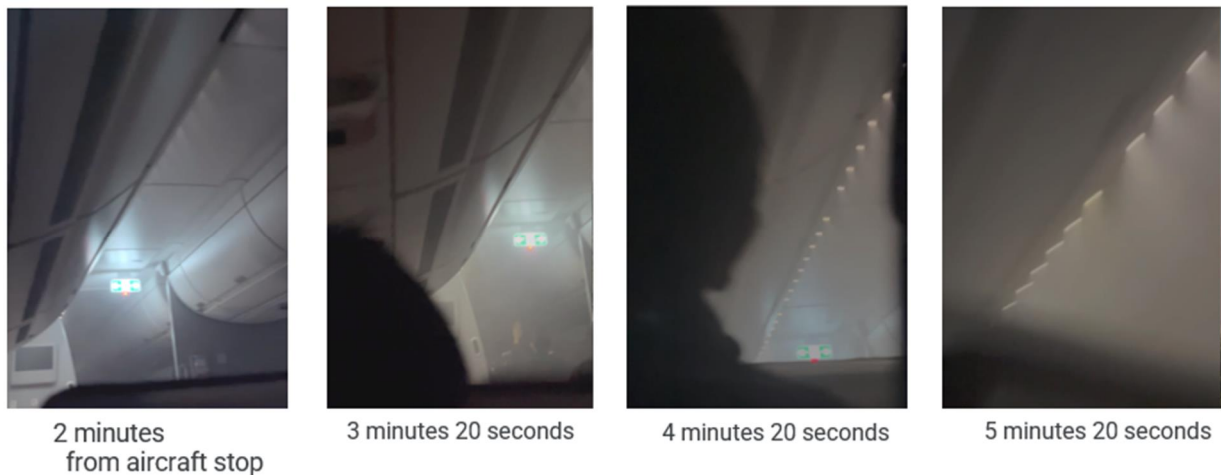
Figure 8 Situation of Smoke Coming in the Cabin
(Provided by passenger in the rear area close to L3)

Figure 8 shows the smoke situation photographed from the rear seat at L3. With the normal lights turned off and only the emergency lights on, the smoke gradually became thicker.

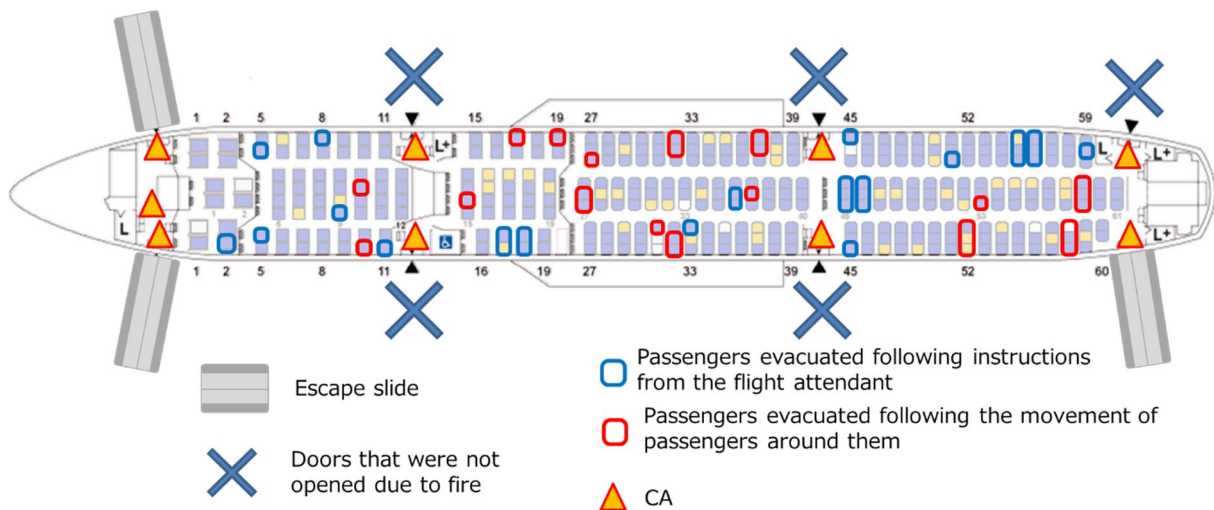
Figure 9 Situation of Awareness for Evacuation Instructions from Crew Members
(Interviews with some passengers)

Some passengers^{*17} were interviewed to confirm the circumstances under which the emergency evacuation instructions were given by the crew and the trigger for the evacuation to begin. The results are shown in Figure 9.

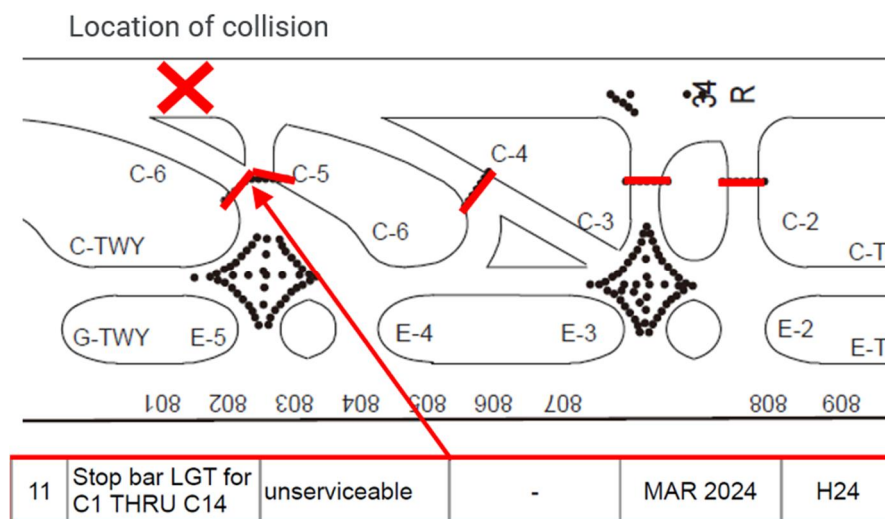
Figure 24: Location of the Out-of-service Stop Bar Lights
(near the taxiway where Aircraft A passed)

Stop bar lights are installed on Runway C of Haneda Airport, but the operation had been suspended due to construction work to renew the aged stop bar control system (see Figure 24).

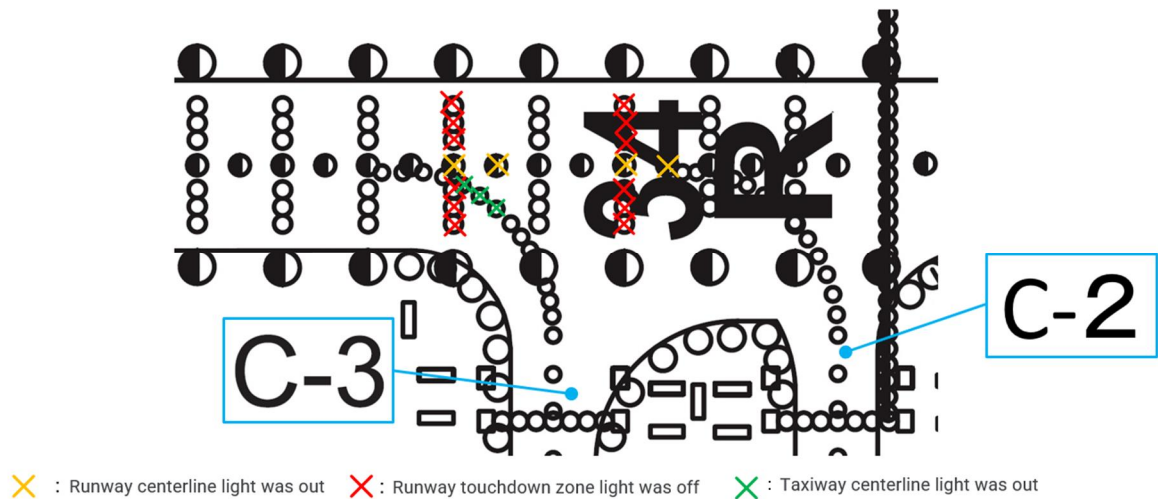
Figure 25: Runway Centerline Lights, etc. that were out of Operation

Due to construction work (runway pavement repairs, etc.), some of the runway center line lights, some of the ground zone lights and some of the taxiway center line lights were out of service (see Figure 25).

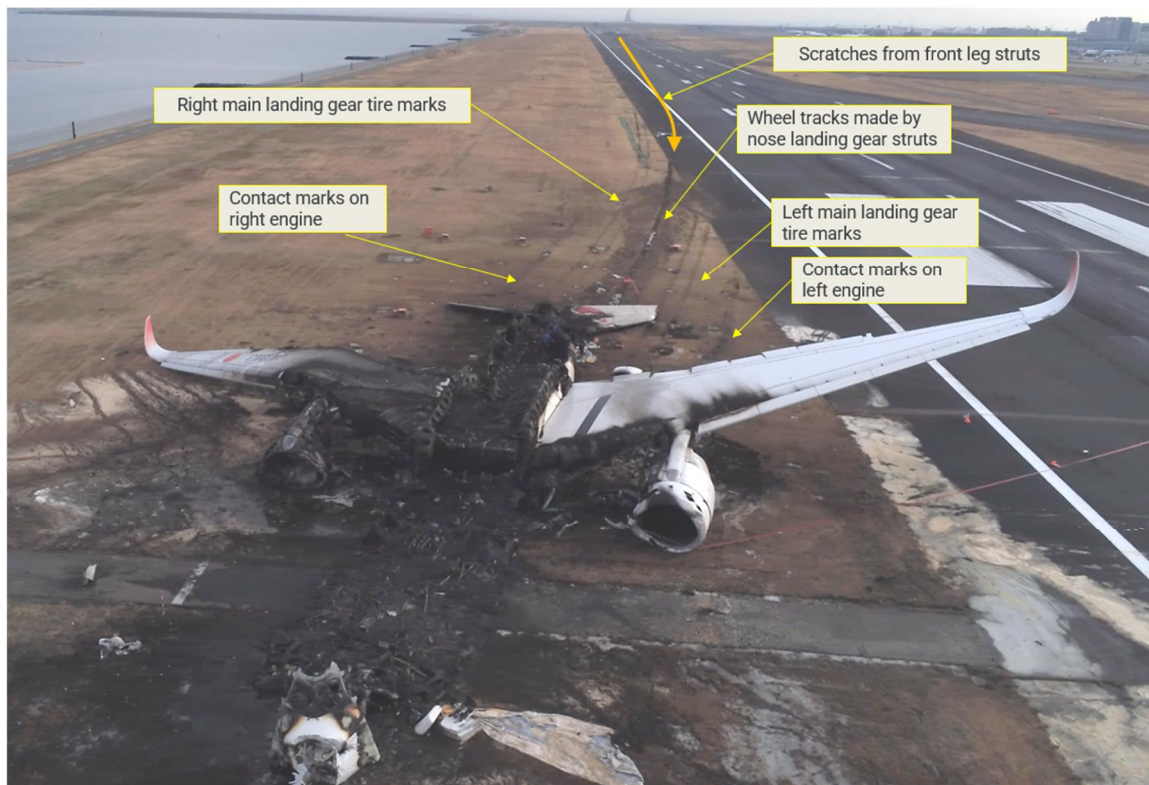
Figure 29: Track Traces after Aircraft B Deviated from the Runway

A line of abrasion marks remained on the runway from the collision point to where Aircraft B had stopped. The abrasion marks were connected to tracks made by the nose landing gear strut of Aircraft B in the grass beside the runway. In the grass where Aircraft B had run off the runway, there were tracks made by the nose and main landing gear, as well as abrasions caused when both engines came into contact with the grass (see Figure 29).

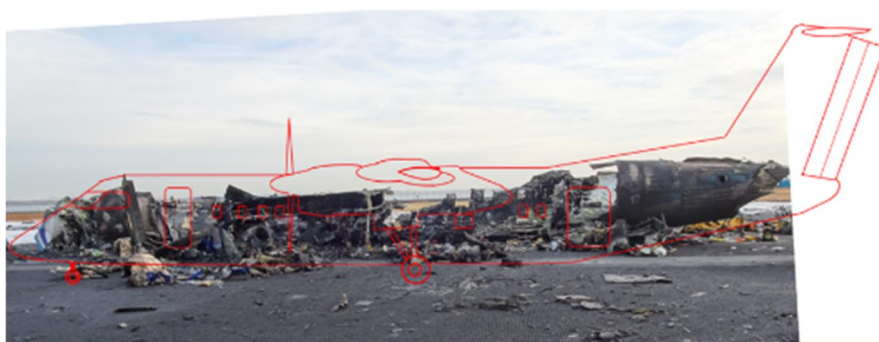
Figure 30-1: Image of aircraft damage

The upper part of the fuselage of Aircraft A was severely damaged, and both the wings and the tail were separated from the fuselage. Aircraft A was crushed by pressure from the upper rear part and was found lying on the runway 90 m from the point of the collision (see Figure 30-1). Aircraft A was also burned by fire except for the lower part of the fuselage and parts that were blown off.

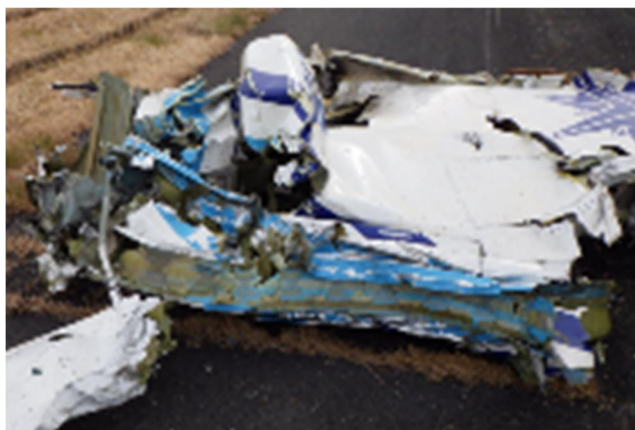
Figure 31-2 Aircraft A Vertical Stabilizer(details)

The tail, which was separated from the tail access door on the underside of the fuselage as a result of the collision, along with the vertical and horizontal stabilizers, and was found in several pieces that were heavily damaged and broken. Part of the rudder was found compressed and buckled from the rear and was found inside the nose structure of Aircraft B.

The main structure of the vertical stabilizer was found close to Aircraft B (see Figures 31-1 and 31-2).

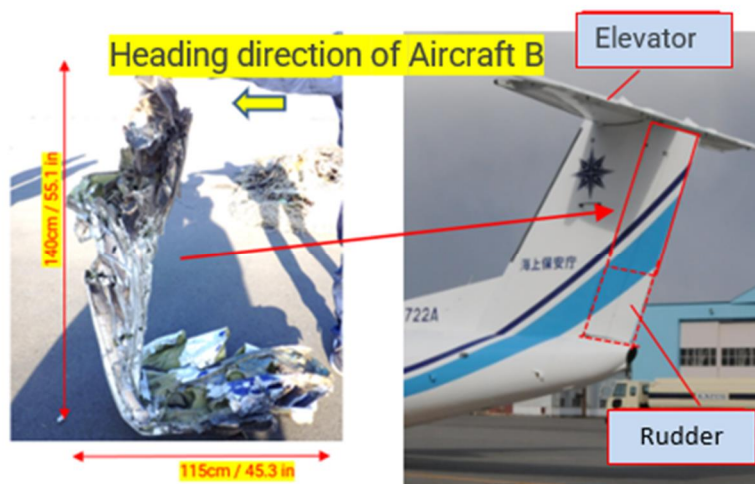
Figure 34-4 Rudder and Elevator of Aircraft A

The nose was burned, except for the windshield frame and its surroundings, and the forward frame. The radome was completely destroyed except for the framework, and the inner frames (hereinafter referred to as "FR0" or "FR1, with frame numbers), of which FR 0 in the forwardmost part was cracked vertically in the center (see Figure 34-3). Inside, part of the crushed rudder (140 cm x 115 cm) (see Figure 34-4) of Aircraft A was embedded, as it penetrated FR1, the pressure bulkhead behind it, and its front protective shield (made of aluminum alloy) (See Figures 34-3, 34-5, and 34-6). In addition, on the extension line, a horizontal crack had appeared in FR0 slightly above the center, and part of Aircraft A's left elevator had pierced the left nose skin FR1 (see Figures 34-3 and 34-4).

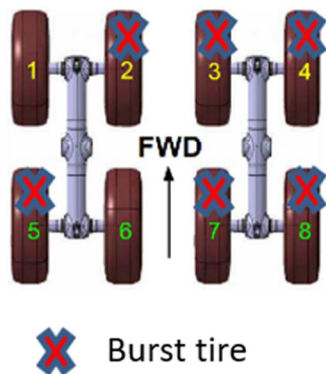
Figure 38-1 Landing Gear Tire Arrangement of Aircraft B

Both main landing gears were attached to the aircraft normally. There were no abnormalities in the main structure, but there were numerous instances of damage, such as broken hydraulic pipes, in the surrounding area. All the tires, except tires No 1 and No6, had burst as a result of damage caused by the collision and the fire (see Figure 38-1).

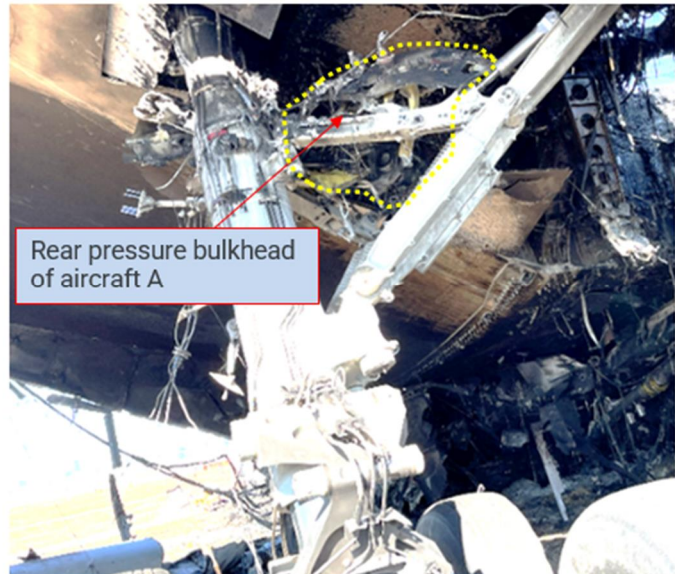
Figure 38-2 Left Main Landing Gear of Aircraft B (from rear)

In addition, part of the rear pressure bulkhead of Aircraft A was caught in the lock link of the left main landing gear strut (see Figure 38-2).

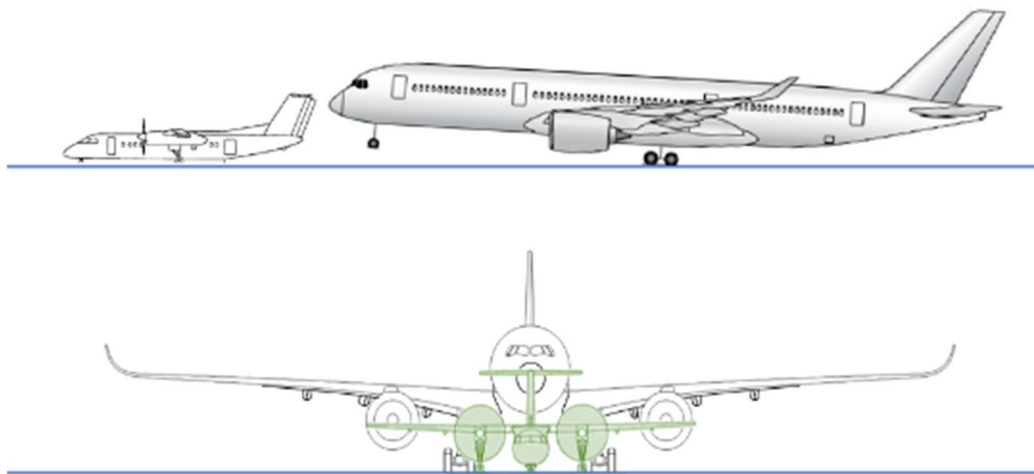
Figure 39: The Situation just before the Collision between Aircraft A and B
(provided by Airbus and de Havilland)

Based on the airport surveillance camera footage and the impact marks of Aircraft B, it is estimated that Aircraft A was stopped with its nose pointing in the same direction as the magnetic heading of the runway when it collided with Aircraft B. From the FDR records of Aircraft B, the pitch angle of Aircraft B was 3.5° up and its heading was 337° (magnetic heading) when it collided with Aircraft A.

From the above, it is most likely that the relative positions of the two colliding aircraft were as shown in Figure 39.

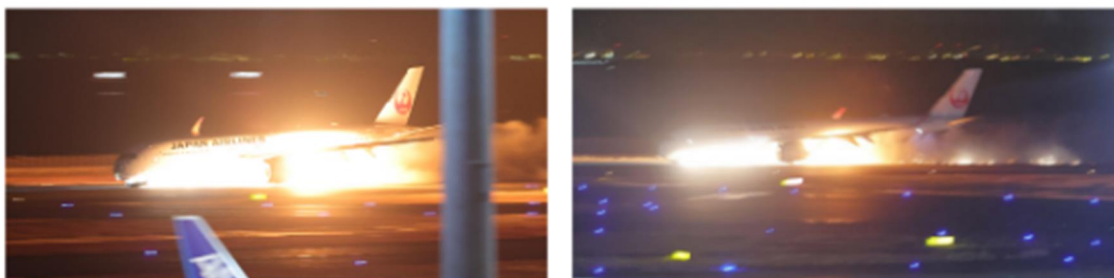
Figure 40-1: Aircraft B Rolling after the Collision.
(provided by an eyewitness)

As rolling the runway, the Aircraft B did not roll over or change course significantly, likely because the main landing gears did not collapse and there was no asymmetric drag from flight controls, reverse thrust, or brakes as they became inoperative.

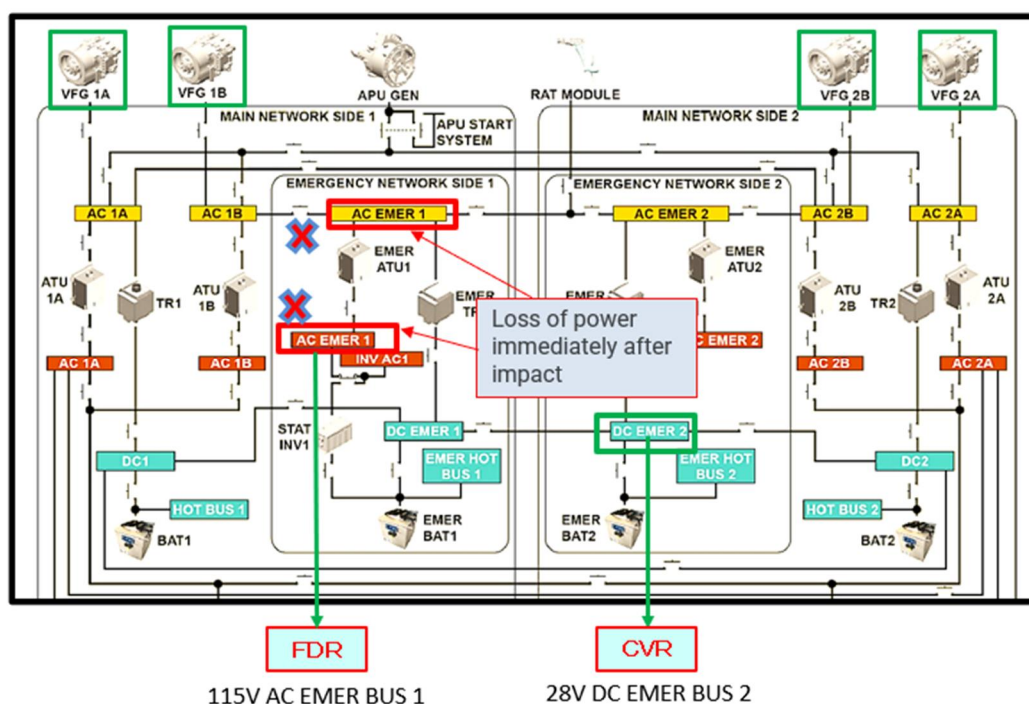
Figure 40-2 BUS related to FDR and CVR
(additions to the figure provided by Airbus)

Aircraft B's FDR stopped recording approximately 1.9 seconds after the collision. The FDR recorded that the output of the 115V AC EMER BUS1, which supplies power to the FDR, was lost 0.8 seconds after the collision, and it is most likely that the FDR stopped operating due to a loss of power or damage to the wiring.

The CVR continued to operate even after the FDR had stopped recording, and stopped 5 seconds after the aircraft stopped off the runway. it is more likely that power was lost to the 28V DC EMER BUS2 which supplies power to the CVR, or the EPDC or surrounding wiring was damaged, as a result of the impact when Aircraft B veered off the runway and stopped (See Figure 40-2) .

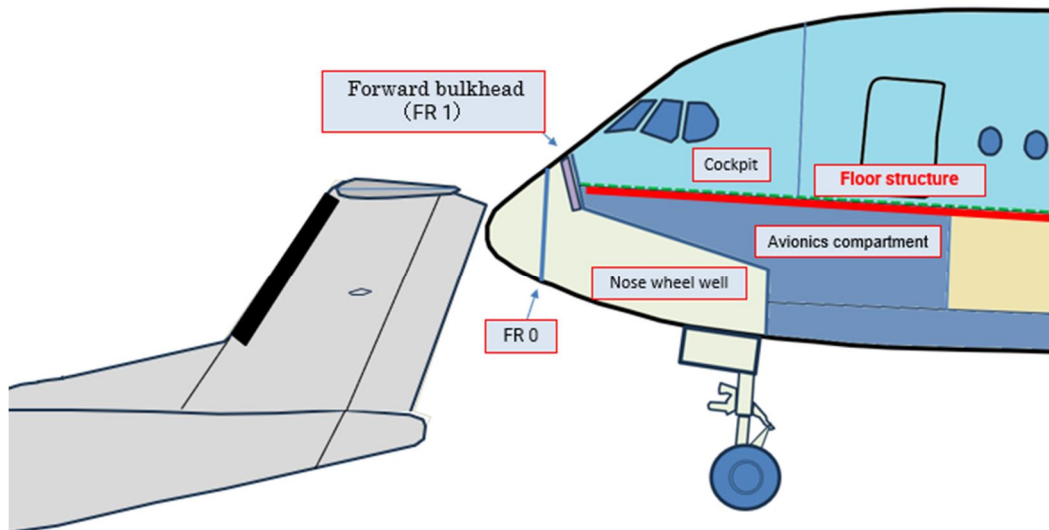
Figure 40-3 Estimated Relative Position at the Time of Collision

The tip of the radome of Aircraft B collided with the T-shaped tail of Aircraft A from the front center. Part of Aircraft A's rudder was crushed and penetrated the forward bulkhead of Aircraft B, however, there was no major damage to the cockpit or passenger cabin of Aircraft B. This is possible because the floor structure of the passenger cabin of Aircraft B supported the fuselage structure due to its attitude at the time of the collision and its relative position to Aircraft A, allowing the nose to retain its shape without being crushed.

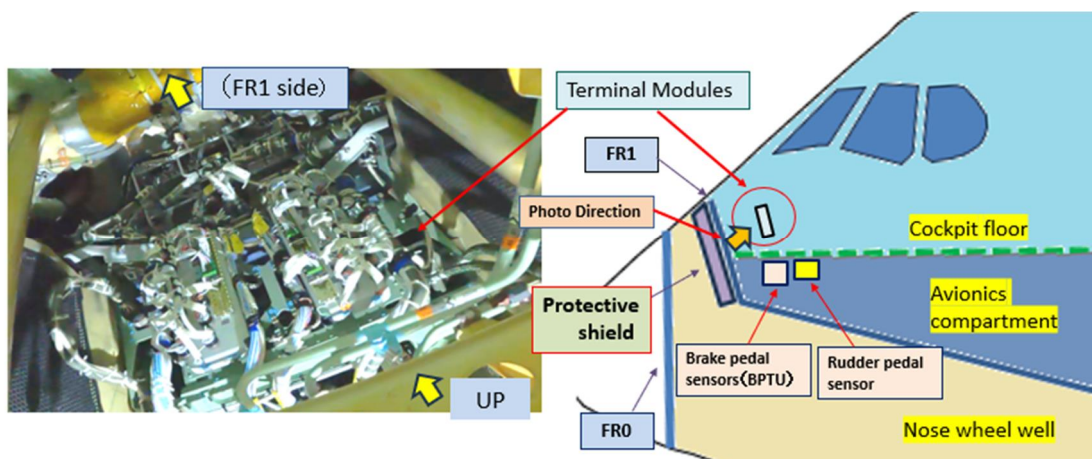
Figure 40-5 Terminal Module & Location of Damaged Equipment

On the cockpit, the cockpit door was separated from its frame by the collision, while the front of the avionics compartment under the cockpit floor was also damaged by the collision. It is believed that serious damage was caused to the following mechanisms (see Figure 40-4 and Figure 40-5):

- Rudder pedal position sensor and its input mechanism
- Brake pedal position sensor (BPTU) and its input mechanism
- Electrical wiring consolidation point (terminal module) behind the central panel of the cockpit
- Surrounding circuit breaker panels and EPDC (Electric Power Distribution Center), surrounding electrical wiring, and others.

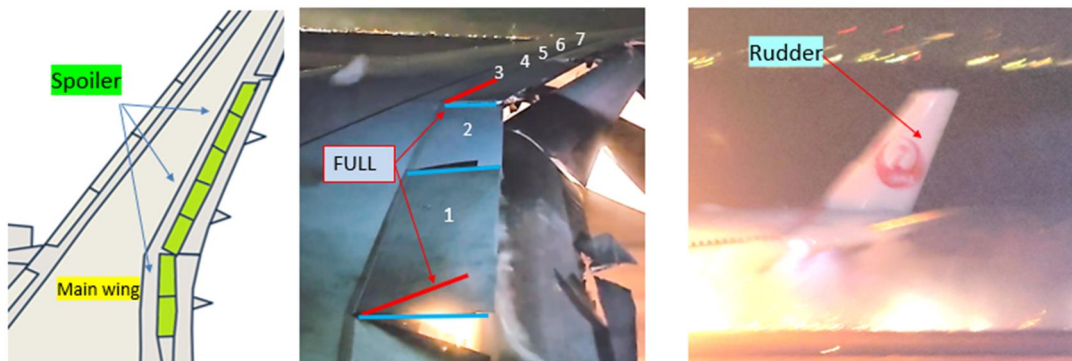
Figure 44: Condition of the Control Surface
(provided by passengers and witnesses)

In addition, the flight crew fully extended the speed brake lever during the roll as they felt there was no sign of deceleration. The FDR recorded that after touchdown, the 14 spoilers^{*36} automatically rose as ground spoilers*, but on the way to the fully open position (100%), they were extended to about 80%, then retracted to about 60%, where the FDR recording stopped. After the collision, images taken from inside the Aircraft B during the roll shows that the seven spoilers on the right wing were extended, but not to the fully extended position, and each was extended unevenly. (see Figure 44).

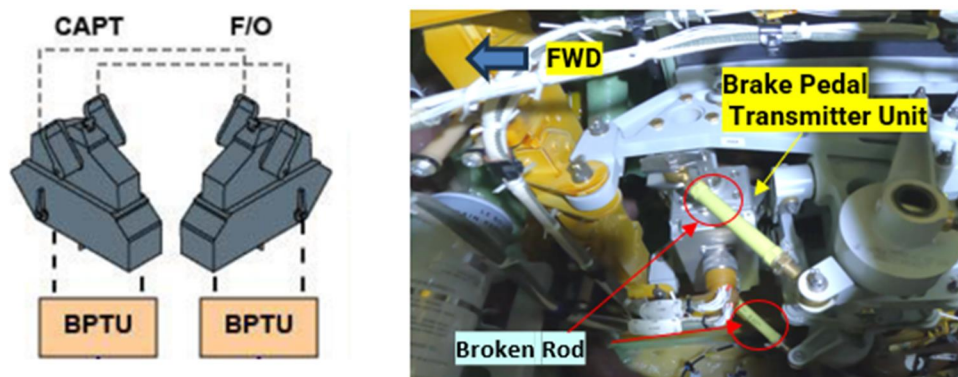
Figure 45-1 BPTU (Brake Pedal Transmitter Unit)
(additions to the diagram provided by Airbus)

Both the left and right BPTUs were found under the cockpit floor during the wreckage search. Both the left and right seats had two rods transmitting the pedal input, but all four were broken (see Figures 45-1 and 45-2).

It is most likely that when the forward bulkhead (FR1) was destroyed by the collision, the BPTU operating mechanism was damaged, and the flight crew's manual brake pedals inputs were transmitted to the braking system. In addition, The brake hydraulic valves and piping at the front of both main landing gears had been damaged as result of the collision with Aircraft A, the main landing gear wells where the brake hydraulic system was located had been damaged, and most of the tires had burst, so it is possible that the brakes would not have operated normally even if the input mechanism had been normal.

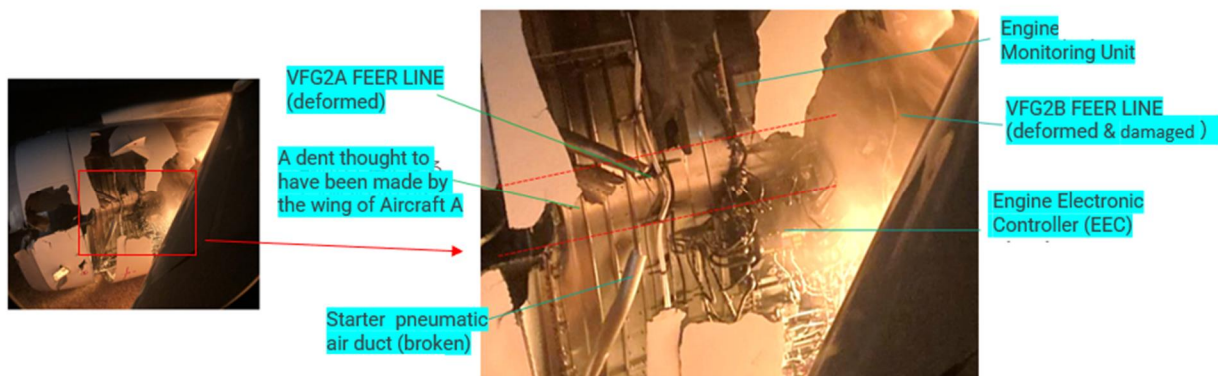
Figure 46-1: Right Engine Immediately after the Collision
(provided by passenger)

The left and right wings of Aircraft A collided with the air intakes of both engines of Aircraft B, then passed between the fuselage and the left and right engines of Aircraft B, and came into contact with the inner fan cowls of Aircraft B, damaging both inner fan cowl and their interiors.(see Figures 46-1 and 46-2). The damage to the right engine was particularly severe, and the wiring around the EEC, which is the core of the engine control system, was damaged (see Figure 46-1).

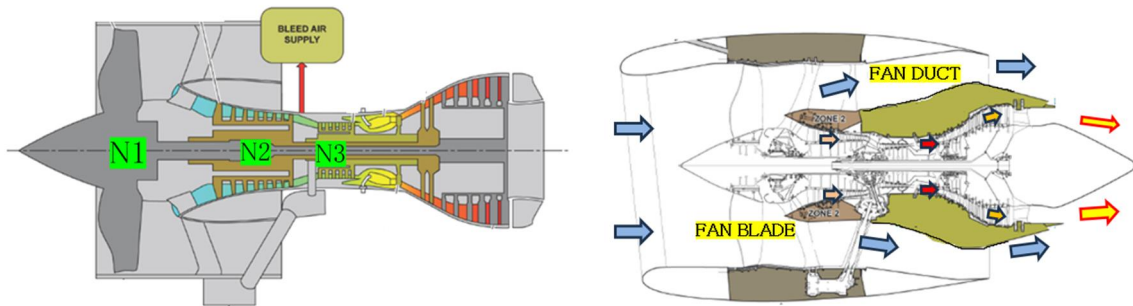
Figure 46-3 Engine Overview (RR TRENT XWB-75)
(Additions to the diagram provided by Airbus)

It is most likely that the main fuel tanks of the left and right main wings of Aircraft A contained approximately 1,600 liters of JET A-1 fuel respectively. And it is highly probable that the destroyed wing structure and scattered fuel were sucked into both engines of Aircraft B, causing damage to the fan blades, the engine interior and the inflow paths in the fan duct, and causing fires. (see Figure 46-3).

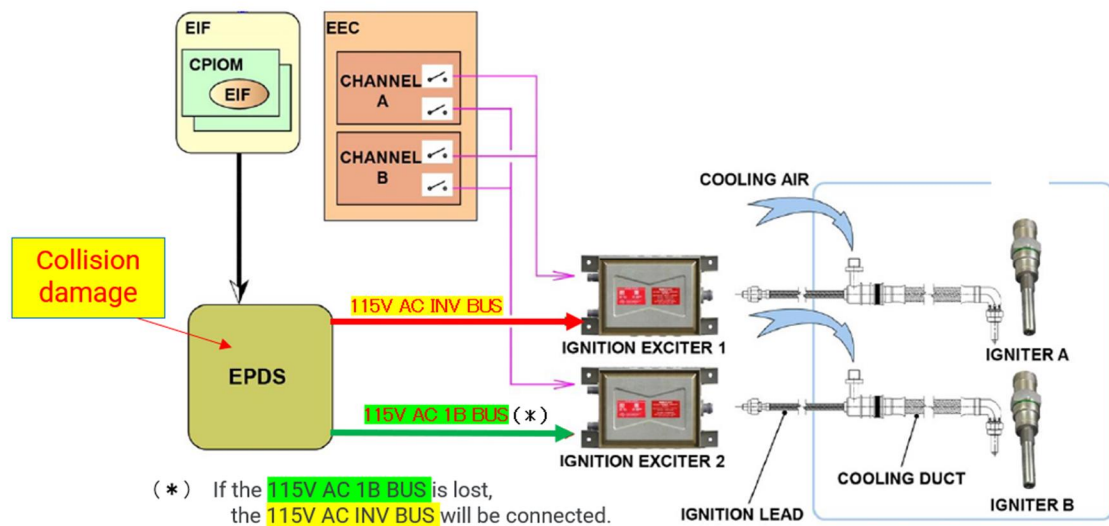
Figure 46-4 Engine Ignition System
(Additions to image provided by Airbus)

After the collision, the EEC detected that the engine had entered a compressor stall^{*38} and activated recovery mode. This involves significantly reducing the fuel flow rate to lower the combustion chamber pressure and reduce back pressure on the compressor in order to clear the airflow blockage in the engine caused by the stall, while at the same time activating the ignition, thereby preventing combustion chamber flameout^{*39}. One second after the compressor stall was detected, the EEC recorded a fault indicating that the aircraft electrical system was not providing power to ignition A.

The left engine's ignition A receives power from the aircraft 115V INV BUS, but the upstream 115V EMER BUS1 lost power immediately after the collision. In this case, power is supplied from the emergency battery via an inverter, but it is believed that this also did not work due to damage caused by the first collision.

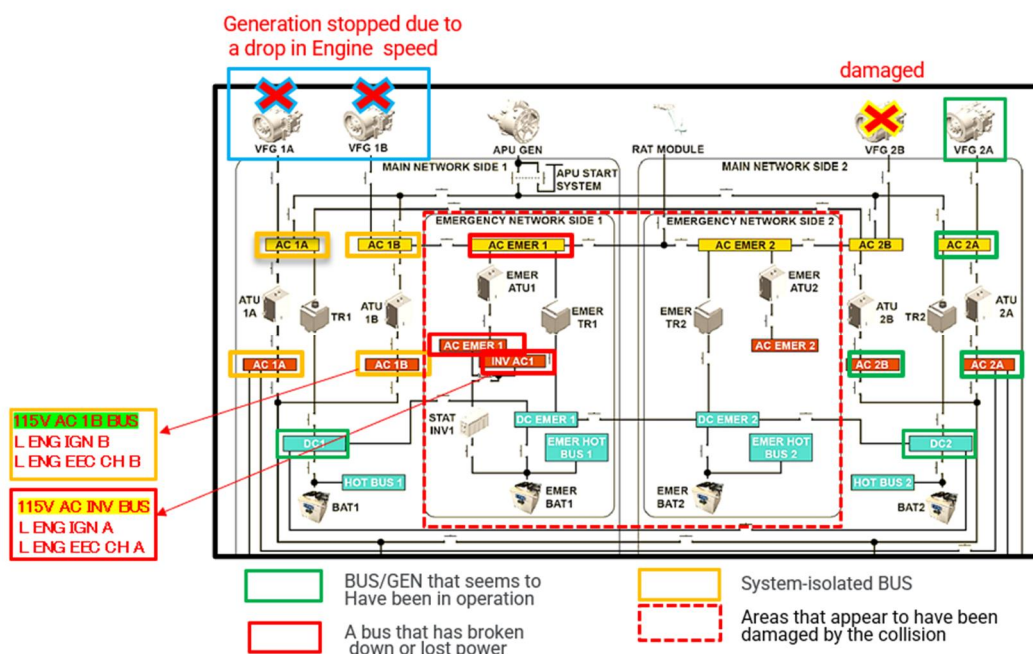
Figure 46-5 Power Distribution during the Roll
(image provided by Airbus with additional details)

The aircraft's electrical power distribution system was designed to isolate and disconnect the 230V and 115V BUS on the other side to reduce the load on the remaining generator (VFG2A), and as a result, the normal bus on Side 1 was automatically disconnected.

Seven seconds after the first ignition command was issued, the EEC issued an ignition command again because the left engine rotation did not increase. However, ignition B, which was receiving power from the isolated 115V BUS on Side 1, did not operate, and ignition A, which was supposed to receive power from the emergency power source, also did not operate, so the left engine speed did not increase (see Figure 46-5).

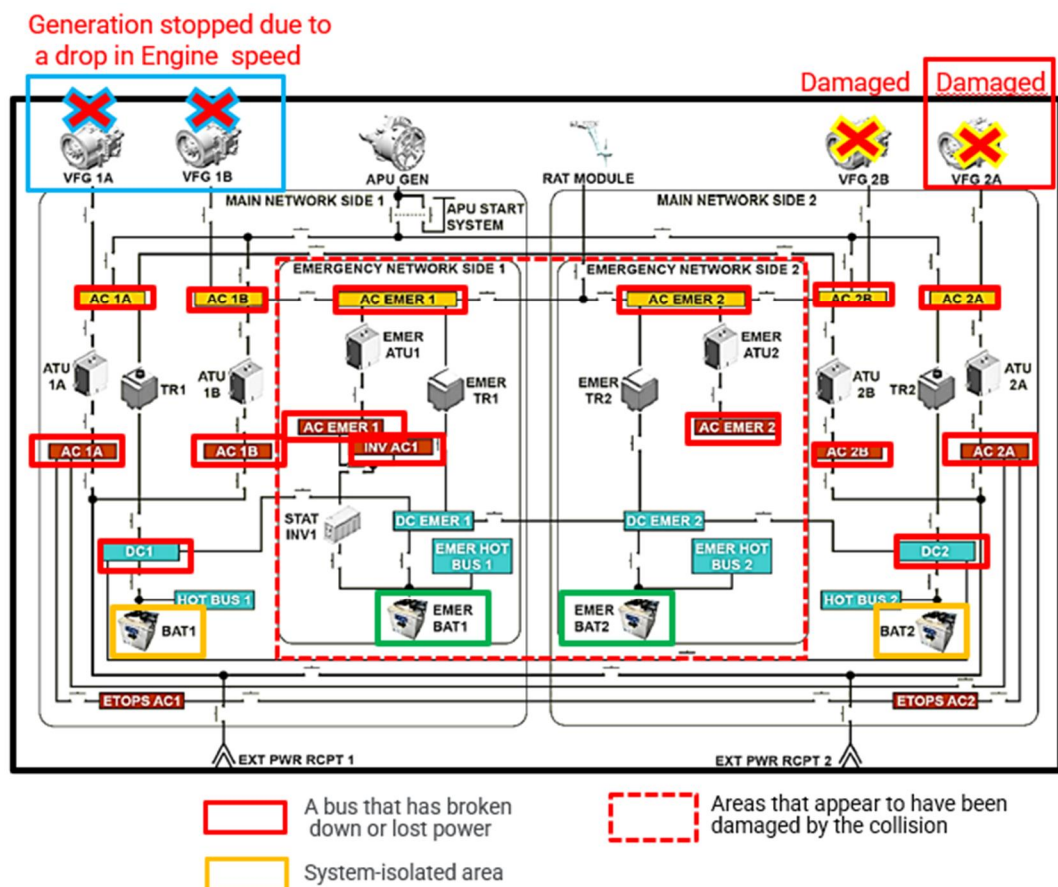
Figure 48: Power Distribution when Aircraft B came to a Stop.
(additions to the diagram provided by Airbus)

Most of the systems that stopped working were powered by the emergency 28V DC EMER BUS. Although most of the systems that received power from the BUS stopped working, some systems, such as the display at the front of the cockpit, were still working. This is probably because the BUS itself was still receiving power, but the wires from the BUS to each system were damaged, or the control side (EPDC) may have been damaged (see Figure 48).

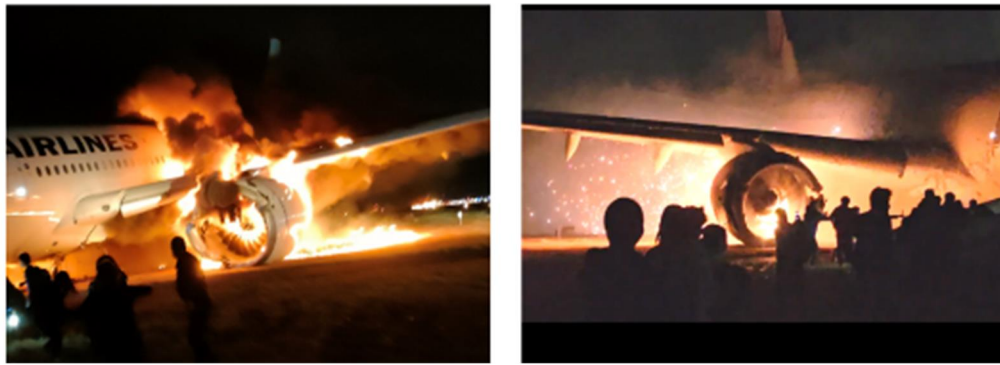
Figure 49-1: Engine Condition after Landing
(provided by passengers)

After Aircraft B stopped, the flames around the left engine gradually grew larger, and the flames spread widely to the engine itself and the surrounding ground (the grass area beside the runway) (see Figure 49-1). After Aircraft B stopped, the fire was contained by water sprayed by fire engines that arrived at the scene, but the Fires continued inside and outside the engine and in the lower fuselage. The flames in the lower fuselage then spread to the passenger cabin, resulting in the aircraft being completely burned.

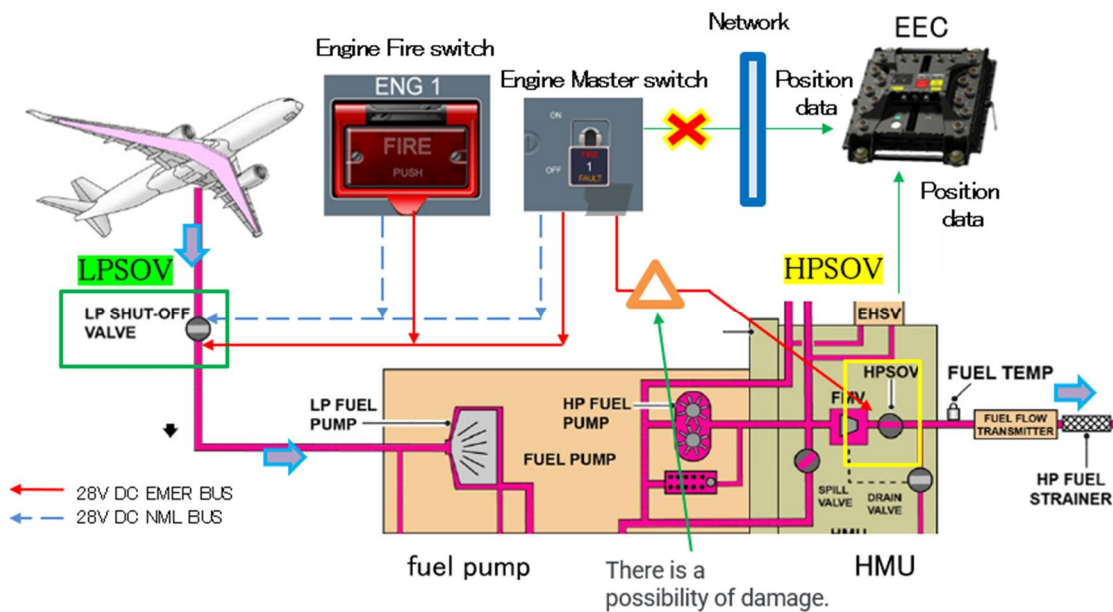
Figure 50-1 Relationship between HPSOV, LPSOV, and EEC
(additions to the diagram provided by Airbus)

Following the checklist shutdown procedure, the left engine master switch was turned "off," which caused the engine to shut down. The EEC's NVM recorded a malfunction message "HMU SOV STUCK" (information that the HPSOV was closed without an order to shut down the engine), and it is believed that the engine shut down due to the HPSOV being closed unintentionally.

Based on the damage around FR1 in the nose of the aircraft, it is possible that the HPSOV closed due to an engine flameout without master switch information being transmitted to the EEC or HMU(HPSOV), or that the LPSOV was closed by operating the master switch or fire switch, cutting off the fuel supply and causing the HPSOV to close due to spring force (see Figure 50-1).

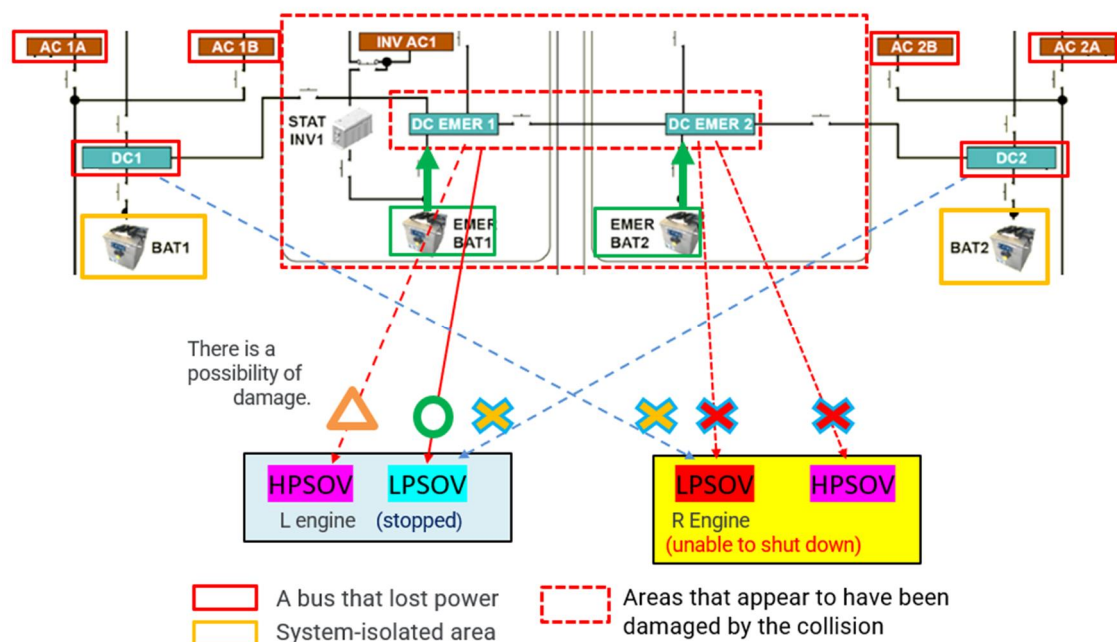
Figure 50-2 Electrical Wiring Diagram for Engine Shutdown System
(additions to diagram provided by Airbus)

When there is no AC power available, the electrical system reconfigures up so that the 28V DC EMER BUS is powered by the emergency battery, but no power is supplied to the 28V DC NML BUS. Based on this, it is estimated that the only power source for driving the LPSOV motor when the engine was shut down was the emergency power source (28V EMER DC BUS) (see Figure 50-2) .

The right engine was taken to shut down after the left engine, but did not shut down. At this time, the right engine's HPSOV and LPSOV were powered by the right emergency power source (28V EMER DC BUS2), but it is highly probable that neither of them were activated (see Figure 50-2). In addition, because the data link between the right engine and the aircraft was severed, no engine information was displayed in the cockpit, and the flight crew members were unable to recognize that the engine was still running.

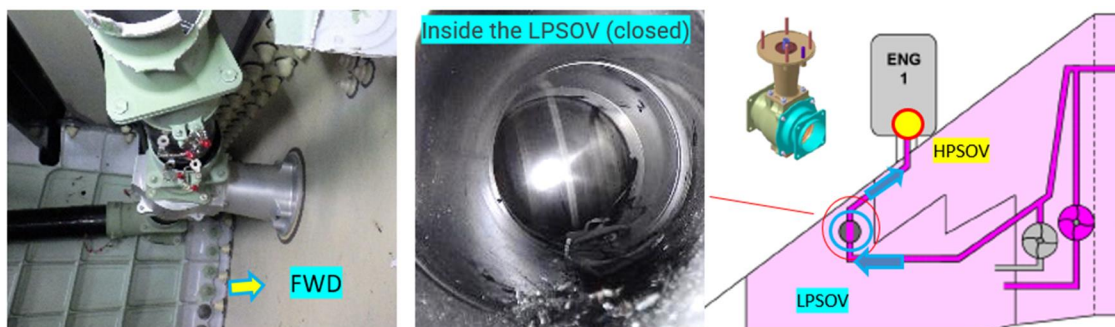
Figure 50-3 : Left LPSOV Status after the Event
(additions to the drawing provided by Airbus)

The left and right LPSOVs have dual power circuits and, taking into consideration damage from fire or a frontal collision, are separately arranged within the fuselage so that the power is dispersed via the trailing edge or wing tip. However, in this accident, the AC power was lost, so the power circuit was only on the emergency power side, and the area from around the main landing gear well to near the right wing trailing edge was also damaged by the collision, so in addition to damage around the avionics compartment, it is possible that the wiring in the right LPSOV, which did not operate, was damaged in that area (see Figure 50-3).

The left engine LPSOV was found in the wreckage with its valve closed. The right LPSOV was completely destroyed by fire and could not be found in the surrounding wreckage (see Figure 50-4).

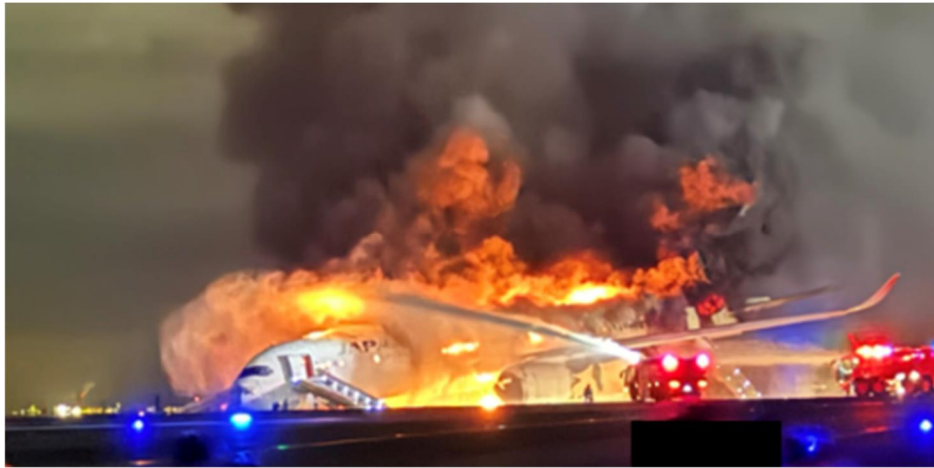
About two minutes after the PIC B had evacuated from the L4 door having confirmed that everyone had evacuated, flames began to be visible through the L3 forward window, and the amount of black smoke from the open L4 door began to increase. This is believed to have been caused by a fire that was ignited at the time of the collision in the main landing gear well to the aft cargo compartment, causing smoke into the cabin, and then spreading to the passenger compartment.

Figure 51-2: Aircraft B on Fire (provided by passengers)
