(AIRCRAFT ACCIDENT INVESTIGATION INTERIM REPORT)

BOMBARDIER DHC-8-315, JA722A

AIRBUS A350-941, JA13XJ

December 25, 2024

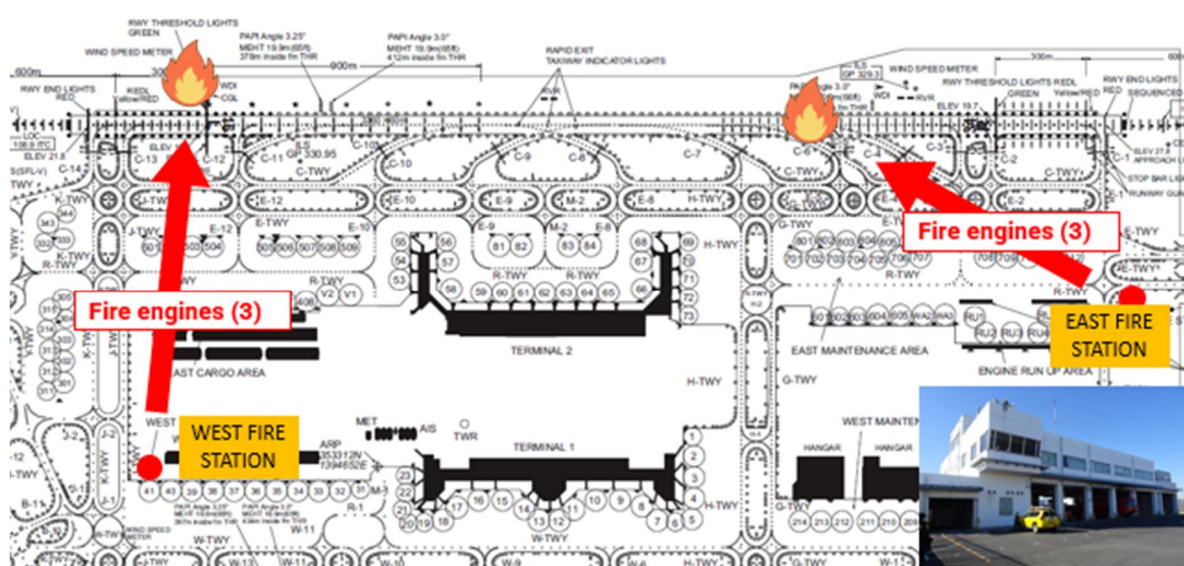
Haneda Airport has six airport chemical fire engines (hereinafter referred to as "fire engines"), and on the day of the accident, three fire engines were on standby at each of the two buildings (East Building and West Building). At the same time as the accident occurred, the control tower reported the incident by crash phone, and all the fire engines on standby were dispatched to the scene (see Figure 52-1). At that time, the airport firefighters on board each fire engine had not been aware of the full extent of the accident and had visually inspected the fire scene near the building where they were waiting, and had been dispatched to that scene. In addition, the airport firefighters who responded did not realize that the fire was in the CFRP aircraft.

Figure 52-1 Initial Response of Airport Firefighting

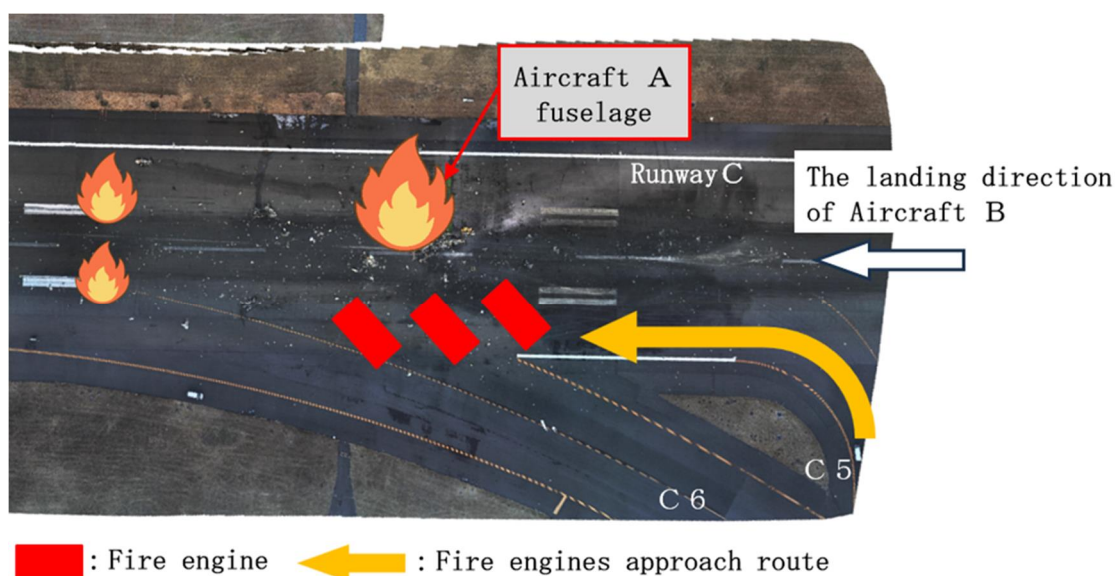
The three fire engines heading for Aircraft A from the East Building approached Aircraft A from taxiway C5. When the fire engines arrived at the scene, there were three main large flames, and flames were also rising in various places in the surrounding area. Two fire engines were used to extinguish the fire in the fuselage, and one was used to extinguish a large fire on the runway in the northwest direction from the fuselage (see Figure 52-2).

Figure 52-2: Situation When the Fire Engines arrived at the Fire Scene on Aircraft A

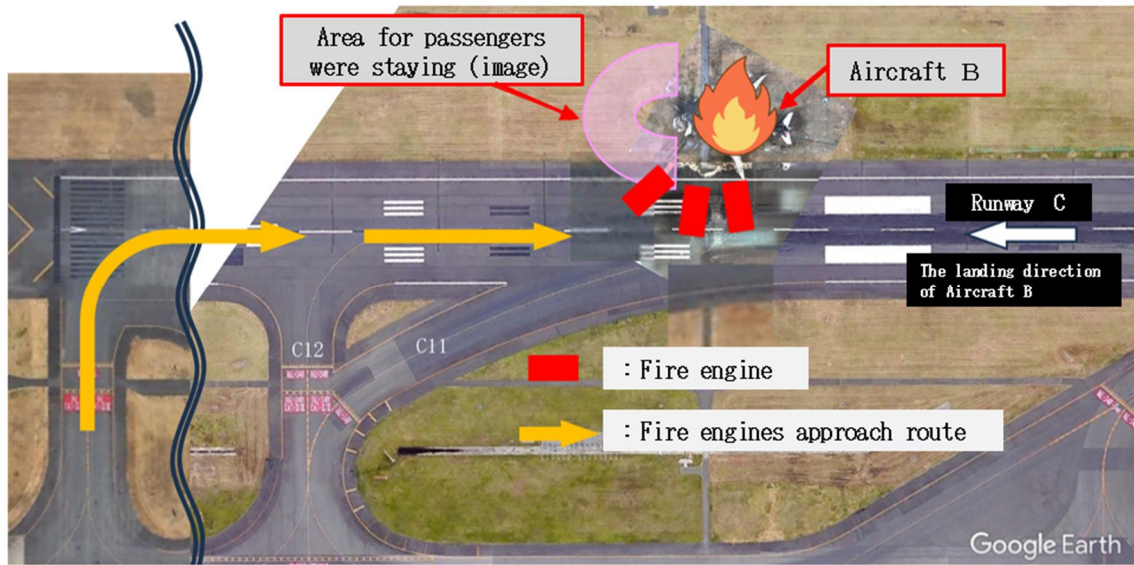
Meanwhile, when the three fire engines dispatched from the West Building arrived at the scene of the fire on Aircraft B, the airport firefighters on board recognized that a fire had started near the left engine and saw that the emergency evacuation of Aircraft B's passengers had begun from L1 and R1, and that the passengers who had escaped were retained around near the front of the nose. Therefore, in addition to giving instructions over the loudspeaker mounted on the fire engine, one airport firefighter got off to the ground and guided the

passengers away from Aircraft B and to move to the rear of the fire engine. While guiding the passengers, water was sprayed to put out the fire near the left engine, and to cool Aircraft B to prevent the fire from spreading to the fuselage and the fuel loaded on the wings from igniting, and to allow the passengers time to escape (see Figure 52-3). When the airport firefighters got off the fire engine to guide passengers and check the fire situation, they confirmed that the right engine of Aircraft B was running. In addition, the crew members of Aircraft B had reported to the airport firefighters engaged in firefighting activities that all passengers and crew members had escaped.

Figure 52-3 Situation when Fire Engines Arrived at the Fire Scene on Aircraft B

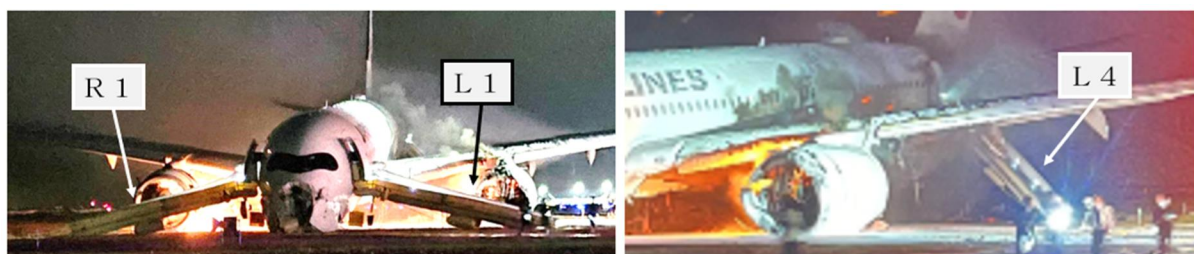
Of the slides used for evacuation, L1 and R1 had a gentle slope because the front of the Aircraft B was lowered due to the broken nose gear, and passengers stopped midway when sliding down the slide. On the other hand, the slope of the L4 slide was steep because the Aircraft B had tilted forward and the floor height of the L4 exit was higher than normal. As a result, many passengers fell when landing. All of the slides used for evacuation landed on grass (see Figures 53-1 and 53-2).

Figure 53-1 L1, R1 and L4 Slides (provided by passengers)

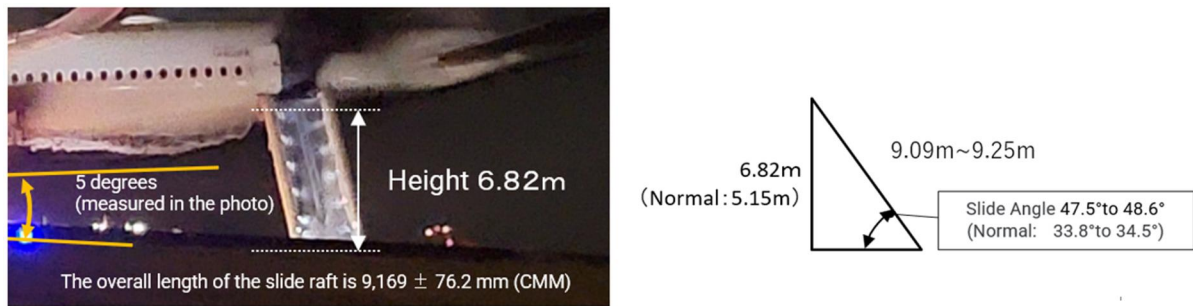
Figure 53-2 L4 Slide Height (provided by passengers)

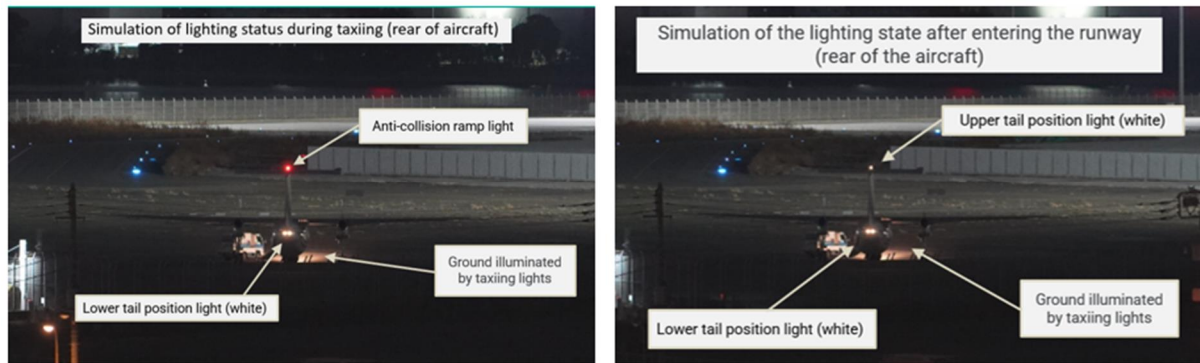
As a result of the verification, the anti-collision ramp light (red strobe) and the upper tail light position light (white) located at the center of the horizontal stabilizer of the aircraft in use, as well as the anti-collision strobe light (white strobe) and the lower tail light position light (white) located in the tail of the fuselage, were visible from the upper rear (see Figure 54).

Figure 54: Photos Taken during Light Visibility Verification by the Same Model of Aircraft A (photos taken on January 29, 2024)

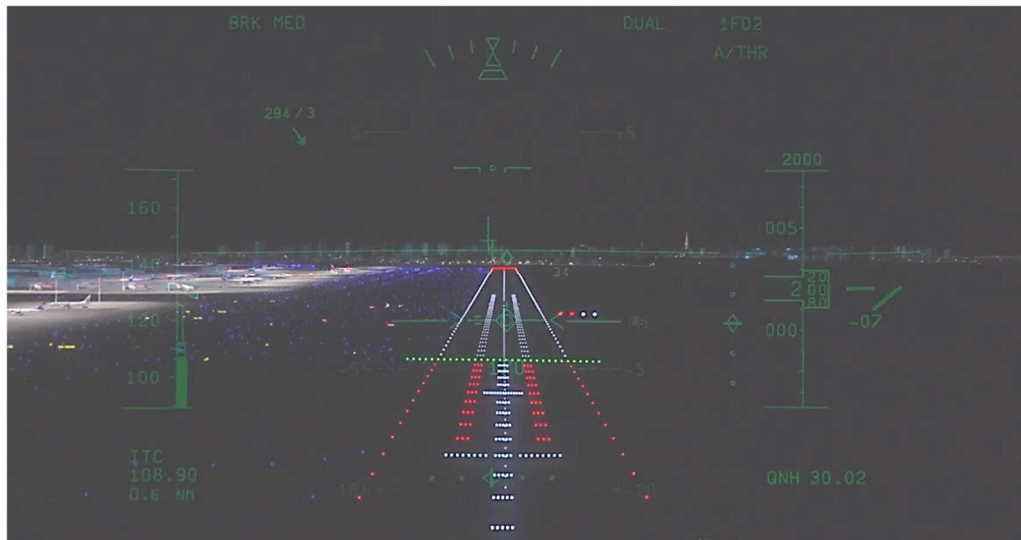
- a The location where Aircraft A was stopped was approximately 150 m northwest (in the direction of landing) of the aiming point for touch down on the runway for Aircraft B's final approach (the point, but at night, is on the runway centerline directly beside the PAPI).
- b The Flight Path Vector display on the HUD during Aircraft B's final approach was close to the final approach descent target point until the flare operation began.
- c Aircraft A was stopped in a position where the runway centerline lights and touchdown strip lights were embedded in the runway surface, and the upper tail light, lower tail light and anti-collision lights attached to the tail of Aircraft A, which were visible from behind, were approximately in the same line as the row of runway centerline lights.

Figure 55-1 Runway 34R Seen through the HUD
(Photo taken during simulator verification)

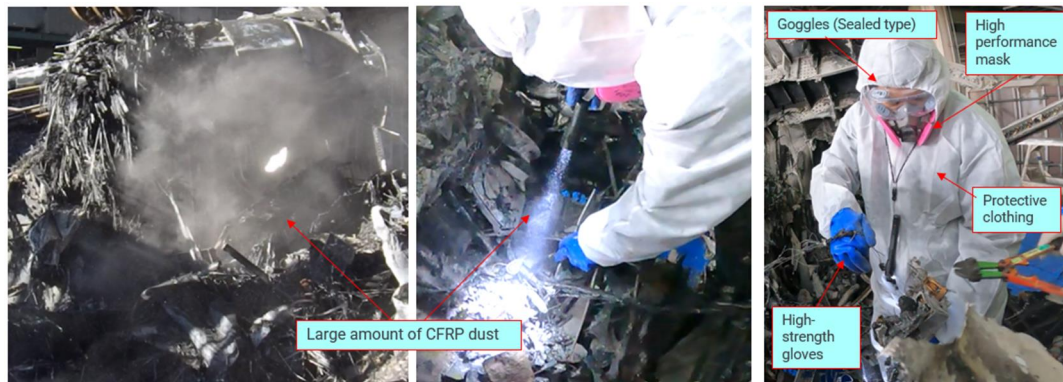
In areas where carbon fiber dust is likely to scatter, it is necessary to wear a mask^{*47} and goggles to prevent the skin exposure and inhalation of dust. Figure 56-1 shows an example of the personal protective equipment (hereinafter referred to as "PPE") to be worn when working at the scene of an aircraft accident that mainly a lot of CFRP materials are used, and Figure 56-2 shows the situation when working while wearing PPE.

Figure 56-2 Situation at the Site (CFRP Dust, Protective Clothing)
