**MARINE ACCIDENT
INVESTIGATION REPORT**

Vessel type and name: Fishing vessel, Nikko-maru

Accident Type: Foundering

Date and time: approximately 03:44, April 5, 2008 (local time, UTC+9 hours)

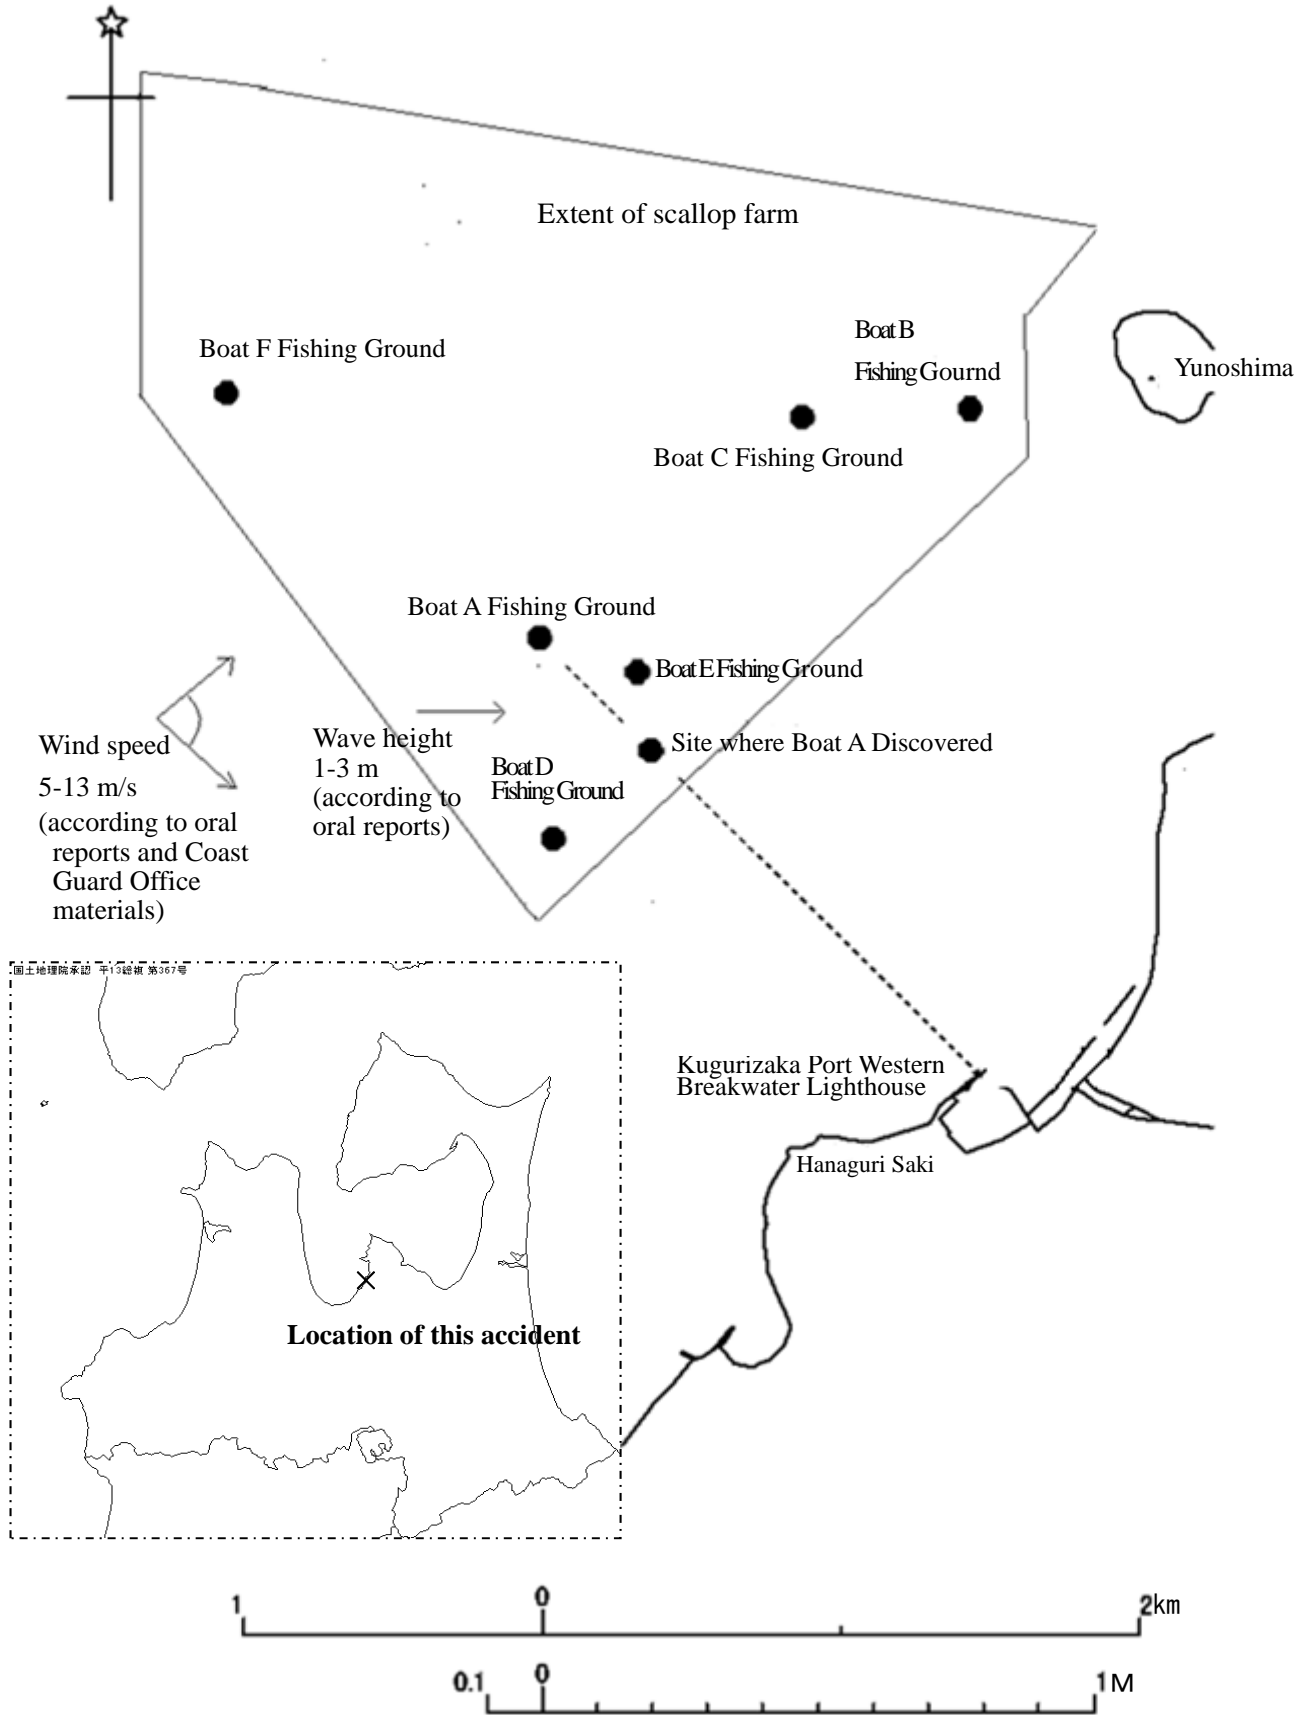
Figure 1 Kugurizaka Fishing Port, the Fishing Grounds of Ship A and its Consort Ships, and the Discovery Location of the Sunken Ship A (outline map)

As described in 2.5.4, one mainline worth of pearl nets had been brought up. And, as described in 2.10.4, the hook on the crane was fastened down, the switches for searchlight and clear view screen were on, and from the positional relationship of the fishing grounds and the location that Ship A was discovered (Refer to Fig. 1), it is probable that the accident occurred during the return to port.

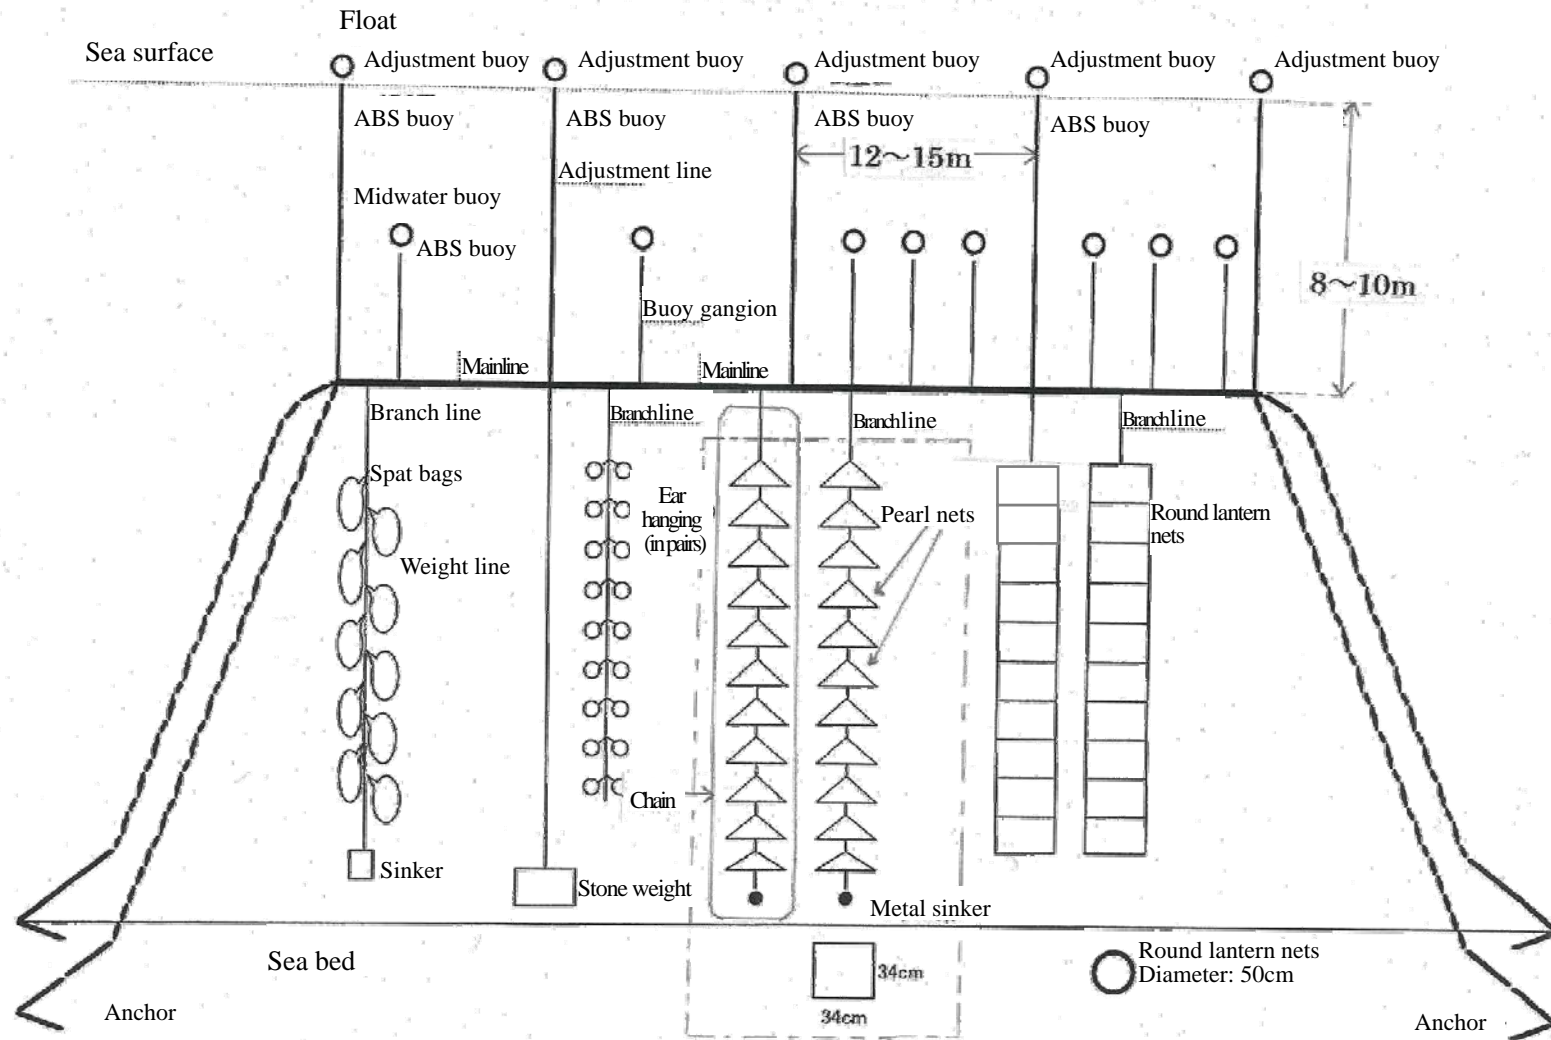
Figure 2 Standard Scallop Farm

According to interviews with Captains C and F, Ship A carried out its operations by using the crane that was normally carried on board to pull up a chain*1 of 10-15 pearl nets (basket: see Fig. 2) with scallops from the port side, bring them inside, and load them on its deck.
