MA2009-12

**MARINE ACCIDENT
INVESTIGATION REPORT**

MARINE ACCIDENT INVESTIGATION REPORT

Vessel type and name: Recreational fishing vessel Koyo Maru No. 7
Vessel number: 220-17774 Niigata
Gross tonnage: 3.2 tons

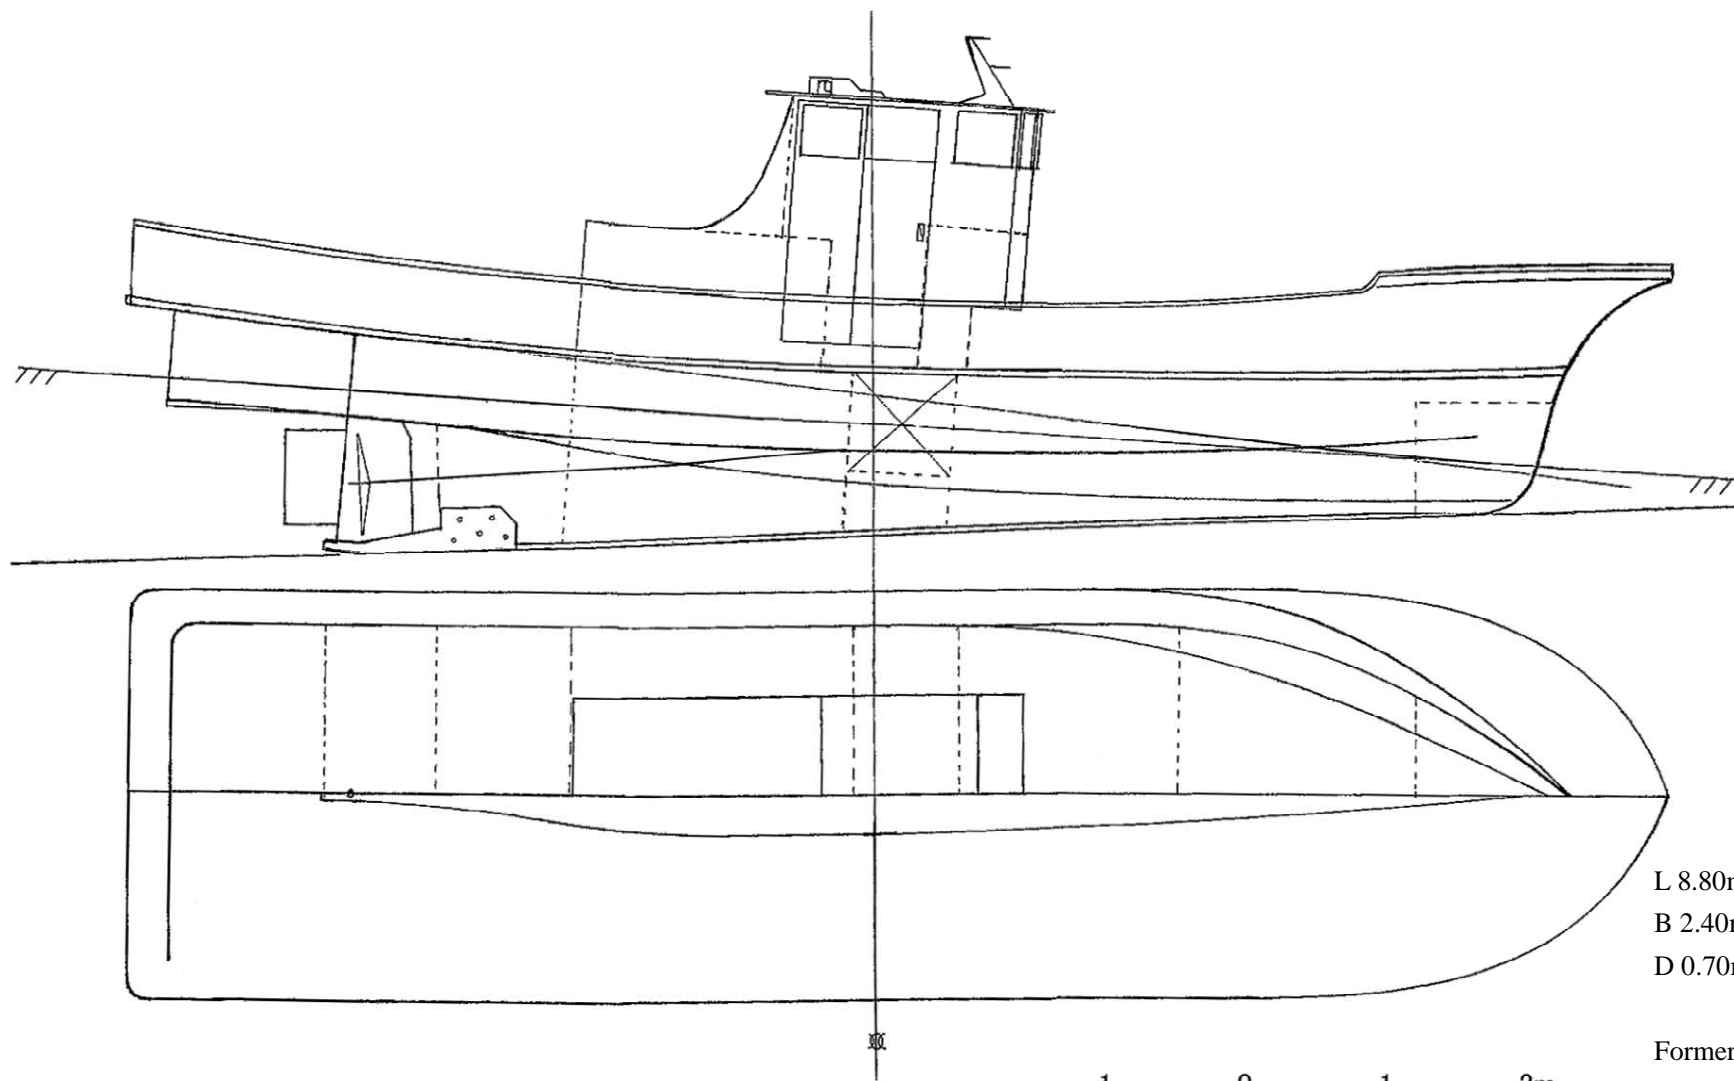
Attached Figure 3 General arrangement plan of Vessel A

Former tonnage: 3.2 tons
New tonnage: 2.8 tons
Shipbuilder A

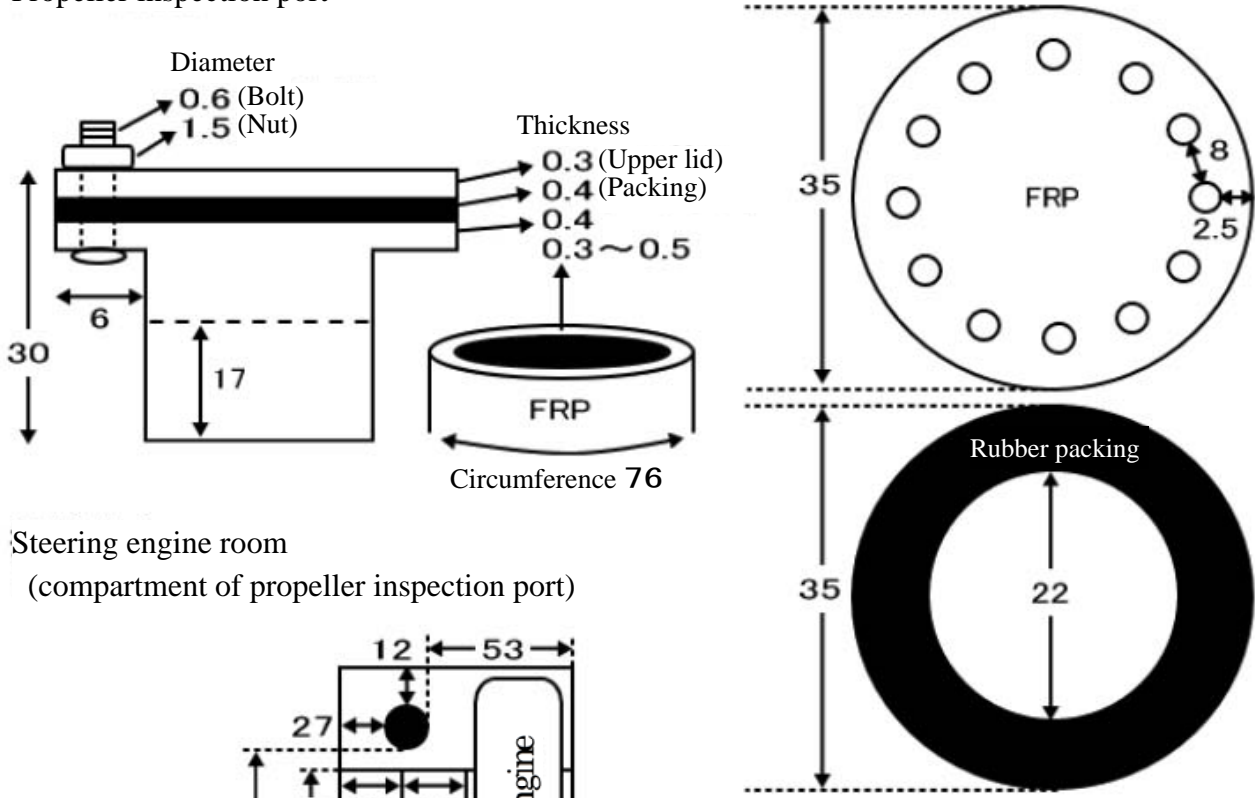
Attached Figure 4 Propeller inspection port of Vessel D

Propeller inspection port

Steering engine room
(compartment of propeller inspection port)

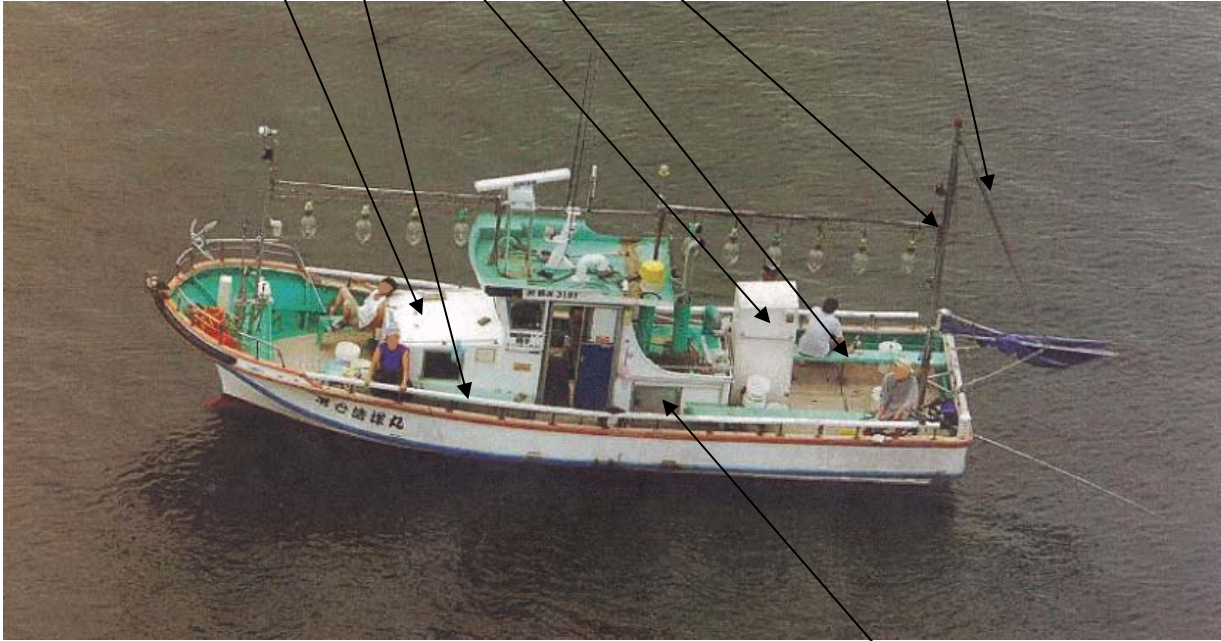
Photo 1 Vessel A before the accident

The additional weight of about 800 kg, resulting from the installation of the following facilities after her building—as evidenced by 2.6.3, 2.8 (3) through (7); Attached Figs. 2 and 3; and Photo 1—contributed to a reduction of about 4 cm in freeboard.

Main facilities additionally installed:
Cabin, handrail, toilet, bench, mast, fish gathering lamps, spanker

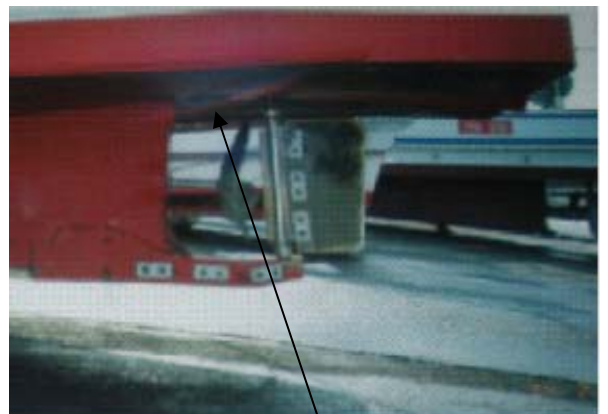
Photo 3
Port stern of Vessel A
upon its construction

It is considered somewhat likely the window of the propeller inspection port came off as a result of fractures of the bolts used to fix the window, or otherwise, owing to vibrations or for other reasons.

Propeller inspection port

The Japan Craft Inspection Organization has already taken further safety measures for propeller inspection ports. However, when inspecting vessel hulls, they should keep records when they have found defects and taken corrective action, and analyze such records for some period and if a considerable number of deficiencies have accumulated, they should communicate such information to ship owners in order to contribute to daily maintenance and upkeep.
