**MARINE ACCIDENT  
INVESTIGATION REPORT**

Vessel type and name: Car carrier; CYGNUS ACE

Vessel type and name: Multi-purpose cargo ship; ORCHID PIA

Accident type: Collision

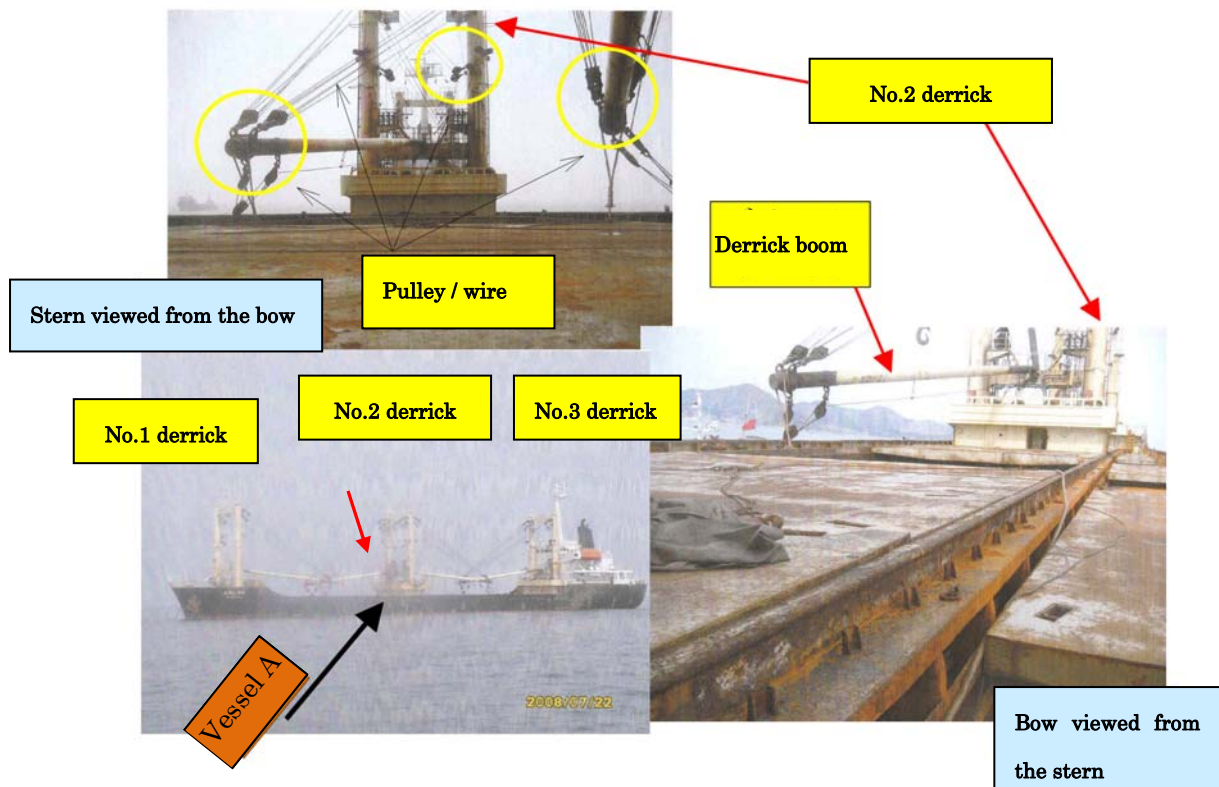
Figure 12: Deck layout of vessel B

- a Ruptures in the foremost bow section of Vessel A were probably caused by the ship's bow striking the derrick boom of Vessel B, where the tip of the boom was latched above the cargo hatch with wires (hereinafter referred to as "parked"; see Figure 12).
- b Ruptures on the starboard bow section of Vessel A were probably caused by the ship's bow striking the accommodation (bridge section) of Vessel B.
- c Pulleys and other components found entangled with the starboard anchor of Vessel A was probably ripped off from the middle or uppermost part of the derrick post on Vessel B.
- d The bow section of Vessel A riding the crest of the wave probably ran over Vessel B which was in the wave trough, causing Vessel B to sink immediately thereafter.

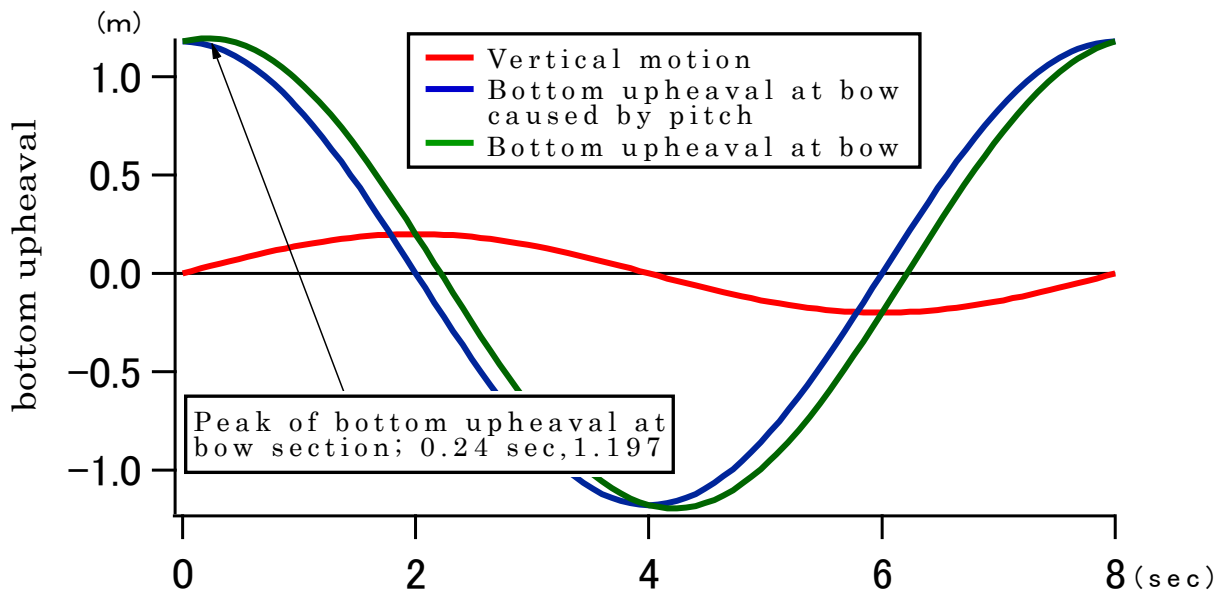
**Diagram 1-1 Relationship between vertical motion and pitch**

Upheaval at the bow section of vessel A is considered to be the combined result of the vertical motion and pitch components. There exists an approximately 90. deg. phase deviation between vertical motion and pitch, with the pitch diminishing to almost zero at the peaks of vertical motion. Diagram 1-1 indicates the upheaval of the bow when the cycle of wave encounter is assessed as 8 sec with the oscillation of pitch angle and vertical motion respectively calculated as 0.1 deg. and 0.20m. According to this diagram, the upheaval of the bottom of the hull reaches 1.20m at 0.24 sec.
