MA2012-4

**MARINE ACCIDENT  
INVESTIGATION REPORT**

**Japan Transport Safety Board**

| Vessel type and name | Cargo ship | SINGAPORE GRACE |

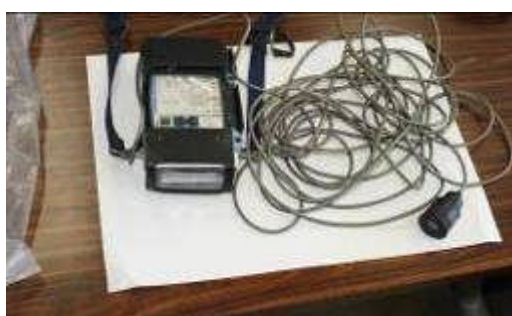
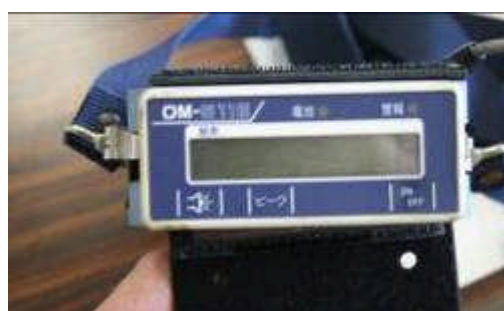
“O<sub>2</sub> Concentration Meter”

The O<sub>2</sub> concentration meter was made in July, 2005, calibrated<sup>47</sup> on May 23, 2008, was flame-proof, had a measuring range of 0~50%, supplied with 10m of sensor cable and when O<sub>2</sub> concentration decreased to 18%, an alarm (“pi-pi-pi-pi”) sounded and a red lamp blinked. The O<sub>2</sub> concentration meter worked normally.

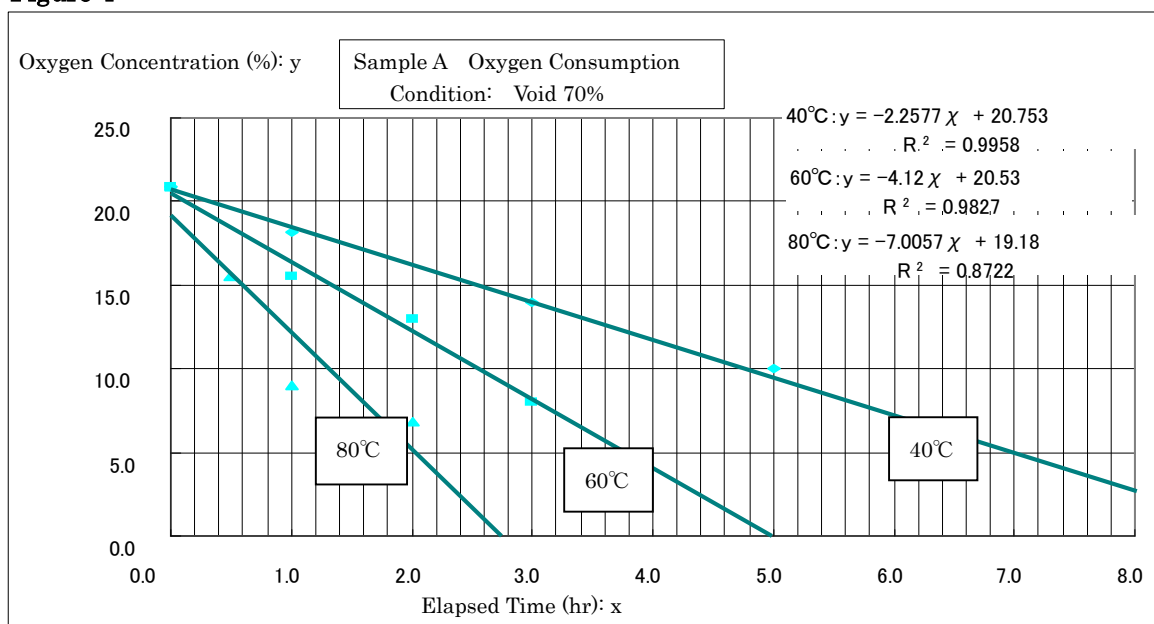
**Figure 4**

Table 1 and Figure 4 show the measurement results

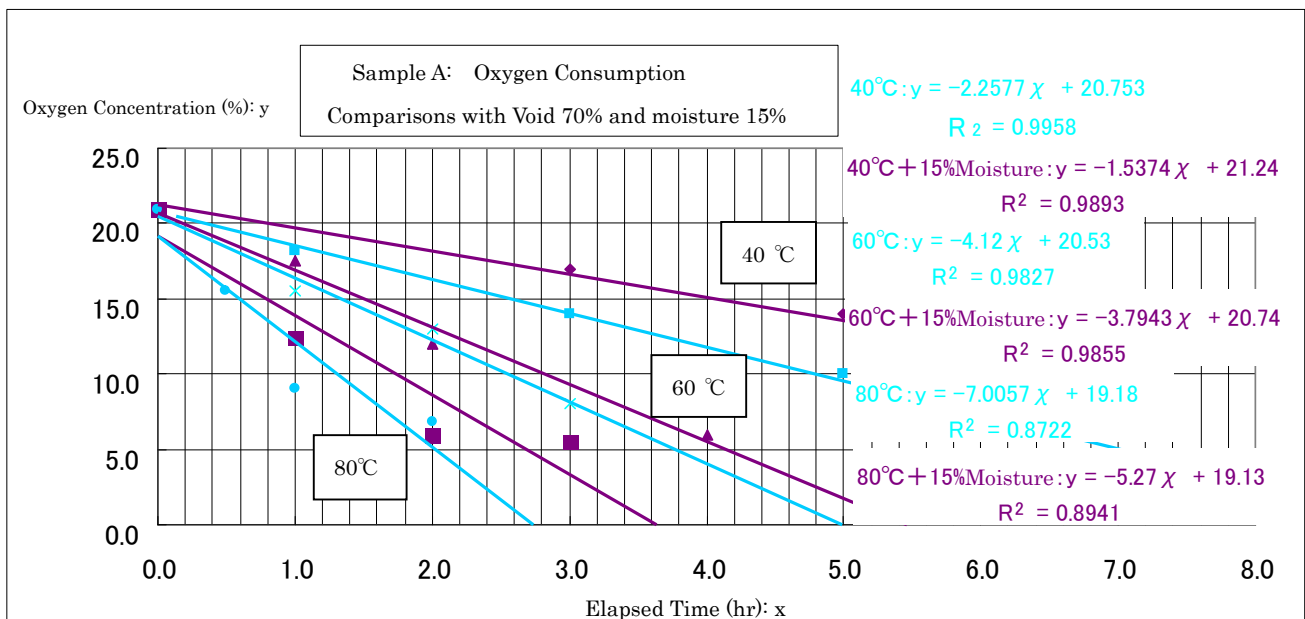
**Figure 8**

(1) Regardless of the differences in temperature and volume of void, the oxygen concentration in the airtight containers decreased.

The relationship between elapsed time and oxygen concentration is considered to be almost proportional.

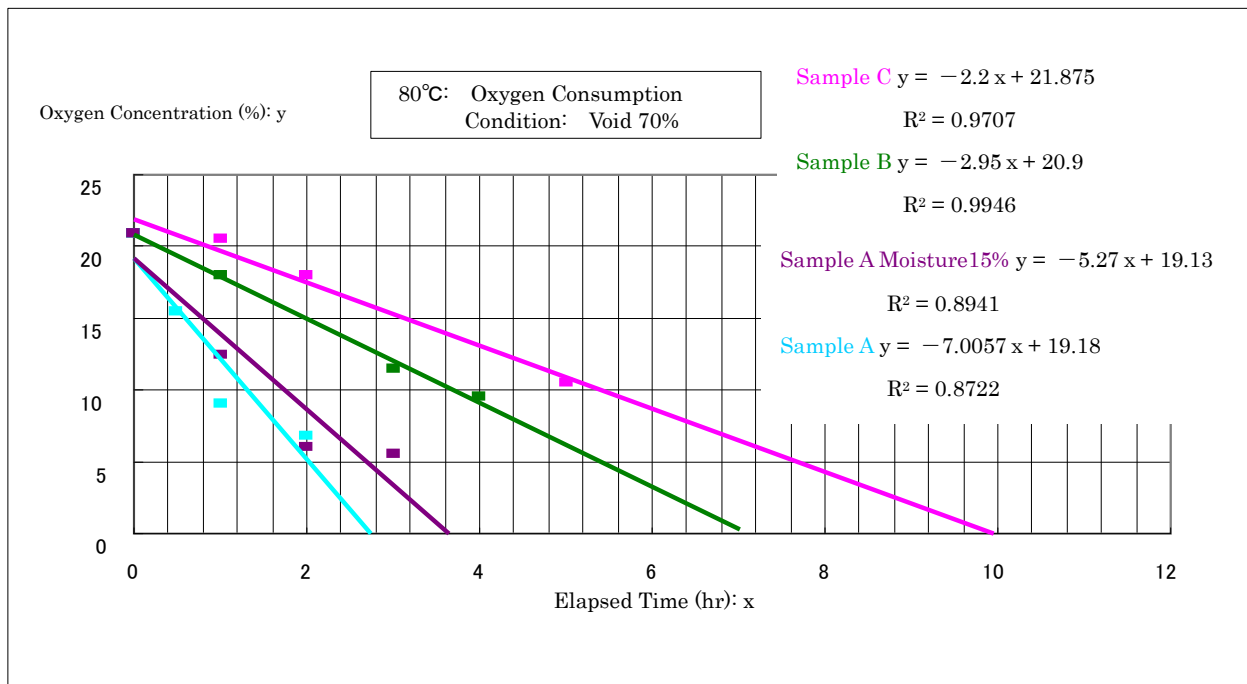
**Figure 13**

- (1) Of the three(3) samples, at every temperature (40°C, 60°C and 80°C) the oxygen consumption rate of Sample A was high and the oxygen concentration in the void decreased from 20.9% to under 10% 6 hours after being sealed.
- (2) Regarding Sample C, it was ascertained that the oxygen consumption rate was especially low at 40°C.  
Looking at the measurements for the oxygen consumption rate at 60°C, the same difference was found.
- (3) Regarding Sample B, the rate was found to be between that of Sample A and Sample C.

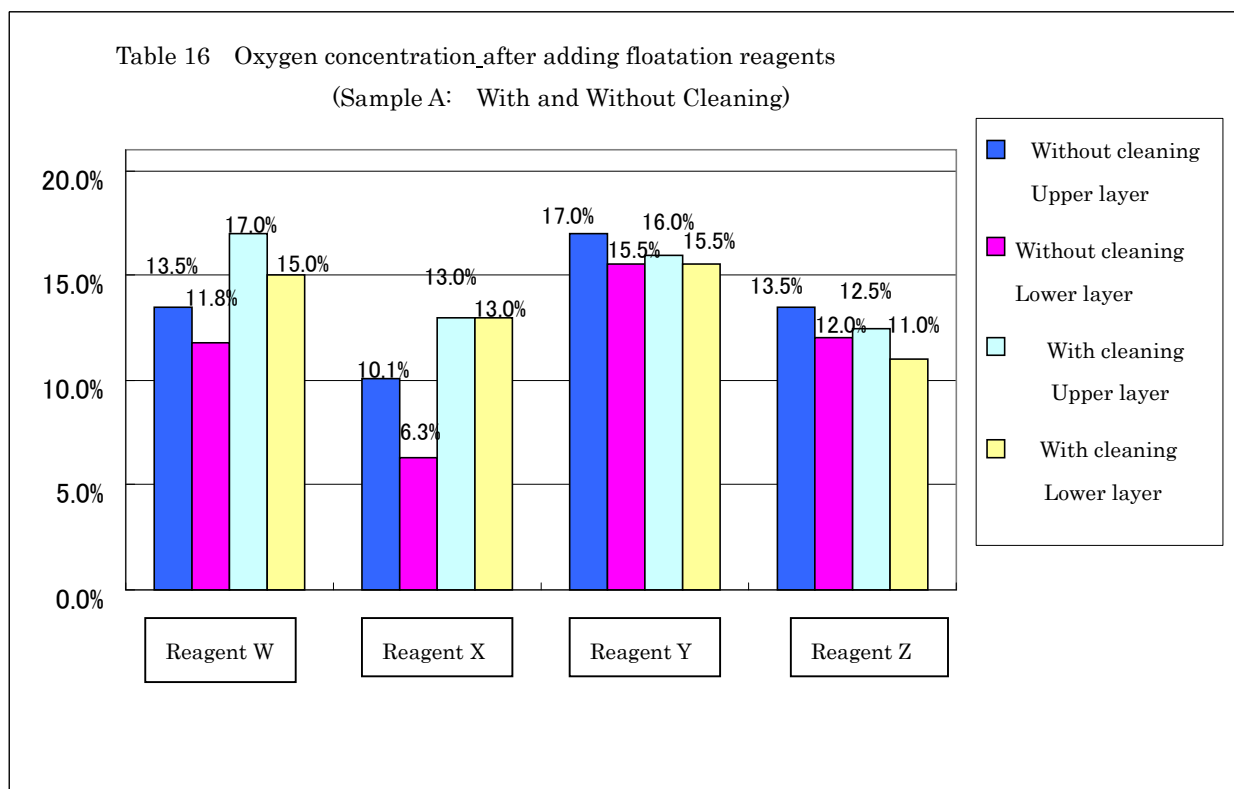
**Figure 16**

Figure 16 shows the comparison of oxygen concentration (Sample A: with/without cleaning by purified water) for each floatation reagent.

- (1) Reagent W and Reagent X: non-cleaned sample tended to have a lower oxygen concentration .
- (2) Reagent Y: high oxygen concentration compared to other floatation reagents.
- (3) The oxygen concentration were shown to be lower in the lower level of the flask.
- (4) It was shown that the oxygen concentration differed by the type of floatation reagent.

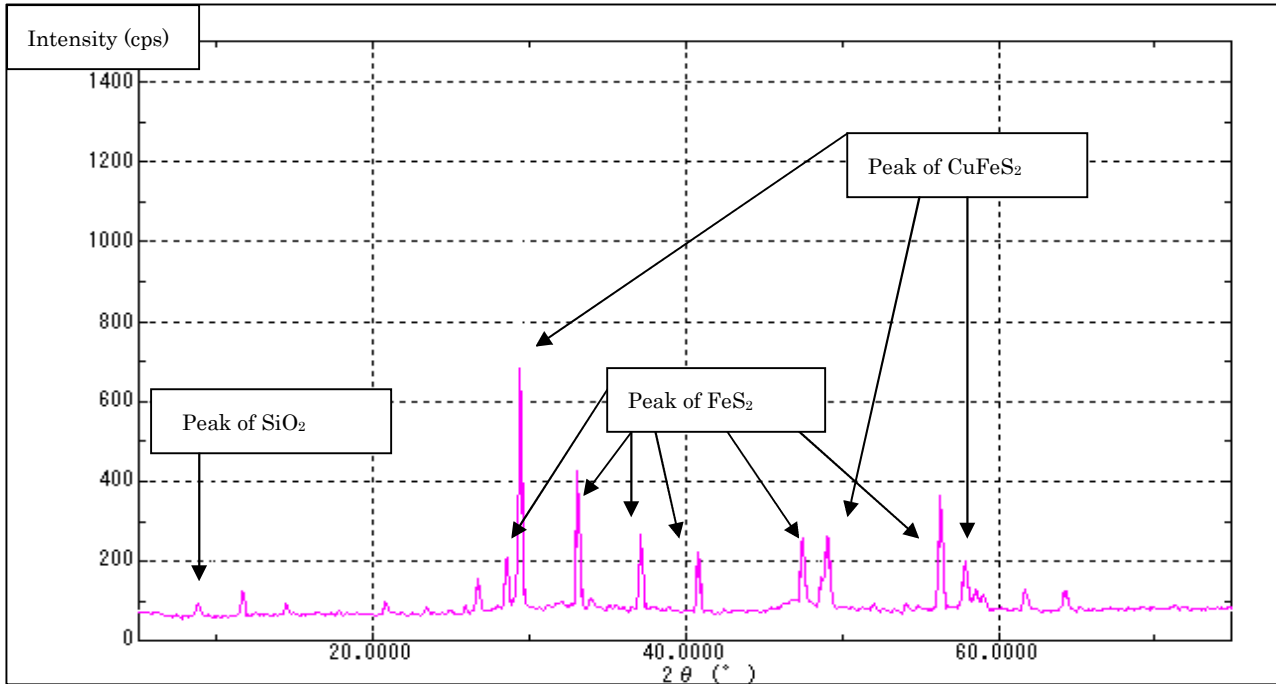
Figure 21 Sample C

(1) For Sample C it was found that the intensity of the peak<sup>\*5</sup> of CuFeS<sub>2</sub> was the lowest of the three samples.

Thus it is considered that the ratio of CuFeS<sub>2</sub> was the lowest.

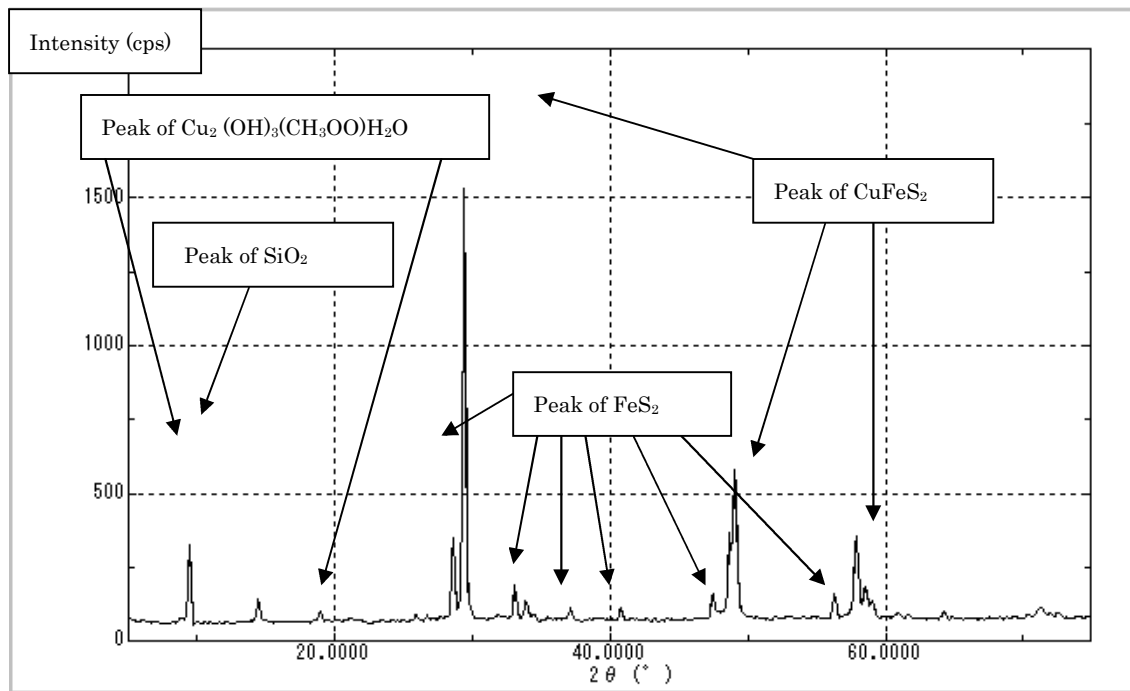
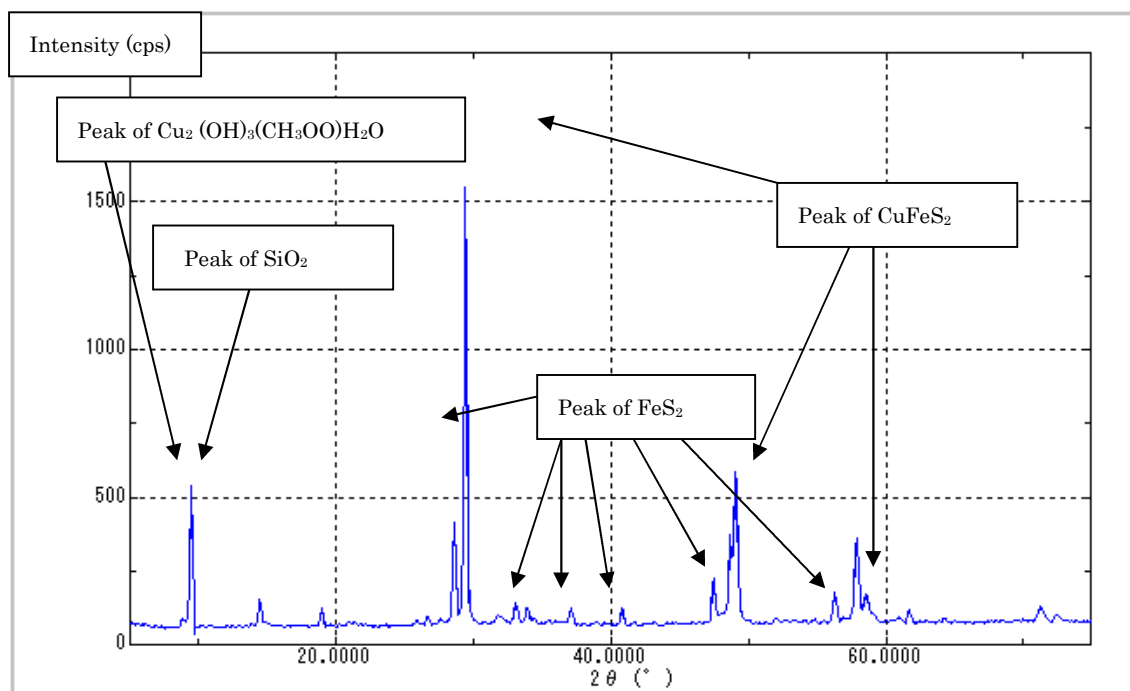
**Figure 22** X-ray diffraction peak after heating at 100°C

- (1) The peak after heating at 100°C and 200°C showed almost no change.
- (2) After heating at 300°C, the peak of  $\text{CuFeS}_2$  decreased, and the peak of  $\text{Fe}_2\text{O}_3$  and  $\text{CuSO}_4$  was ascertained.
- (3) From the results of (1) and (2), it is considered that the compound morphology of  $\text{CuFeS}_2$  was changed by heating.

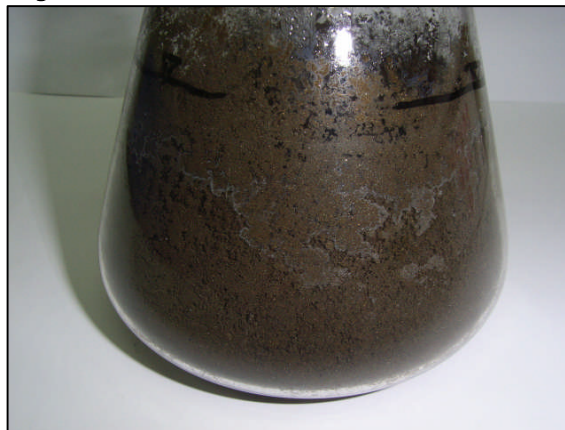
Figure 29

In the test for oxygen consumption at  $80^\circ\text{C}$ , whiteness separated (Figure 29).

It is considered that the elements were separated out by moisture evaporation after the water soluble components in Sample A dissipated.

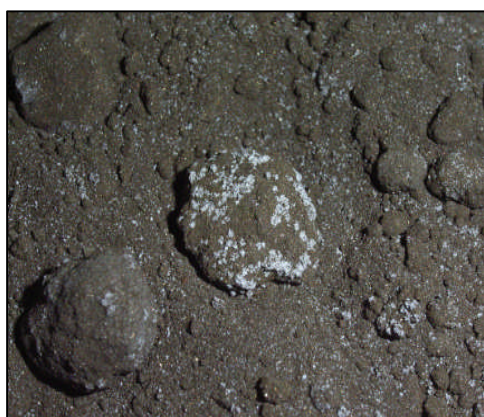
Figure 30

Whiteness was found when Sample A was dried at  $105^\circ\text{C}$  (Figure 30).

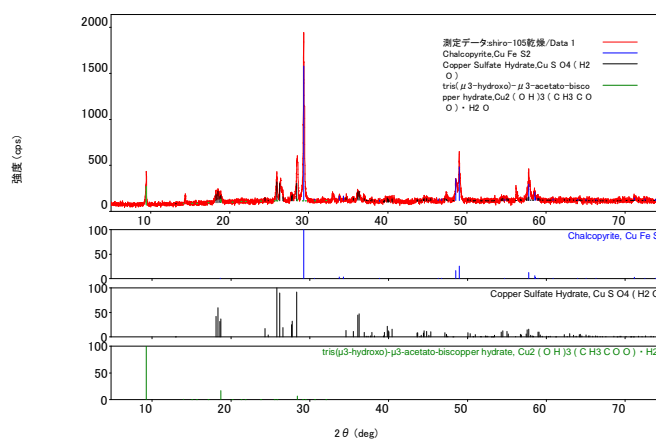
Figure 31

As the result,  $\text{CuFeS}_2$  and  $\text{CuSO}_4(\text{H}_2\text{O})$  were detected (see Figure 31).
