**MARINE ACCIDENT
INVESTIGATION REPORT**

Accident type	Fatality of stevedore
Date and time	At around 1830–1832 hours on August 18, 2010
Location	Pier P, Hattaro Area of the Port of Hachinohe, Hachinohe City, Aomori Prefecture, Japan (Approximate position: 40°33.8'N 141°29.3'E)
Summary of the accident	<p>At around 1830–1832 hours on August 18, 2010, while cargo was being discharged from the No. 4 cargo hold on the cargo ship STAR KVARVEN moored at a pier in the Port of Hachinohe, a signal person, who was traveling from the hatch covers laid on the No. 3 cargo hold to the hatch covers on the No. 5 cargo hold, fell from either a hatch cover on the No. 3 cargo hold or the maintenance ladder at the foot of the gantry crane.</p> <p>The signal person was taken to a hospital, but was later pronounced dead.</p>
Process and progress of the investigation	<p>(1) Setup of the investigation The Japan Transport Safety Board appointed an investigator-in-charge, a marine accident investigator and a regional investigator (from the Sendai Regional Office) to investigate this accident on August 20, 2010.</p> <p>(2) Collection of evidence August 20, 2010: Interviews August 20 and 23, 2010: Collection

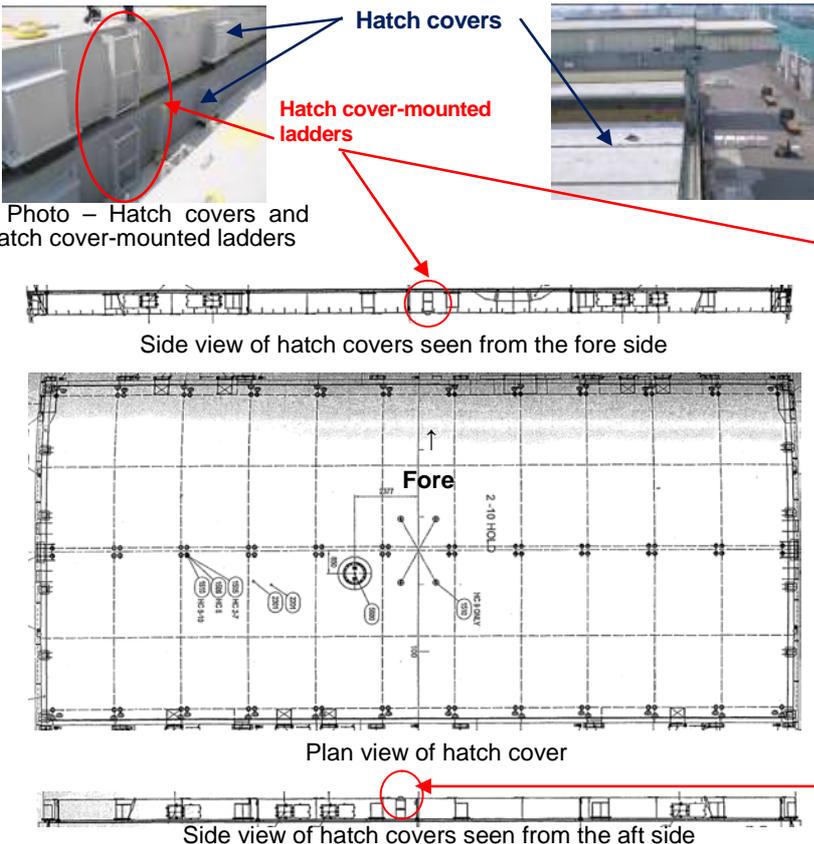
- 1) The hatch covers on the Ship were of a Pontoon type where an open cover can be laid over other closed hatch covers.
- 2) Each hatch cover was 0.835 m thick and made of steel.
- 3) The upper end of the hatch coaming (steel plates erected vertically around the hatch) was about 1.5 m above the upper deck. The hatch coaming was equipped with a vertical ladder extending to the upper deck between the adjoining cargo holds (hereafter referred to as a “hatch coaming-mounted ladder”).
(See [Specified route to the upper deck](#) on Page 9.)
- 4) A vertical ladders were provided at around the center of the front and rear sides of the hatch covers on the No. 2 to No. 11 cargo holds (hereafter referred to as a “hatch cover-mounted ladder”).

<p>Photo – Hatch covers and hatch cover-mounted ladders</p> <p>Side view of hatch covers seen from the fore side</p> <p>Plan view of hatch cover</p> <p>Side view of hatch covers seen from the aft side</p>
<p>Loading conditions at the time of arrival at the Port of Hachinohe</p>	<p>(1) Draft: Fore 9.96 m, Aft 10.27 m</p> <p>(2) The Ship arrived at the port loaded with about 34,000 tons of clay, wood pulp and others.</p>
<p>Stevedores (1) Composition and duties</p>	<p>When the accident occurred, the following stevedores from Shinmaru Kouun Co., Ltd. (hereafter referred to as “the stevedores” and “Company A” respectively) were discharging cargo from the No. 4 and No. 7 cargo holds. The composition and duties of the stevedores were as follows. The stevedores, excluding the foreman, were grouped into four units, A to D.</p> <ol style="list-style-type: none"> 1) Foreman <p>The foreman, while monitoring the entire cargo handling operation, issued orders, including from which cargo hold the cargo was to be discharged, and when the hydraulic excavator was to enter a cargo hold.</p> 2) Signal person <ol style="list-style-type: none"> a. The signal person acted as a unit chief. b. The signal person relayed the foreman’s orders to the crane operator and the onboard worker. c. The signal person kept the worker in the cargo hold informed of any emerging danger such as crane movement. d. The signal person logged the volume of cargo that had been discharged. 3) Onboard worker <p>The onboard worker worked in the cargo hold, removing foreign matter,</p>

Actions taken	<p>(1) After the accident, Company A implemented following measures:</p> <ol style="list-style-type: none"> 1) Only the signal person shall issue orders to the crane operator. 2) Traveling to/from hatch covers shall be made via the hatch coaming-mounted ladders (steps). The use of the maintenance ladders installed on the gantry cranes shall be banned. 3) Travel between work sites and other operations shall be carried out by at least two persons wherever practically possible to ensure cross monitoring of each other's working conditions. <p>(2) The management company for the Ship implemented following measures:</p> <ol style="list-style-type: none"> 1) Soon after learning of the accident, the company instructed all its managing ships to paint one metre wide around all hatch covers with anti slip paint same as the ship and her sister ships that already painted when delivered to owner. 2) In order to facilitate the lifting from the upper deck to the hatch covers, the ladders were moved or redesigned.
