MA2012-8

**MARINE ACCIDENT  
INVESTIGATION REPORT**

Vessel type and Name: Pure car carrier VEGA LEADER  
IMO number: 9213818  
Gross tonnage: 51,496 tons

Accident type: Injuries on longshoremen  
Date and time: About 0950 hrs, December 1, 2010  
Location: Nissan Motor Honmoku Wharf, Yokohama Section 5, Keihin Port  
305° true, about 200 m from Nissan Honmoku Wharf Lighthouse at  
Yokohama City, Kanagawa Prefecture  
(Approximately 35°25.4'N, 139°40.7'E)

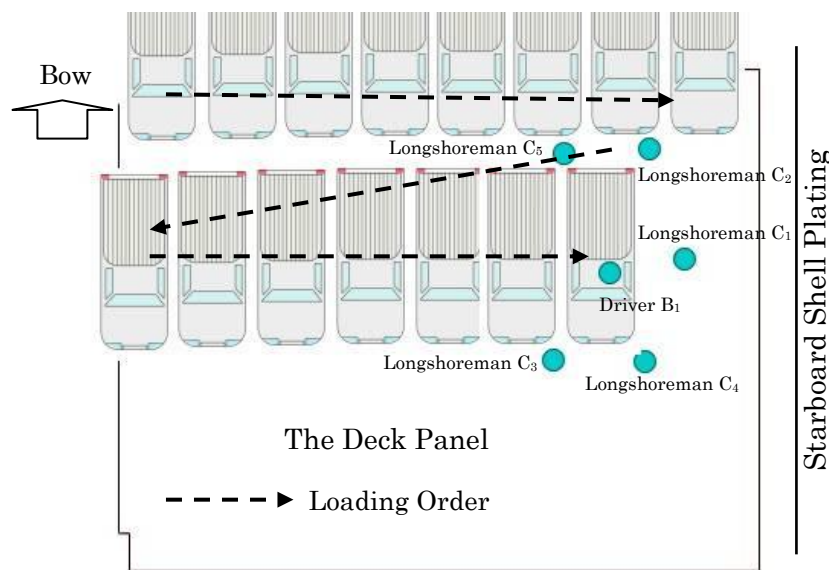
Figure 2.1.2-1: Work Situation on the Deck Panel

On the Deck Panel, as shown in the figure below (Figure 2.1.2-1: Work Situation on the Deck Panel), eight cars were loaded on the first row, facing the stern. Their front tires were on the Deck Panel, and their rear tires were on the deck panel next to the Deck Panel toward the bow side. Their fronts were tied to the Deck Panel with lashing belts. The loading of cars to be placed on the second row began; the cars were placed one by one on the second row from the ship center-line side to the starboard side, and when the 7th car on the second row was parked in its position, the accident occurred.

Longshoreman C<sub>5</sub> was just starting to lash the right rear of the 7th car behind the car parked on its right side; at that time, the Deck Panel fell.

Driver B<sub>1</sub>, after driving the 7th car on the second row, parking the car so that it faced the stern on the cue from Longshoreman C<sub>1</sub>, putting the shift lever to the low position, pulling the lever on the parking brake and closing the window, stopped the engine; when he tried to get out of the car, at around 0950 hrs, he noticed that the car tilted towards rear left, and the Deck Panel sunk lower three times.

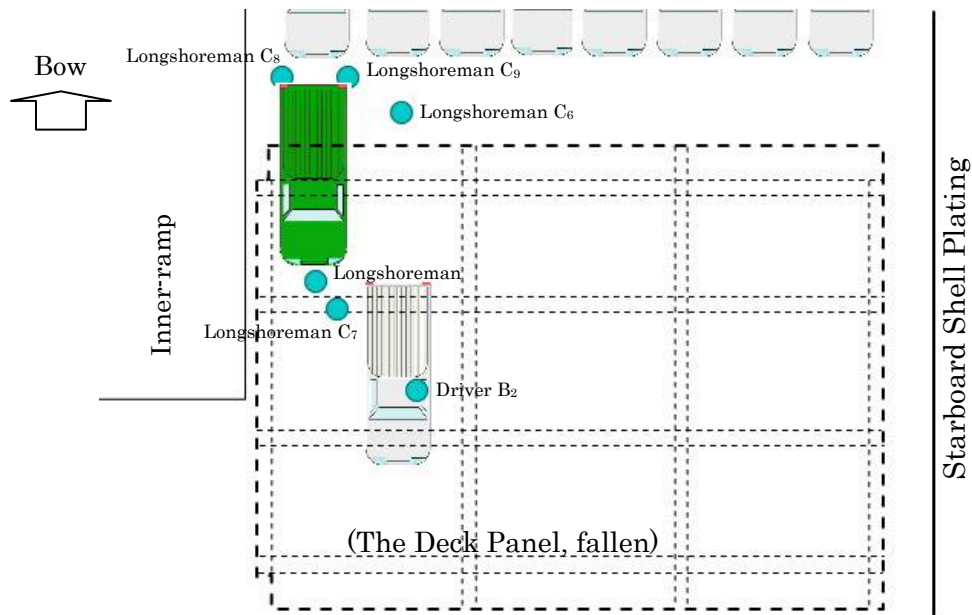
Figure: 2.1.2-2: Work Situation on car deck No. 6 immediately below the Deck Panel

On car deck No. 6, cars were loaded one by one from the bow end and lashed. Near the place immediately below the Deck Panel, as shown in the figure below (Figure 2.1.2-2.: Work Situation on Car Deck No. 6 immediately below the Deck Panel), the driver had gotten out of the first car, which was placed at the bow end and ship center side and was in the middle of lashing; while the second car was waiting at the stern end of the first car to park next to the car, the accident occurred.

Longshoreman C<sub>9</sub>, working on lashing at the rear left of a car with his body under the car, heard a roaring sound, and was pushed hard, far toward bow; he, without knowing what had happened, fearing for his physical safety, took shelter under the ship-center inner-ramp.

Driver B<sub>2</sub>, after taking-off his helmet and putting it on the front passenger seat, driving a car inside through the stern-ramp, making a u-turn at the stern end toward the accident occurrence site, and reversing and stopping the car under the Deck Panel, waited for a cue from Longshoreman C<sub>6</sub> to park next to the car being lashed; suddenly, he had the tilting Deck Panel in sight, feared for his safety, and touched the shift lever. At that moment, the window shield on the front passenger-seat side was broken, and he was able to exit the car through the broken window with no assistance.

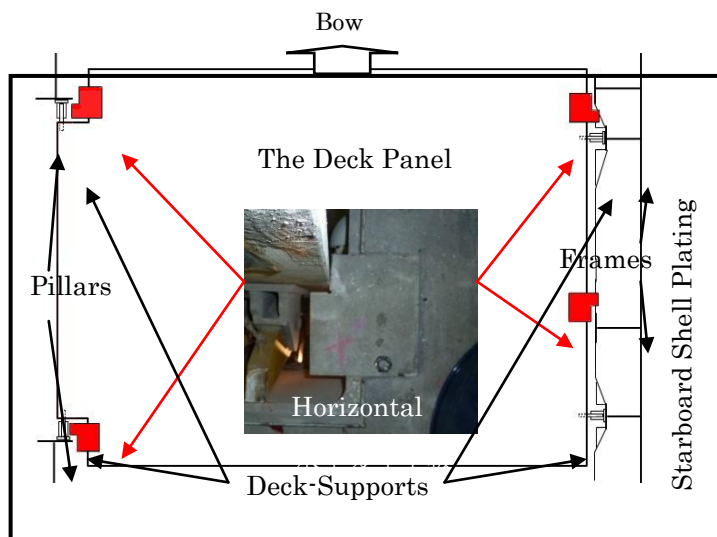
Figure 2.5.4-3: Horizontal Guide-Plates and Deck Supports

A deck panel was equipped with horizontal-guide plates<sup>10</sup> (refer to Figure 2.5.4-3: Horizontal Guide-Plates and Deck Supports) at four positions on the deck panel in such a way that the horizontal guide-plates are installed in a position aligned with the frames and the pillars installed on the ship-center line. A cut made on the plate and the pillar or frame prevents a deck panel from sliding horizontally.

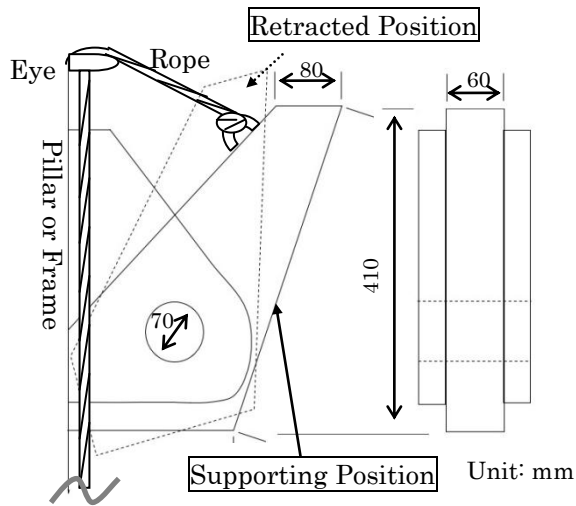
Figure 2.5.4-4: Deck Support

When a pull-up rope is released, because the center of gravity of a deck support is higher than the steel shaft and away from the shaft toward the deck panel, the gravity pulls the deck support down to tilt the deck support, so that it supports a deck panel. The size of a deck support is 60 mm wide and 80 mm deep, measured on its surface contacting a deck panel.

Note that, on Deck Support 1, there was no rope tied; moreover some of other deck supports at the normal position of other deck panels had lost pull-up ropes.

According to Chief Officer A, oiling on a deck support had not been executed, because damage to cars, such as contamination by oil, or accidents by tire-slipping, was feared.

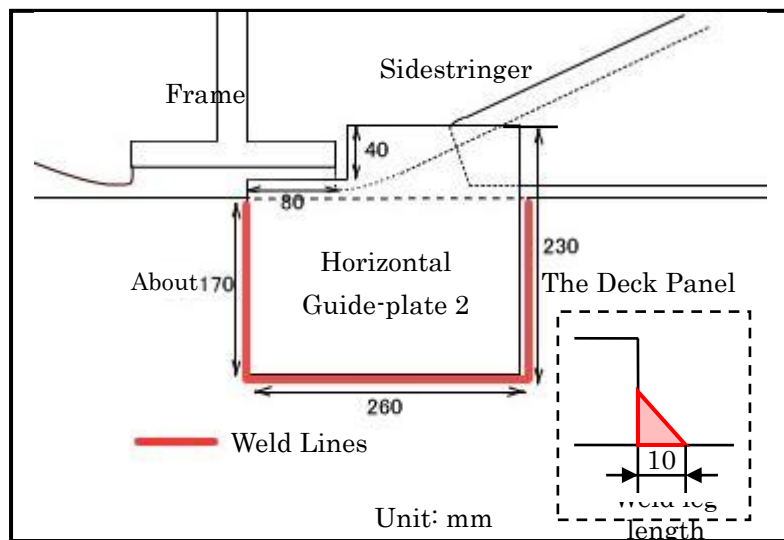
Figure 2.5.4-6: Horizontal Guide-Plate 2

Horizontal Guide-Plate 2, as shown in the figure below (Figure 2.5.4-6: Horizontal Guide-Plate 2), was structured with a steel plate 230 mm long, 260 mm wide, and 20 mm thick, with a cut 40 mm long and 80 mm wide in one of its corners. It was fillet-welded on the deck surface of the Deck Panel with a weld leg length of about 10 mm.

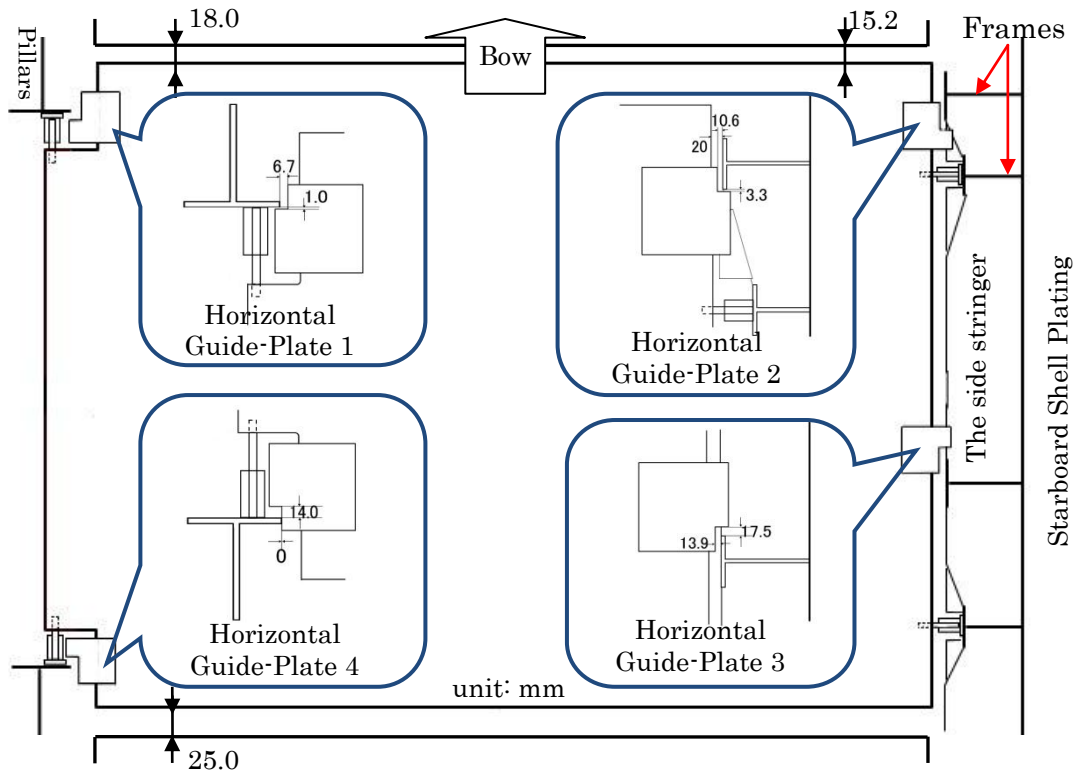
Figure 2.5.4.-8: Gaps between the Deck Panel and surrounding Structures

The following gaps were measured after setting the Deck Panel on the normal position, and recovering the horizontal guide-plates bent in the accident into their normal state without bends: the gaps between the horizontal guide-plates and pillars or frames; and the gaps between the Deck Panel and the adjacent deck panels. The gaps measured in the

normal state are shown in the figure below (Figure 2.5.4-8: Gaps between the Deck Panel and surrounding Structures)

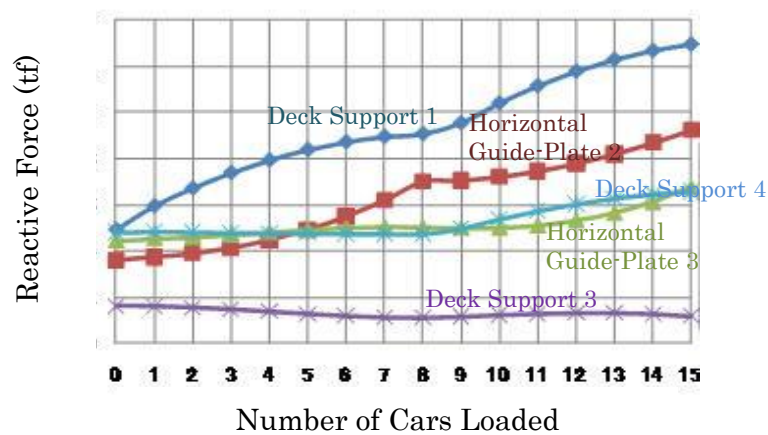
Figure 2.5.5-2: History of Reactive Force at each Supporting Point

The reactive forces at the support points (corresponding to Horizontal Guide-Plates 2 and 3, and Deck Supports 1, 3, and 4) by a load distribution set for the analysis in such a way that it should be the same as that at the time of the accident occurrence, where the cars were loaded one by one as described in 2.5.2(2), were obtained by elastic finite element analysis with the boundary condition set on the Deck Panel as shown in the figure below (Figure 2.5.5-1: Setting of Boundary Condition on the Model of the Deck Panel); the results are shown in the figure below (Figure 2.5.5-2: History of Reactive Force at Each Support Point).
