MA2013-5

**MARINE ACCIDENT
INVESTIGATION REPORT**

Vessel type and name Cargo ship OUTSAILING 9
IMO number 9546318
Gross tonnage 2,926 tons

Accident type Collision
Date and time Around 00:11, March 28, 2010
Location South of the Naruto Strait
 Around 084° true bearing, 280 m from the Narutotobishima
 Lighthouse, Naruto City, Tokushima Prefecture
 (Approximately 34°13.9' N, 134°39.1' E)

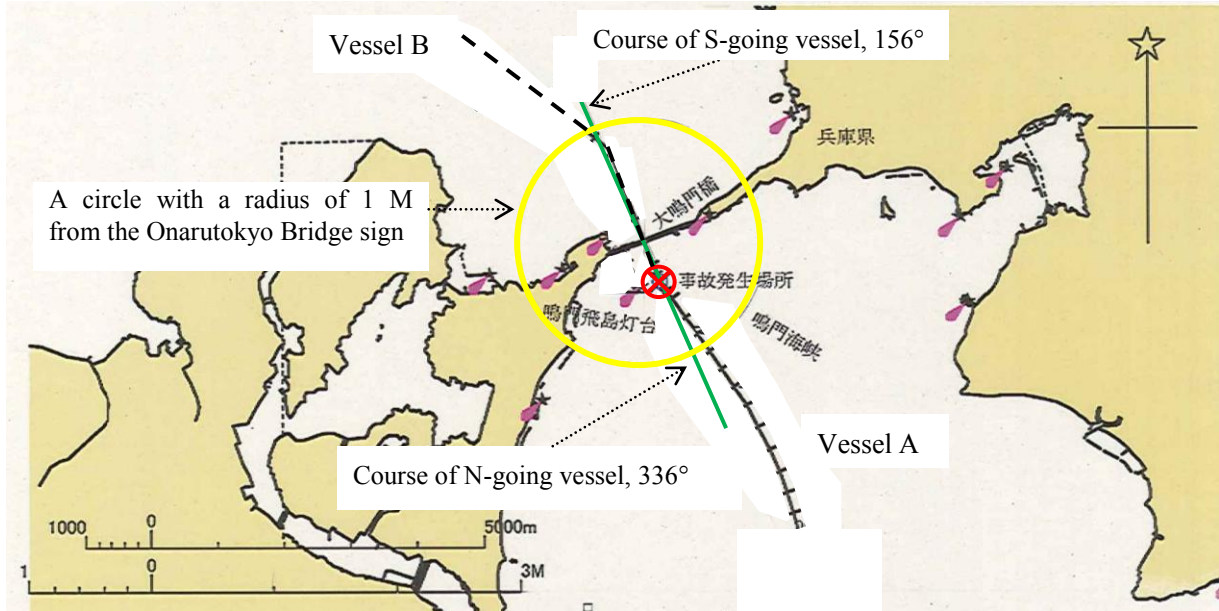
Attached Figure 4 Estimated Routes of Two Vessels and the Method of Passage specified in the Sailing Directions

(Refer to Attached Figure 4. Estimated Routes of Two Vessels and the Method of Passage specified in the Sailing Directions)
