MA2013-4

**MARINE ACCIDENT
INVESTIGATION REPORT**

Accident Type	Injury of crew members
Date and Time	At around 1700 hours (local time, UTC+9 hours) on November 15, 2011.
Location	In the northwestern waters of Tsunoshima, Shimonoseki City, Yamaguchi Prefecture, Japan. At around 312° true bearing, 10.2 nautical miles from Tsunoshima Light House (Approximately 34°28.1' N., 130°41.3' E.)
Process and Progress of the Investigation	(1) Set up of the Accident Investigation The Japan Transport Safety Board appointed an investigator-in-charge from Moji Office and one other investigator to investigate this accident on November 16, 2011. (2) Comments from parties relevant to the cause of accident Comments on the draft report were invited from parties relevant to the cause of the accident. (3) Comments from the flag State Comments on the draft report were invited from the flag State of a cargo ship, CABRERA.
Factual Information Vessel type and name, Gross Tonnage, Vessel number, Owner, etc. L × B × D, Hull material, Engine, Output, Date of launch, etc.	A Cargo ship CABRERA (registered in Republic of Malta), 24,210 tons, 9537977 (IMO No.), CABRERA SHIPPING A/S (hereinafter referred to as "Comp

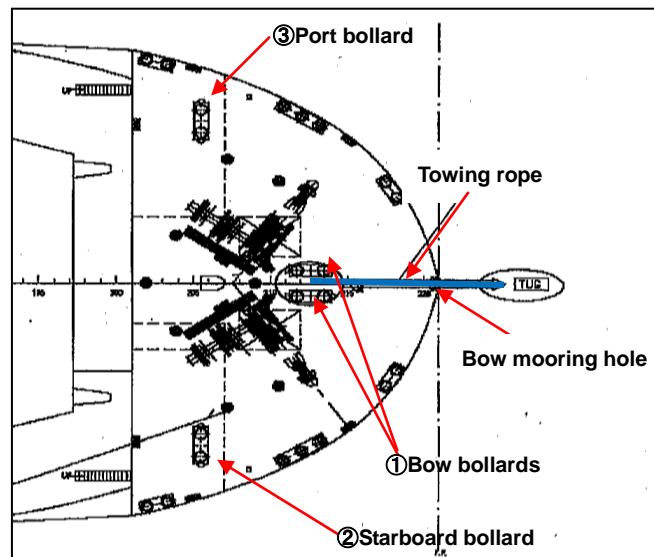
“Excerpt from Emergency Towing Equipment Manual”

Vessel A had a practice to use the bow bollard when being towed.

Following the Emergency Towing Equipment Manual of Vessel A, the officer A intended to take the towing rope of Vessel B from the “bow mooring hole (hereinafter referred to as “bow hole”)” and to moor it at the bow bollard, so he decided to lower a rope to pick up the towing rope (hereinafter referred to as “pickup rope”) down onto Vessel B, tie 2 heaving lines of Vessel B with the pickup rope, and then tie the heaving lines with 2 pendant wires to bring them to the forecastle deck of Vessel A, so as to moor the pendant wire at the bow bollard.

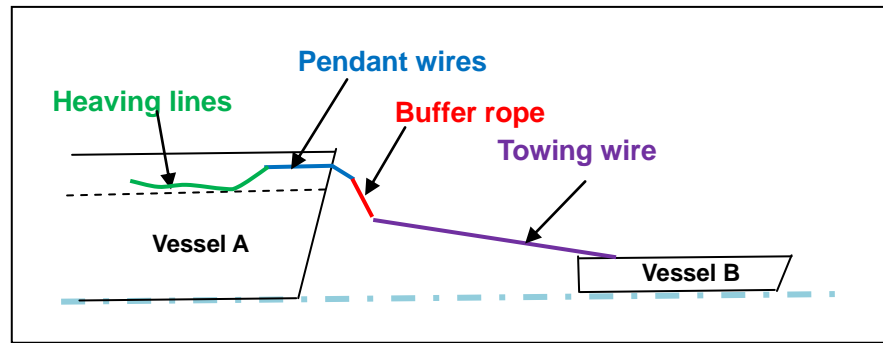
“Schematic of Towing Rope”

Vessel A → pickup rope → heaving lines → pendant wires → buffer rope → towing rope → Vessel B

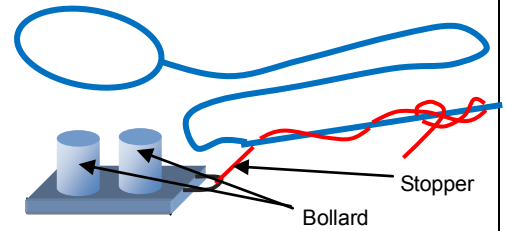
“Stopper”

The ordinary seaman A_1 was standing right side of the starboard bollard with a backup stopper to replace the cut-off stopper, and the ordinary seaman A_2 was standing about 1 m away from the bow, while they were taking the stopper to the starboard bollard in order to moor the pendant wire temporarily at the said starboard, when, at about 17 00 hours, the heaving line was broken, and the pendant wire hit the lower leg of the ordinary seaman A_1 and A_2 , knocking both of them down screaming.
