MA2013-1

**MARINE ACCIDENT
INVESTIGATION REPORT**

Vessel type and Name: Cargo ship AQUAMARINE

Vessel type and Name: Fishing vessel HIRASHIN MARU

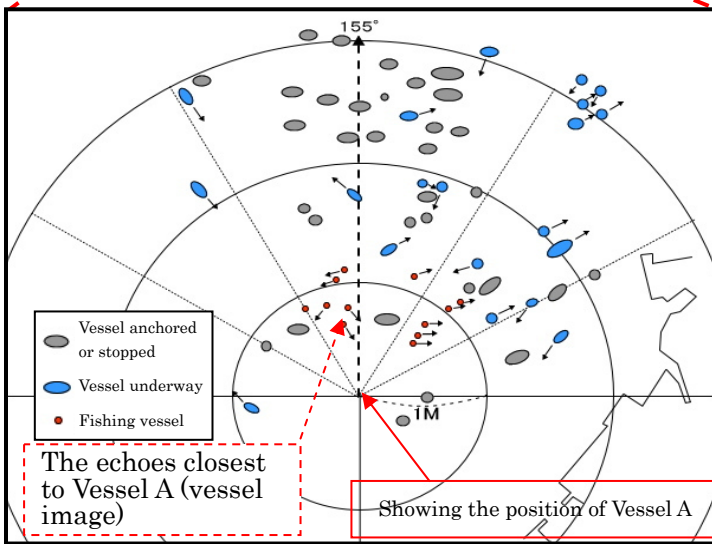
According to the radar echo images from among the VDR records, the situation in the water area where the accident occurred is showed in “Situation in the Area within 3 M of Vessel A at around 06:11” as shown below.

“Situation in the Area within 3 M of Vessel A at around 06:11”

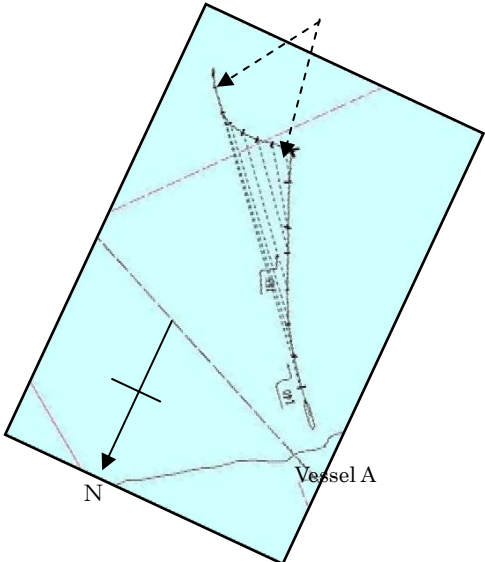
Also, from among the vessel images (echos) recorded during around 06:06 to 06:14, July 6, relative positions of the image of the vessel (the echo) which came closest to Vessel A to the position of Vessel A are indicated in “Correlation Diagram of the Echo and Vessel A” as shown below. (For more details, see Figure 1: Plots of Estimated Ship Positions)

“Correlation Diagram of the Echoes and Vessel A”

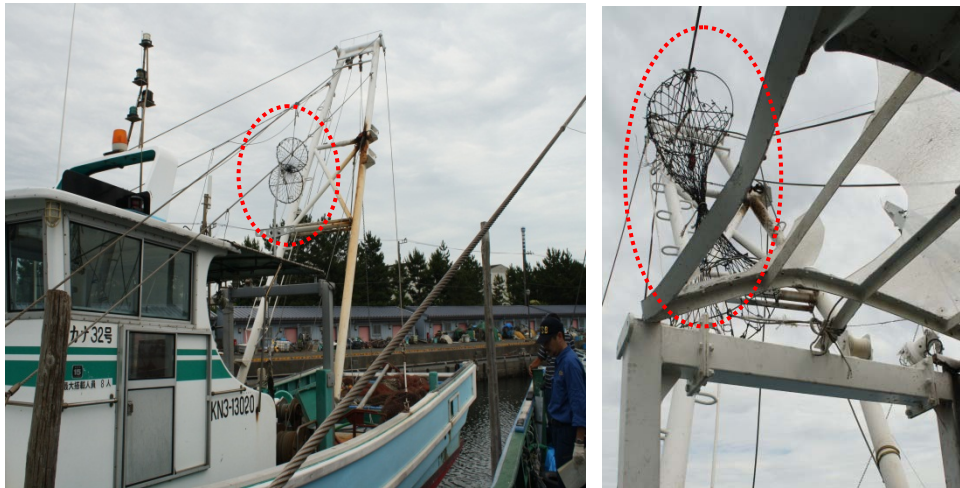
Around the mast for drawing a fishing net on Vessel B which was landed after the occurrence of the accident, “a shape consisting of two cones with their apexes together in a vertical line one above the other” (hereinafter referred to as “the Shape”) was exhibited, for the purpose of letting other vessels know that Vessel B was “engaged in fishing.”

“The Shape”

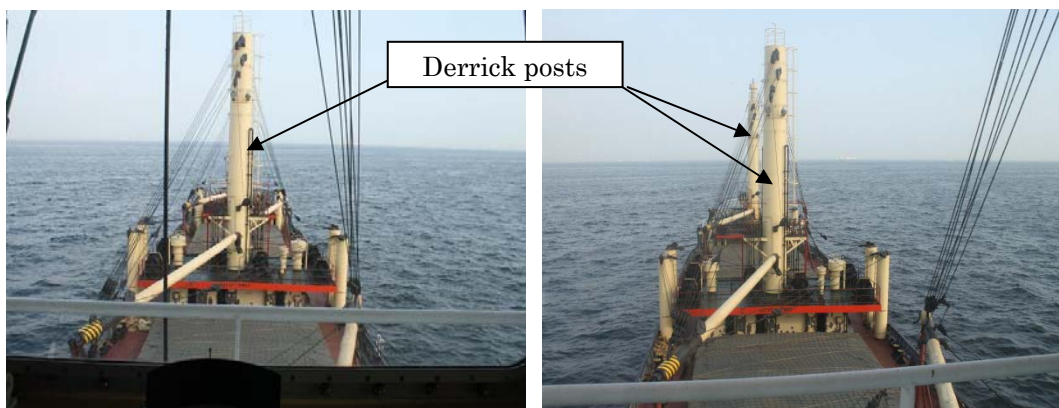
There was no structure to generate a dead angle except the derrick posts.

“Visibility in the Bow Direction of Vessel A”

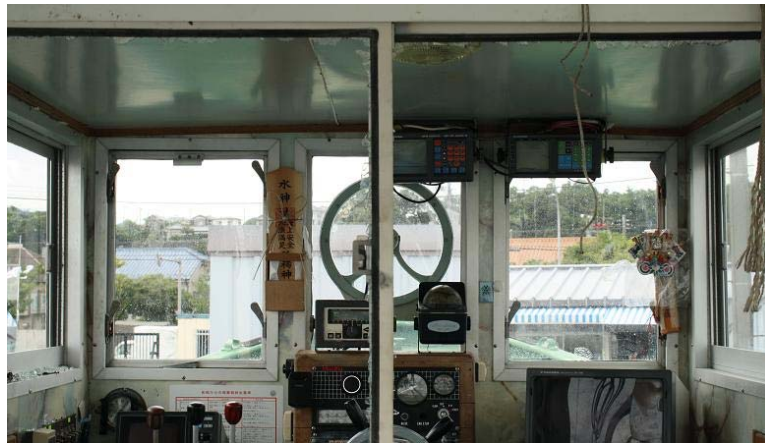
As there were three windows installed on the front, and two windows on either side of the wheel house, and navigational equipment were placed under the windows on the front of the wheel house, there was no structure to generate a dead angle.

“Visibility in the Bow Direction of Vessel B”

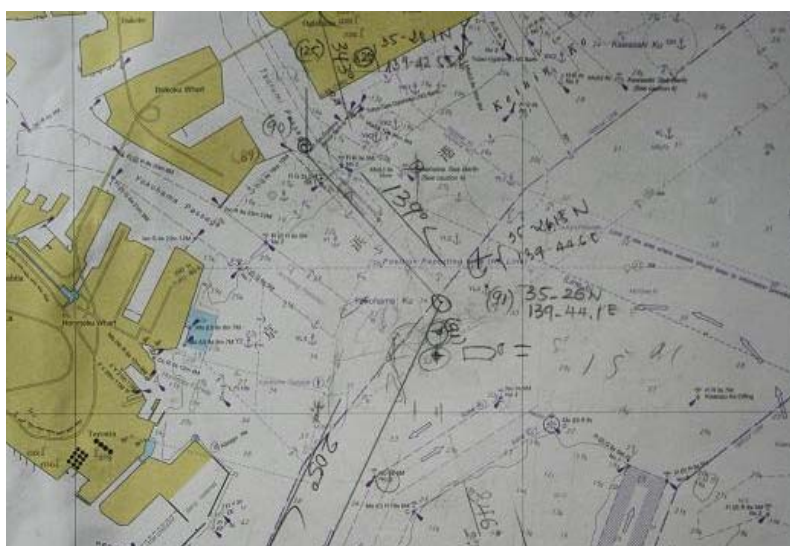
On the chart used by Vessel A, a course was indicated which was proceeding southeast at a course of 139° along the Tsurumi Passage, and sailing toward the Uraga Channel Passage after altering to 205° at a point 113°, 4,050 meters from the Yokohama Daikoku Wharf Breakwater West Lighthouse.

“Chart Used by Vessel A”

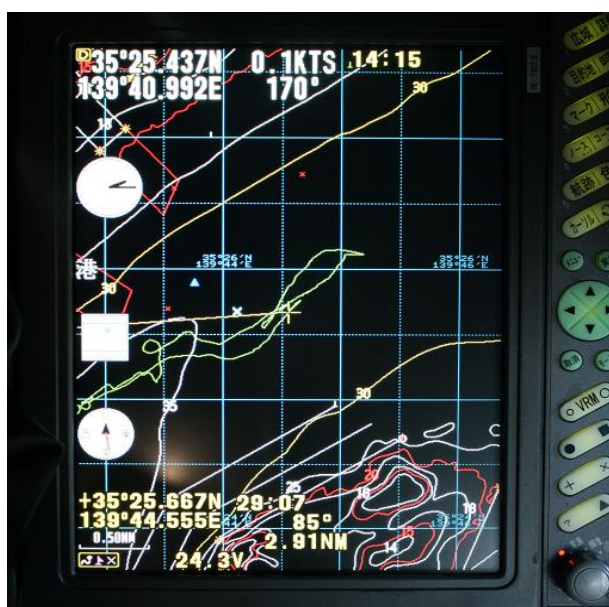
According to the statement of the skipper of Consort Vessel C and the record of tracks of Consort Vessel C stored in the GPS plotter, Vessel B moved at a distance about 50 meters behind Consort Vessel C from the starboard side to the port side at around the point displayed by the cursor (See the pictures below, in which the point is displayed by “+”), and sailed away from Consort Vessel C while making a left turn. After that, Consort Vessel C stopped and started lifting the net, leaving behind tracks of having went astern for the distance as long as Trawl Warp.

“Tracks of Consort Vessel C”

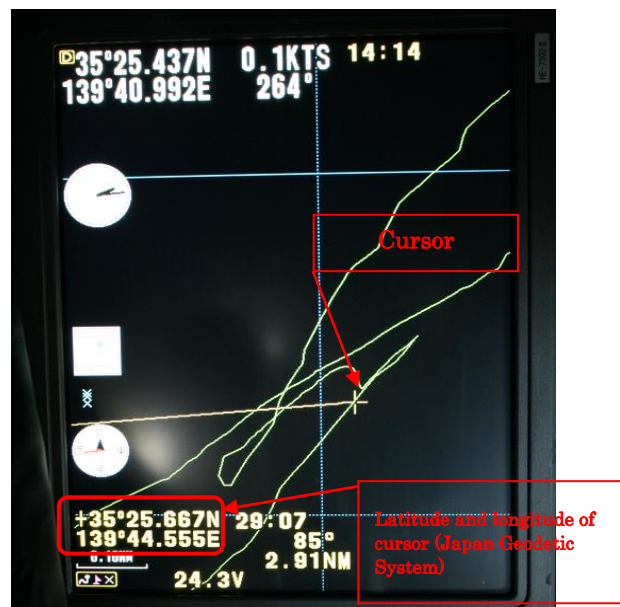
The position at around the point displayed by the cursor on the monitor screen of the GPS plotter (35° 25.667' N, 139° 44.555' E) was expressed by the Japan Geodetic System (Tokyo datum), and was 35° 25' 51.8" N, 139° 44' 21.7" N when converted to the World Geodetic System.

“Enlarged Picture of Tracks”

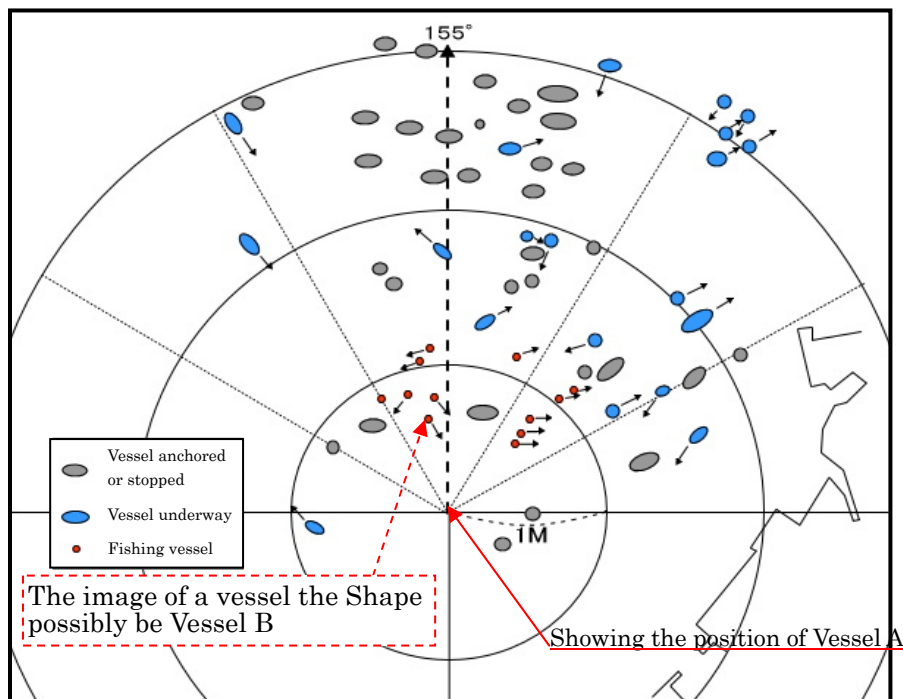
Accordingly, it is probable that the vessel indicated by the echo was Vessel B.

“Situation in the Area within 3 M of Vessel A at around 06:11 (excerpt)”
