**MARINE ACCIDENT
INVESTIGATION REPORT**

Vessel type and name: Container ship KOTA DUTA

Vessel type and name: Cargo ship TANYA KARPINSKAYA

Accident type: Collision

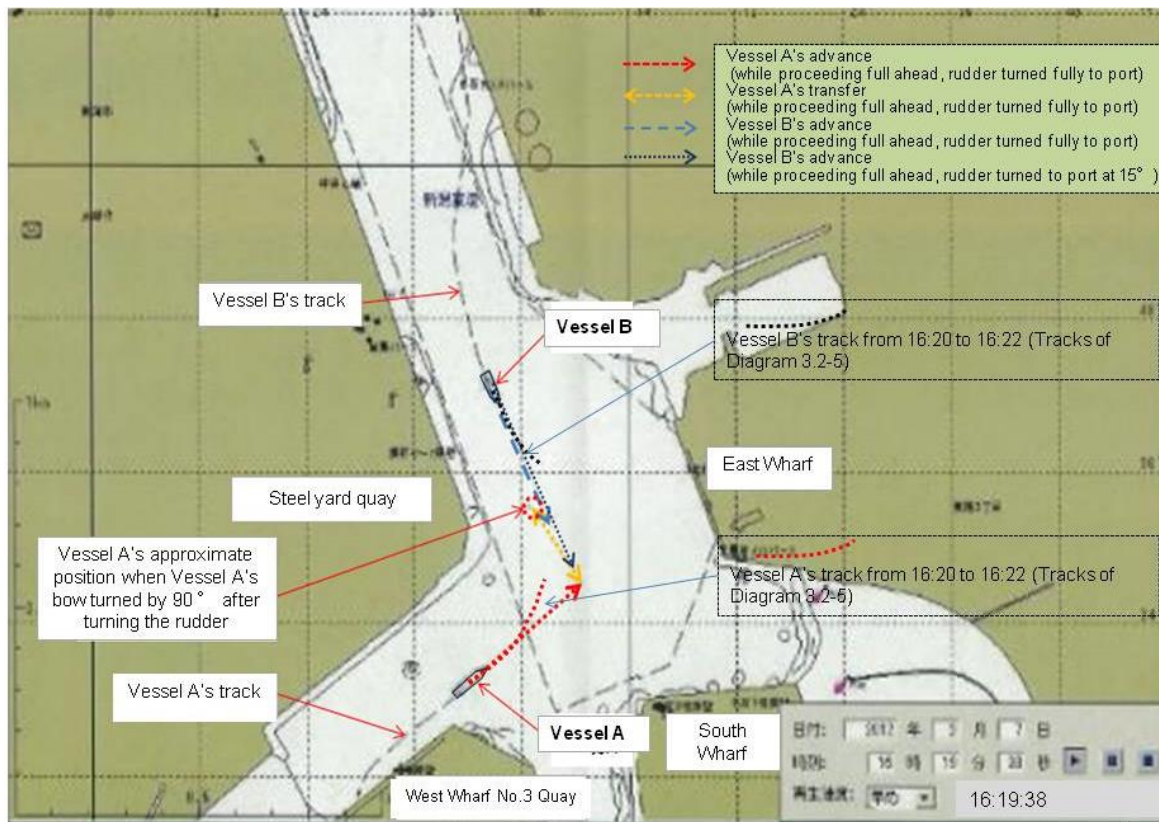
Figure 3.2-2 Situation in which Master B offered the conduct of vessel via VHF

Since we were unable to acquire the advance and transfer for the approximate position when Vessel A turned the rudder and its bow turned by 90° at the speed of approximately 5.3kn and that speed has almost no impact on the scale of the turning circle unless it is an extremely slow vessel or a high speed vessel underway in high speed according to the Navigation Handbook (3rd revised edition) (edited by the Navigation Handbook Editing Committee, issued by Kaibundo in 2004), we calculated the approximate position of Vessel A when they steered the rudder and the bow turned by 90° by using the advance and transfer when the rudder was

turned in full ahead. In addition, Figure 3.2-2 was prepared by using the recreated display of this accident at 16:19:38, which is the closest to 16:19:33.

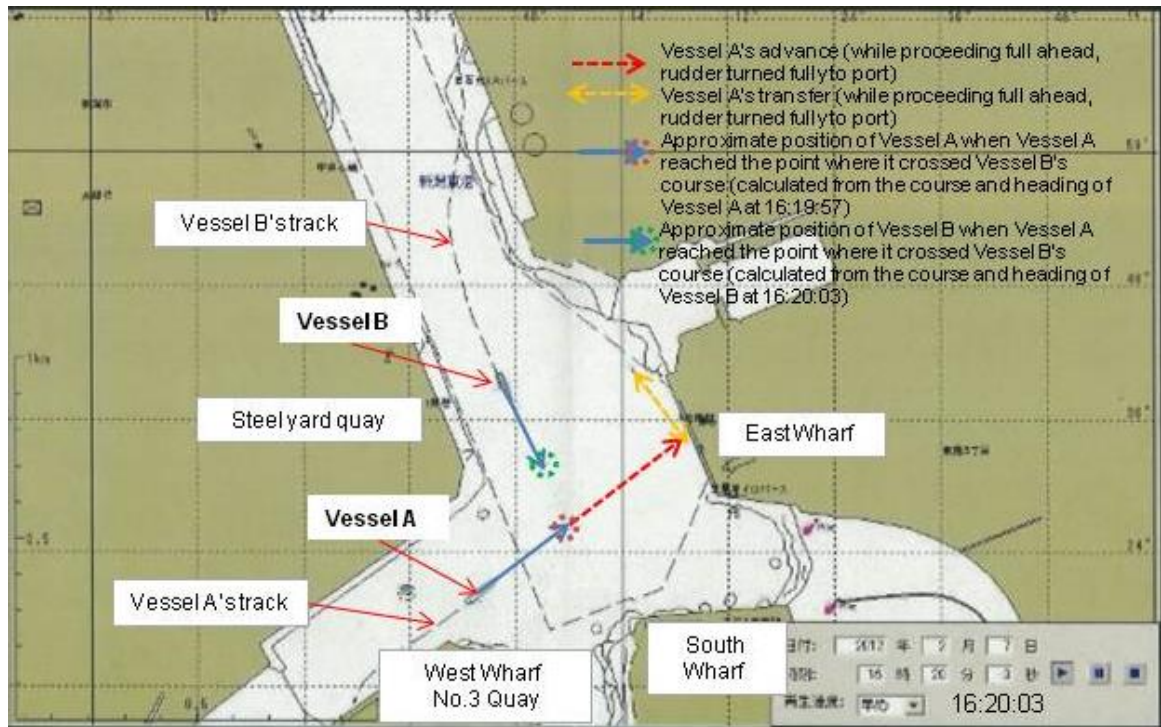
Figure 3.2-4 Approximate position of Vessel B when Vessel A reached the point where it crossed Vessel B's course

Figure 3.2-3 Situation in which Master A and Master B agreed to the conduct of vessel
(iv) It is somewhat likely that Vessel A would have approached the East Wharf after passing Vessel B on the port side if Vessel A navigated in the course and heading of 16:19:57 and Vessel B navigated in the course and heading of 16:20:03 in the vessel positions of 16:20:03 as shown in Figure 3.2-4.
