MA2014-1

**MARINE ACCIDENT  
INVESTIGATION REPORT**

Vessel type and name: Container ship YONG CAI

Vessel type and name: Fishing vessel SHINYOMARU No.2

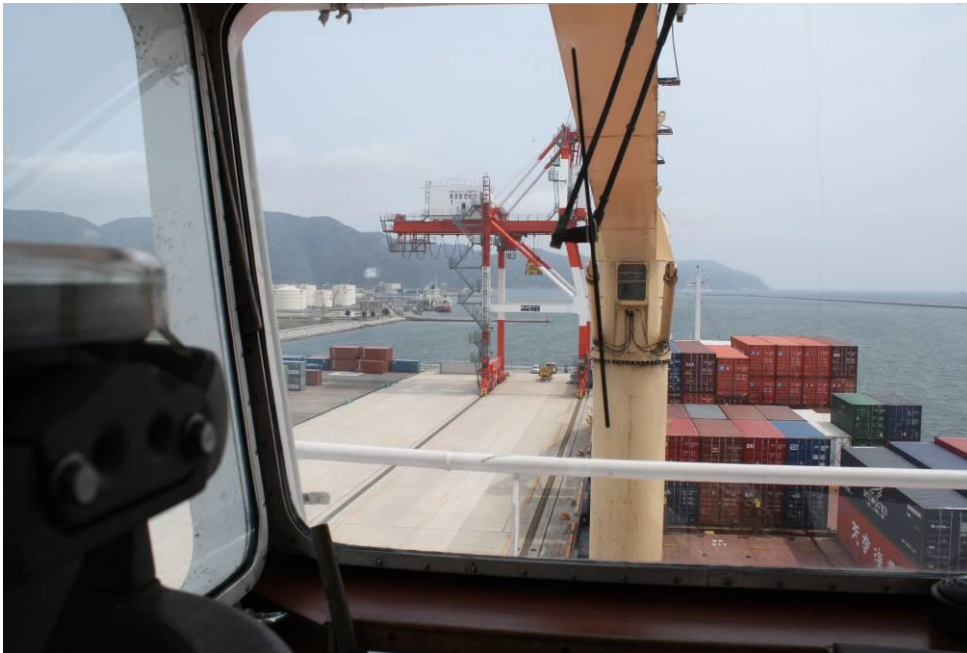
According to the document which was placed in the bridge, the length of the blind area from the bow was 225.5m in case of the light condition, and 197.2m in case of the loaded condition.

Photo 2-3 The forward view from the port side in the bridge

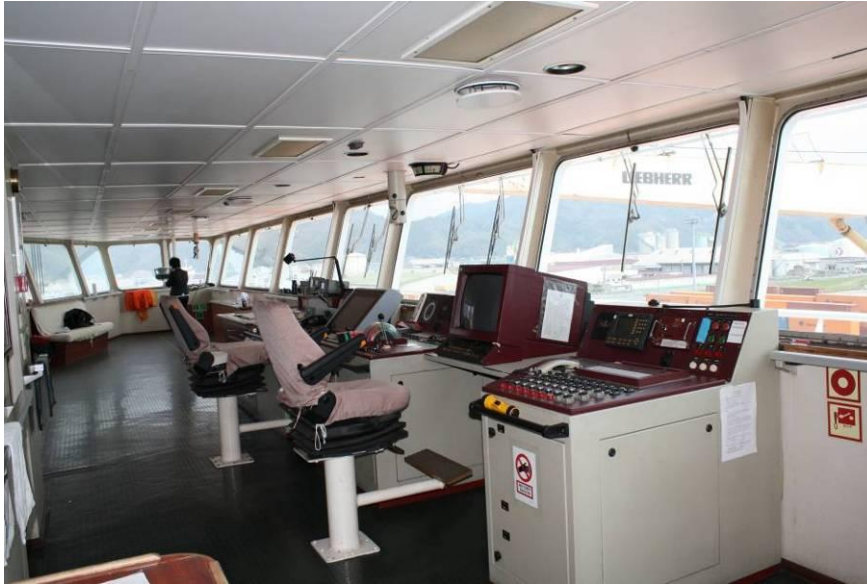
On the fore side in the bridge, there were installed power switch board of such as the navigation light, radar, steering stand, radar and chart table from the starboard side to the port side. In addition, there were installed clock, NAVTEX receiver, GPS plotter, and AIS equipment on the chart table. On the aft side in the bridge, there were installed PC, printer, and FAX at the port side and radio equipment was installed at the starboard side.

There were a gyro repeater and bow thruster remote control stand installed on the edges of the starboard side and port side in the bridge respectively.

Photo 2-4 The fore side of the bridge

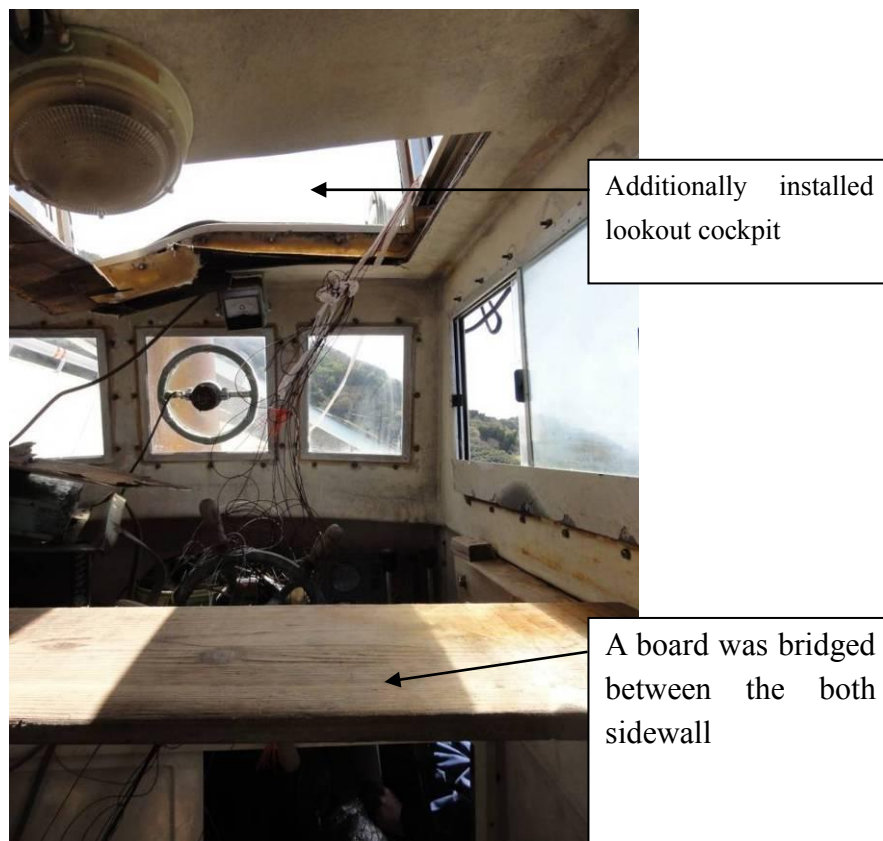
A lookout cockpit, which was surrounded by glasses in four directions, was additionally installed above the wheelhouse ceiling. A board was bridged between the both sidewall in the wheelhouse, and the surrounding views were favorable when the investigator look out a cockpit window by sitting on the board.

Photo 2-8 Wheelhouse

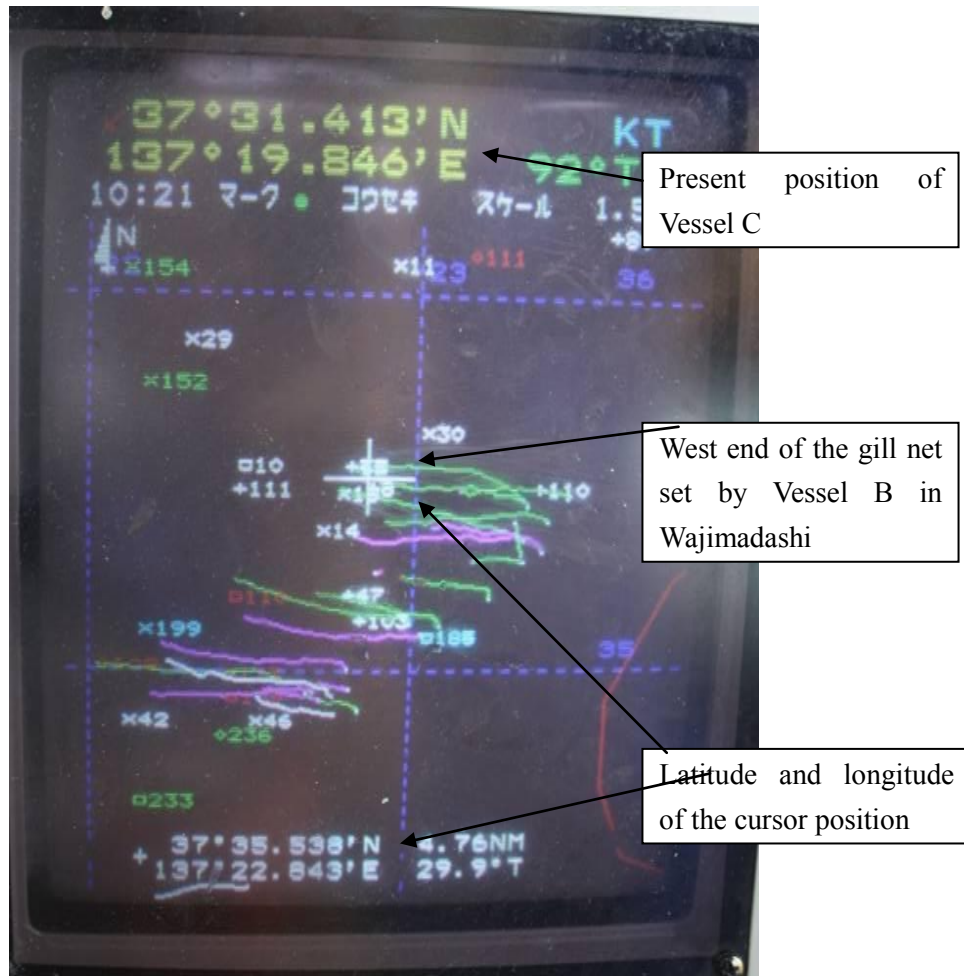
- (1) The location where gill nets are set in each fishing ground is marked on GPS plotter by each vessel, so each fishing vessel had a designated location. According to the marks for the location in which Vessel B set the gill nets in Wajimadashi shown on the GPS plotter installed on Vessel C, the west end of the gill net was slightly south of mark 30 where the cursor was set.

Photo 2-10 Vessel C's GPS plotter screen (west end of the gill net)

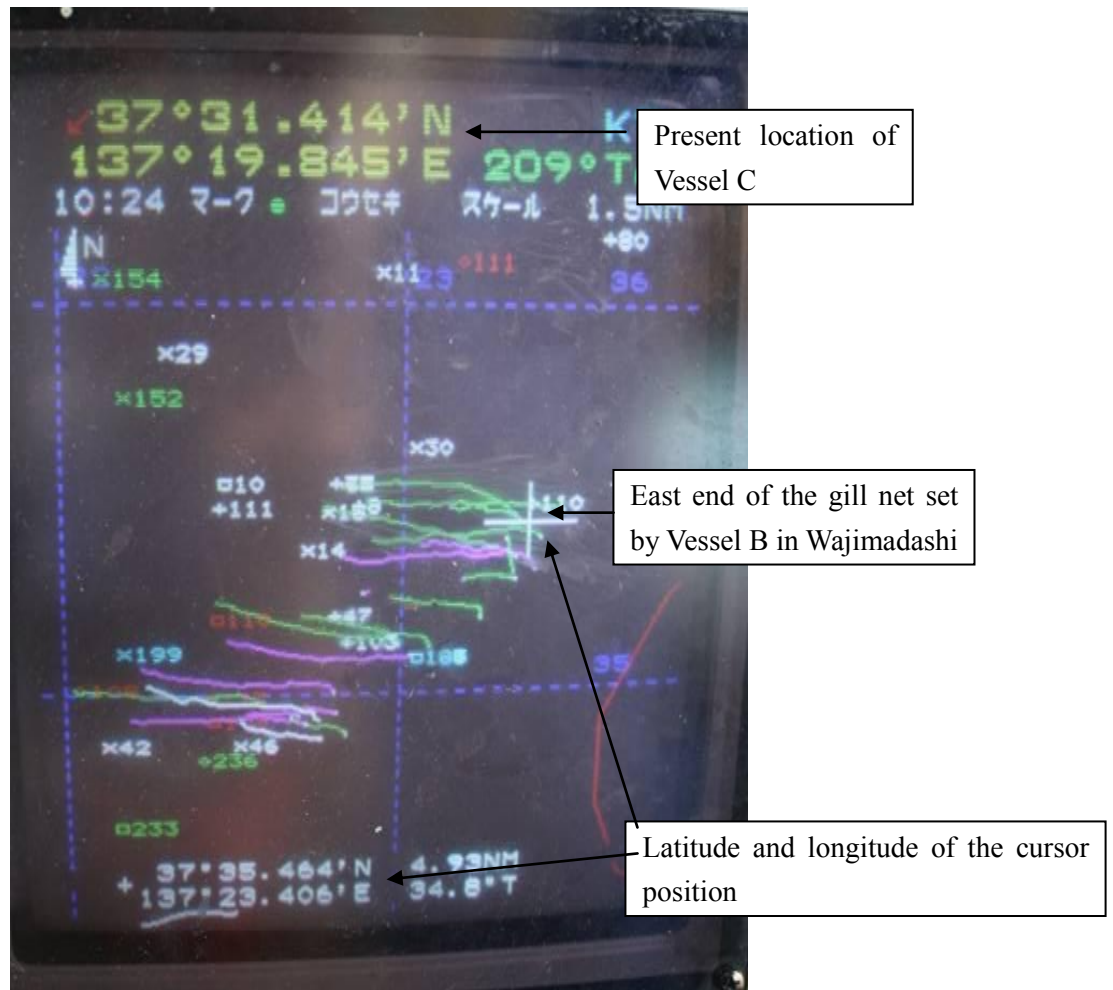
(2) The east end of Vessel B's gill net in Wajimadashi was slightly south of mark 110 where the cursor was set. When the latitude and longitude were confirmed, they were as follows.

Photo 2-11 Vessel C's GPS plotter screen (east end of the gill net)

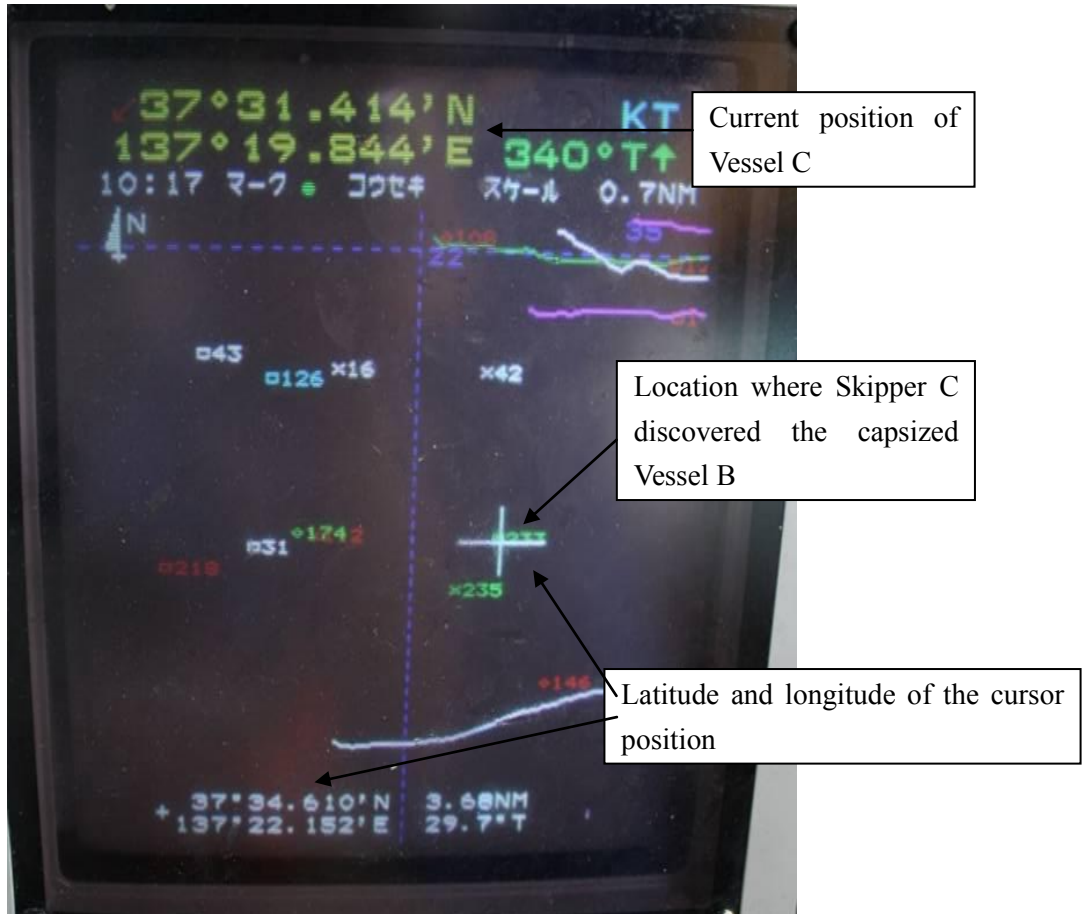
- (1) The location marked with "□233" was the location where the capsized Vessel B was discovered. The fishing tool gill net was caught on a rock on the sea bed, and Vessel B was immobile.

Photo 2-12 Vessel C's GPS plotter screen (Vessel B discovery location)

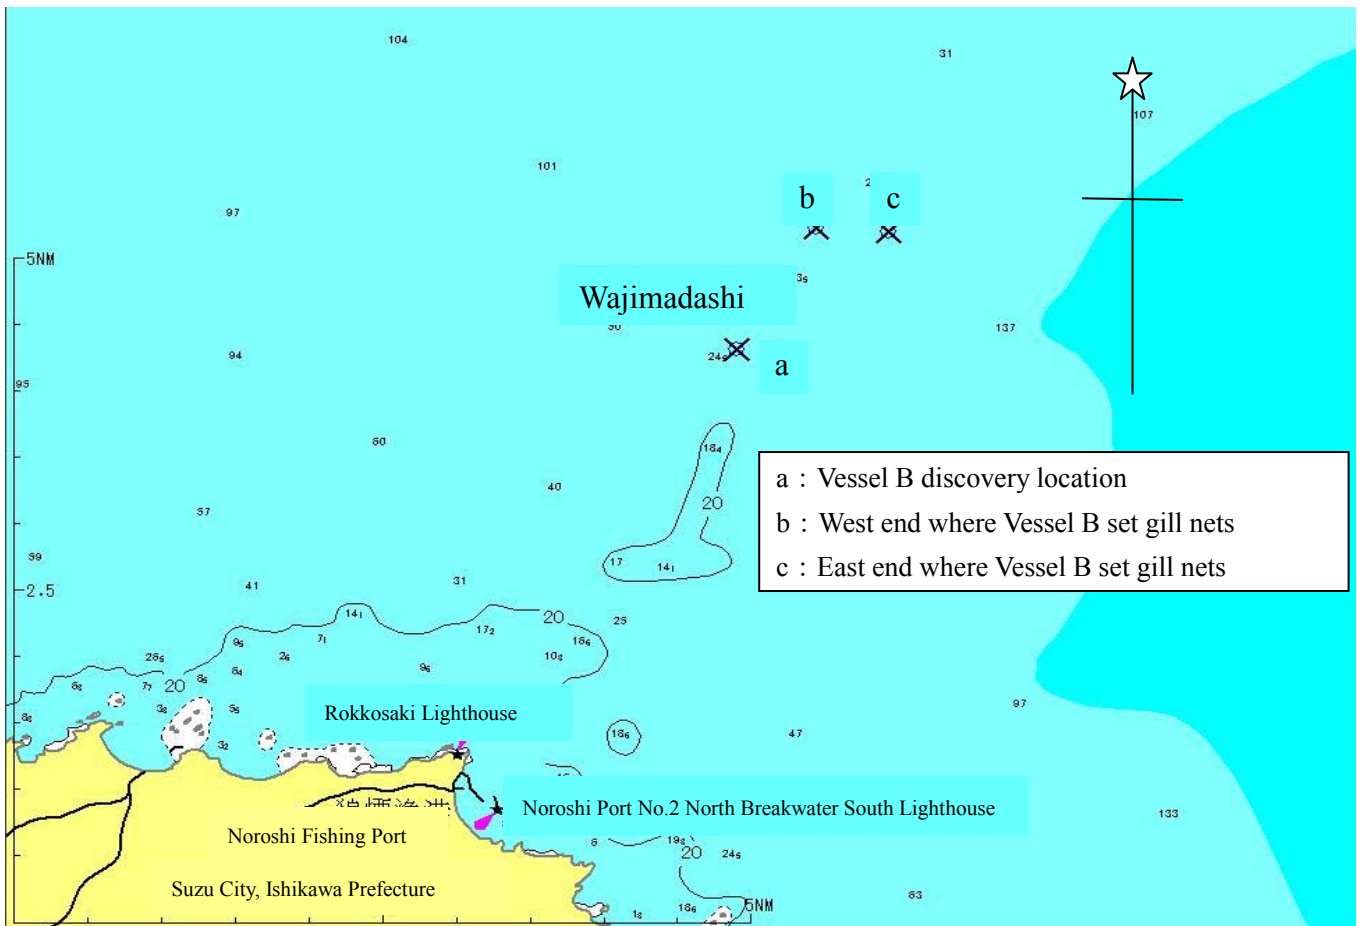
The west end and east end where Vessel B set gill nets in Wajimadashi, where the capsized Vessel B was discovered, were as shown in the Diagram 2-1.

Diagram 2-1 Vessel B discovery location, and the west end and the east end where Vessel B set gill nets
