MA2014-6

**MARINE ACCIDENT
INVESTIGATION REPORT**

Vessel type and name: Cargo ship TAIGAN

Accident type: Fire

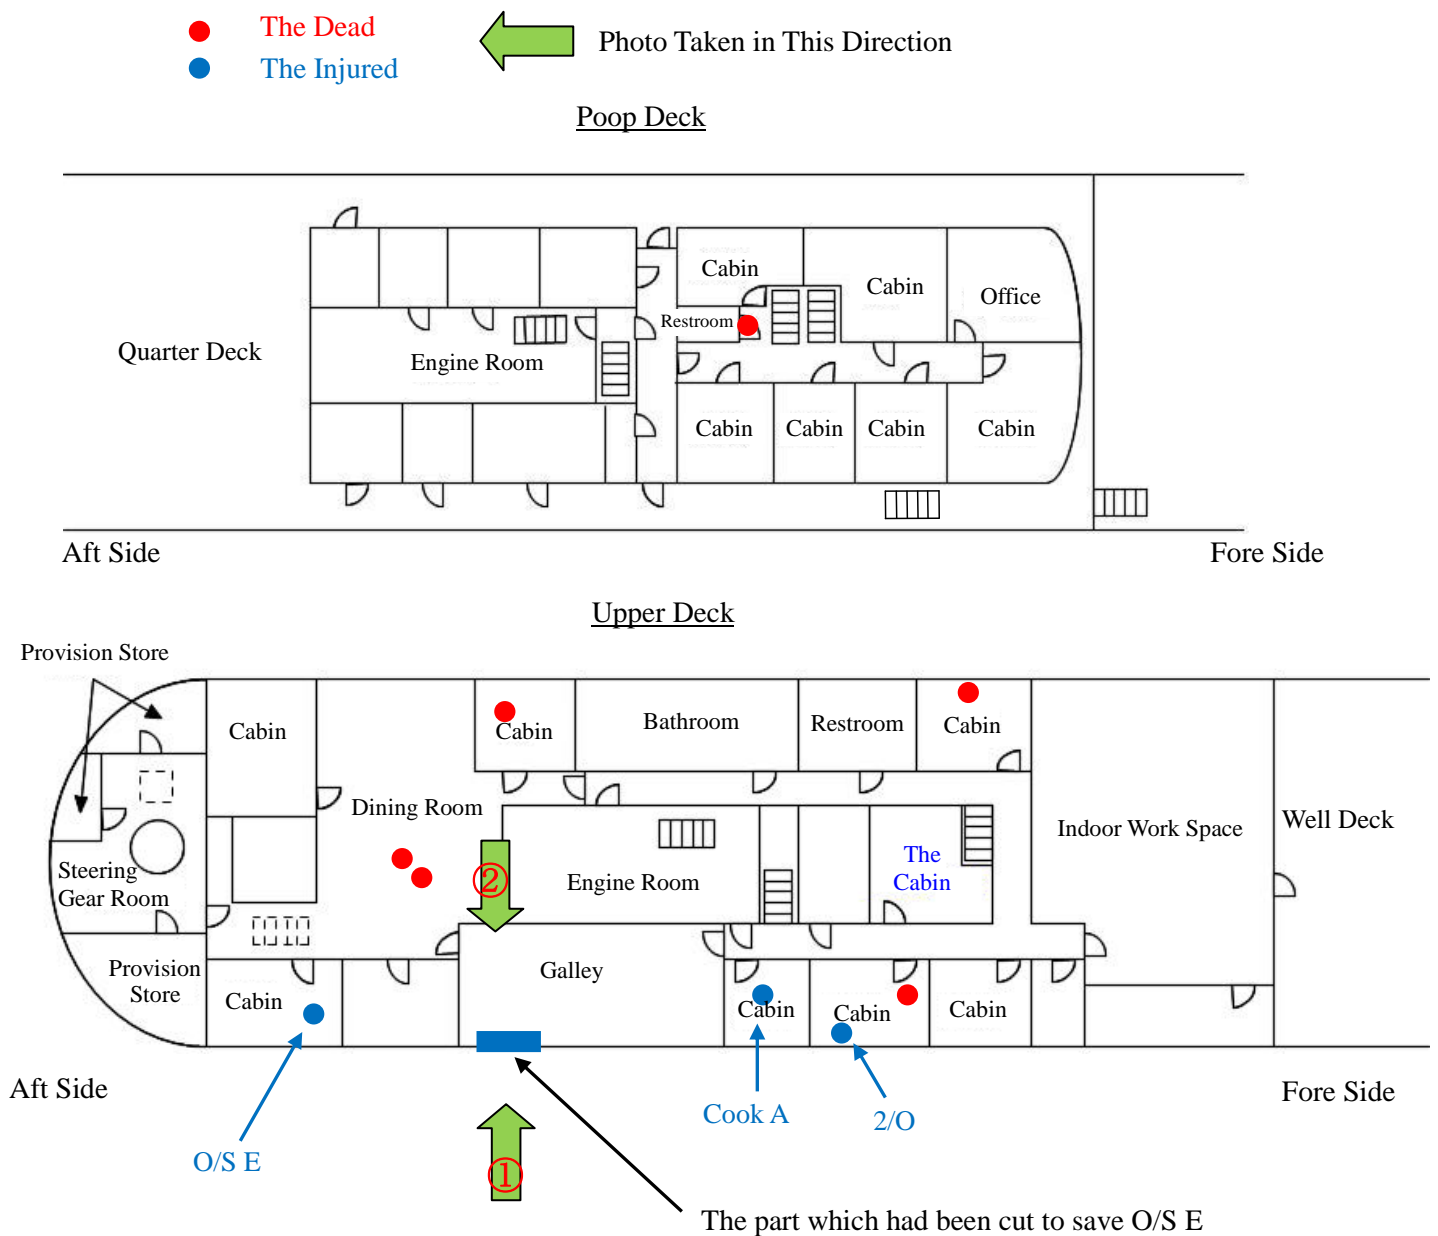
Figure 2.1-1 "Places Where Dead and Injured Crew Members Found"

At about 11:32, May 16, the fire brigade of the Local Fire Authorities entered the Vessel's accommodation spaces to start searching for the six members who were missing. The fire brigade found one in the aft side corridor in the poop deck accommodation spaces, one in a cabin on the forward port side, one in a cabin on the aft side of the bathroom on the port side, and one in a cabin on the forward starboard side of the upper deck accommodation spaces. The fire brigade also found two near the table in the mess room of the upper deck. The fire brigade confirmed the fatality of all the six. The six deceased members were later identified as the Ref/E, the Boatswain, the on-coming C/O, the 4/E, O/S H, and O/S I.

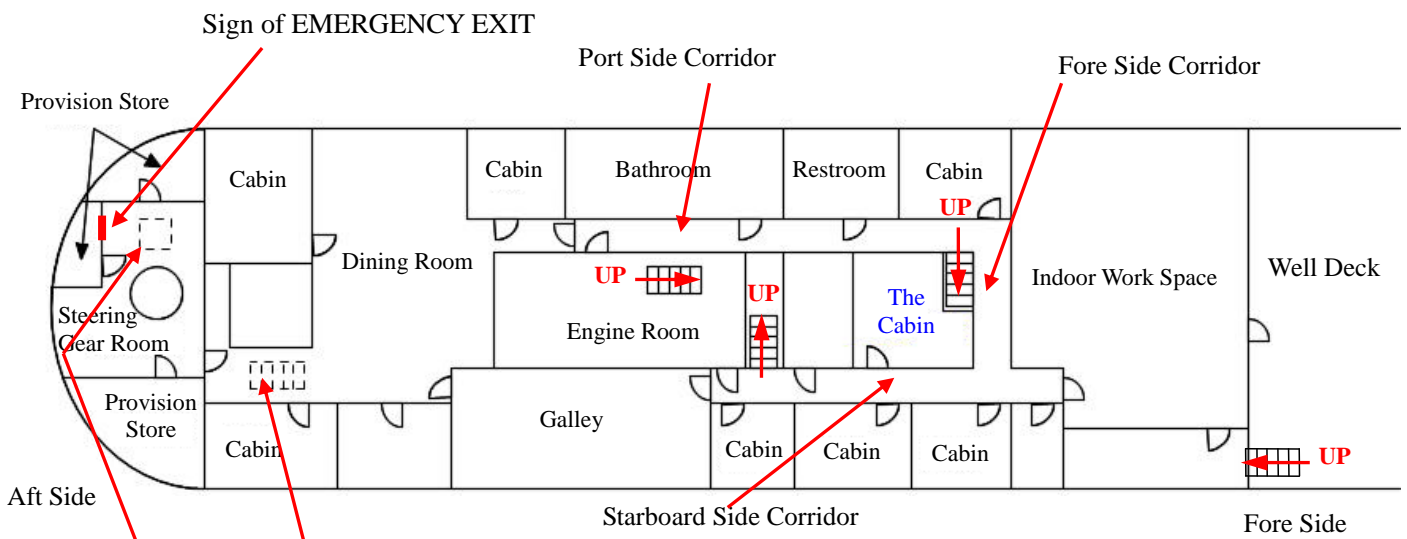
Figure 2.5-2 "Upper Deck Arrangement"

Trace of an upward stairway being removed

According to the on-site investigation, the upward stairway in the mess room had been removed; besides, the escape hatch had been welded at the time of the accident, nevertheless there was the sign of EMERGENCY EXIT on the aft sidewall in the steering gear room.

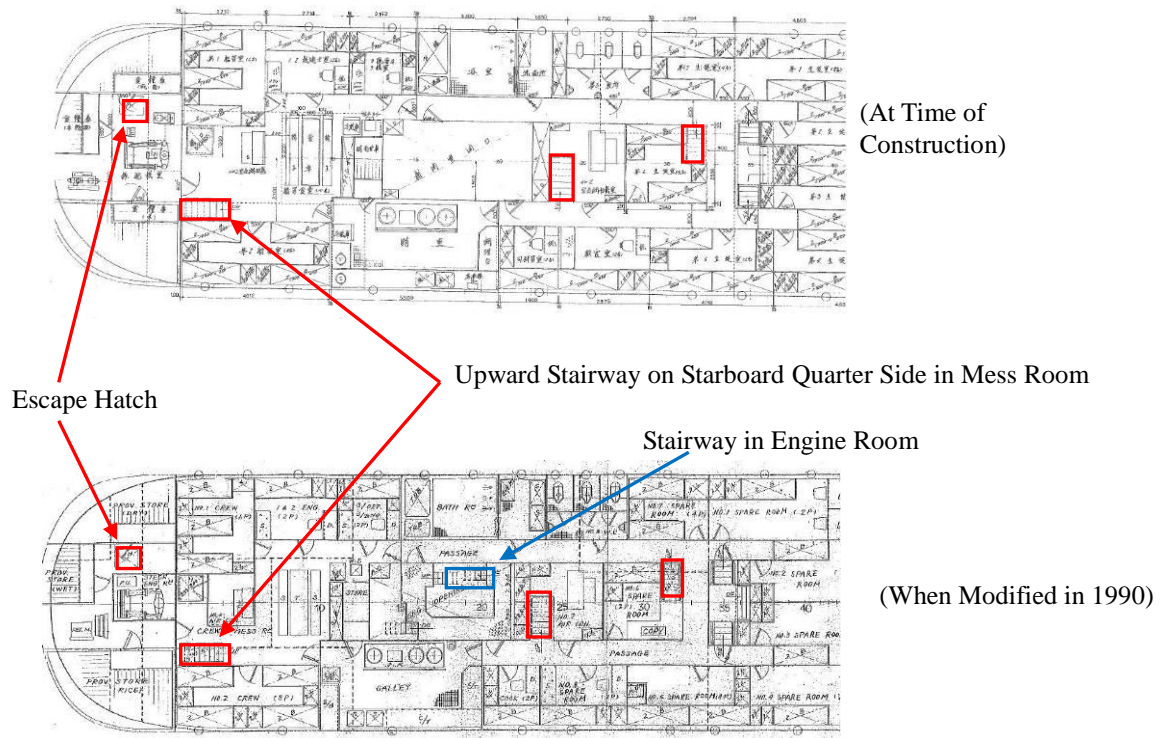
Figure 2.5-3 "General Arrangements at Time of Construction and When Modified in 1990"

- 3) According to the general arrangements at the time of construction and when modified in 1990, there was another stairway from the upper deck up to the poop deck on the starboard quarter of the mess room. In addition, there was an escape hatch on the port side in the steering gear room, which allowed one to get out directly to the quarter deck without having to pass through the corridors and stairways from fore side the upper deck engine room. (See Figure 2.5-2 and Figure 2.5-3)

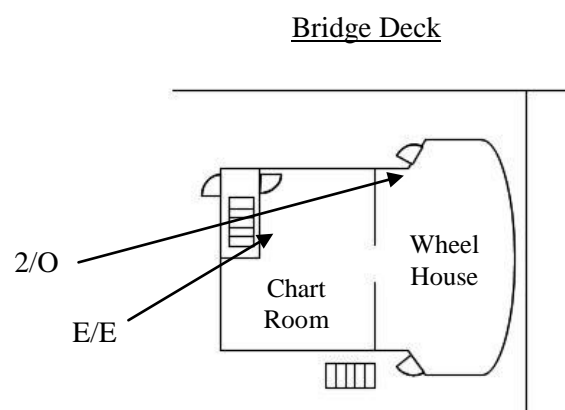
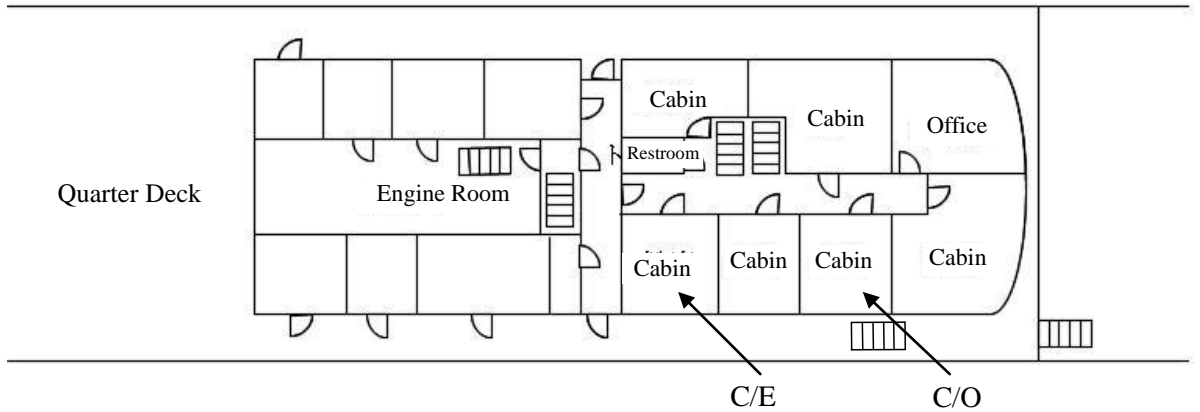
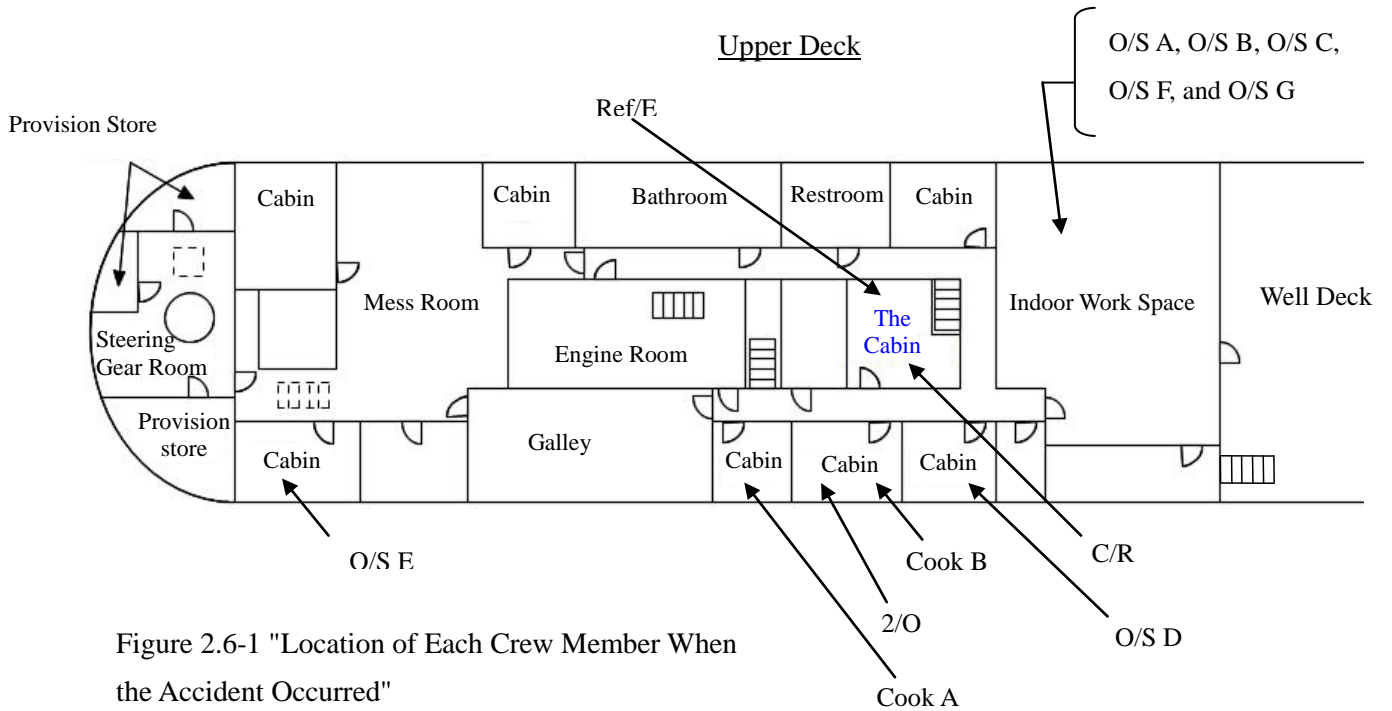
Figure 2.6-1 "Location of Each Crew Member When the Accident Occurred"

In the meantime, the C/O, the 2/O, O/S A, O/S B, and O/S F, and Cook B tried to extinguish fire with fire-fighting hoses.

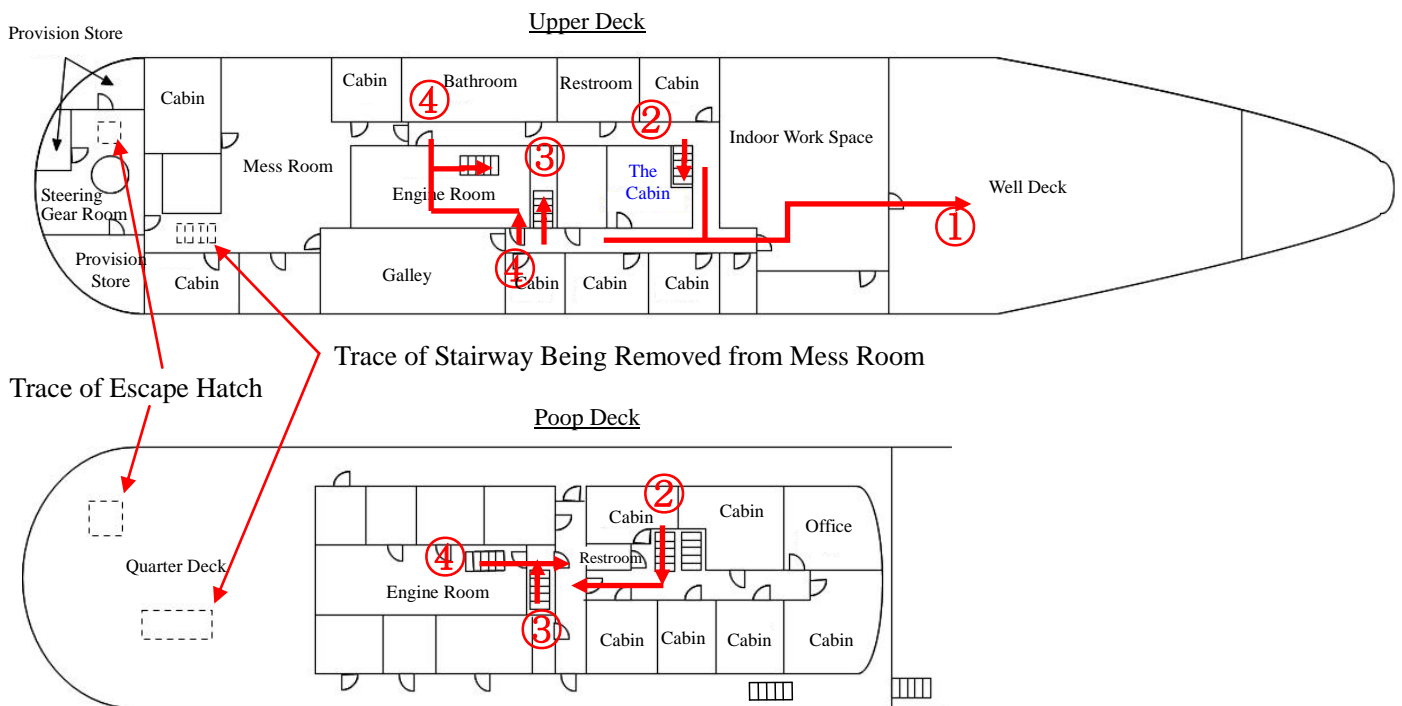
Figure 2.8-1 "Escape Routes"

- 1) A route to escape from the stairway on the aft side of the mess room to the quarter deck.
 - 2) A route to enter the steering gear room from the mess room and escape to the quarter deck through the escape hatch on the port side in the steering gear room.

Company B is recommended to try to secure escape routes regardless where a fire breaks out, for example, by having one on the fore side and another on the aft side.
