MA2015-10

**MARINE ACCIDENT
INVESTIGATION REPORT**

MARINE ACCIDENT INVESTIGATION REPORT

Vessel type and name:	Container ship, WAN HAI 162
IMO number:	9132909
Gross tonnage	13,246 tons
Vessel type and name	Fishing vessel, SEINAN MARU No.7
Fishing vessel registration number:	OS2-1480
Gross tonnage:	9.7 tons
Vessel type and name:	Fishing vessel, SEINAN MARU No.8
Fishing vessel registration number:	OS2-1730
Gross tonnage:	9.7 tons
Accident type:	Collision
Date and time:	About 5:59am, February 25, 2013
Location:	Off the west coast of Kansai International Airport Approximately 2.7 nautical miles in approximately 274° from Kansai International Airport Offing Light Beacon A, Osaka Prefecture (Approximate position: 34°25.9' North, 135°08.3' East)

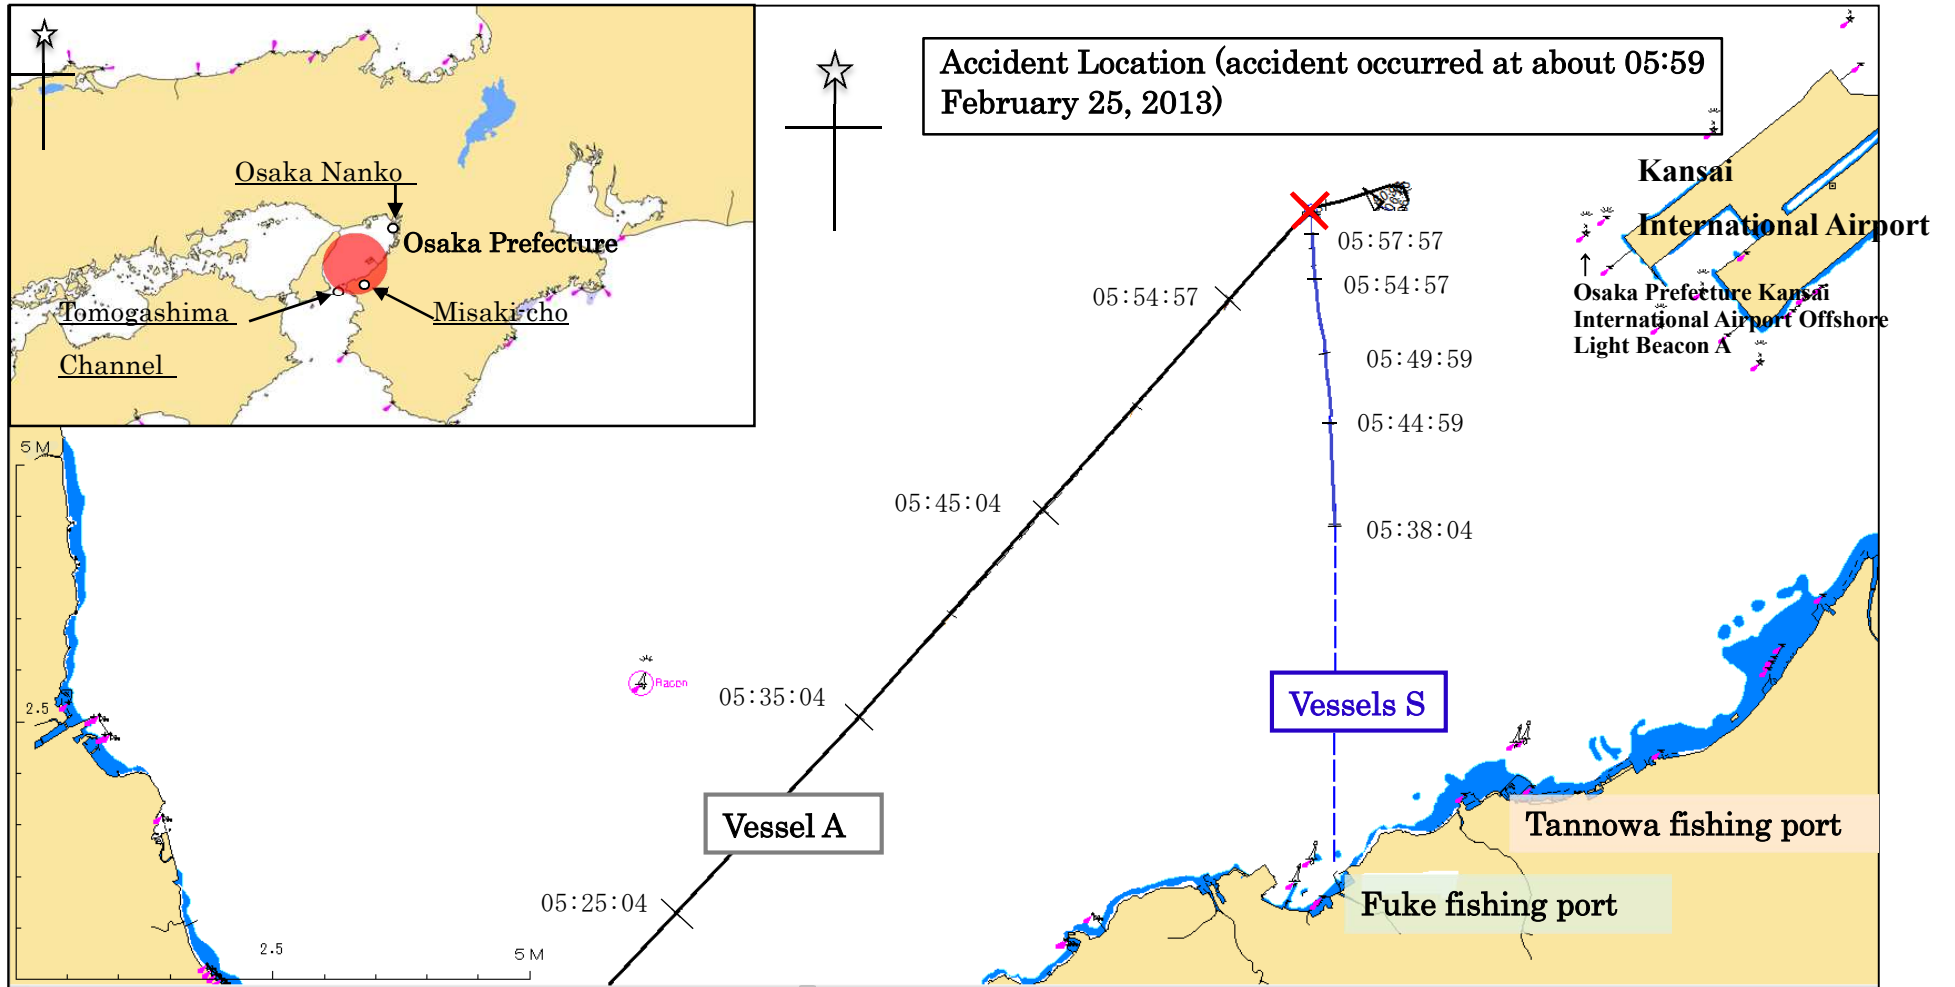
Figure 1: Estimated navigation routes (full figure)

The route sailed by Vessels S from the time they left Fuke fishing port until the accident is the route indicated on Figure 1; "Estimated navigation routes (full figure)," and is based on positions determined from radar images from the time they left the port until their arrival at the point where the accident took place.

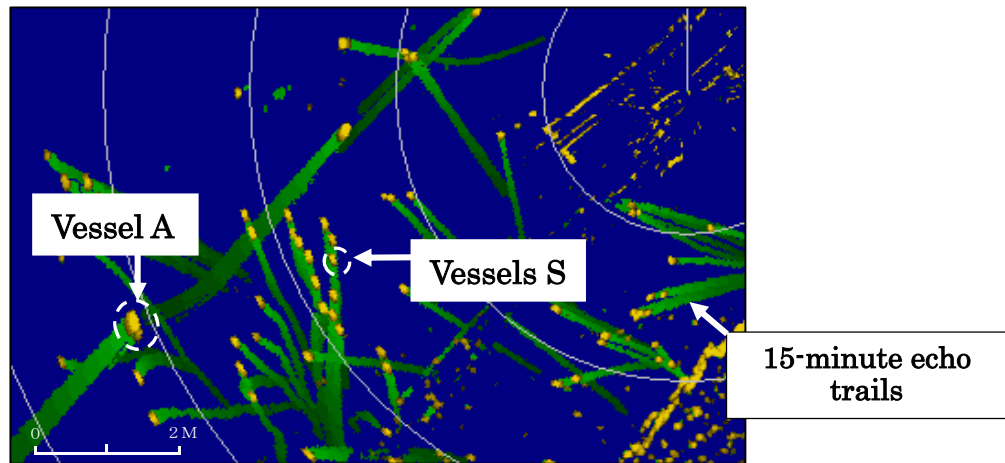
(1) About 05:45:00 (prior to the accident)

- (3) According to radar image 1, at about 05:45, there were more than 20 vessels including Vessels S, traveling in west-northwest to north bearings within a three nautical mile radius from the starboard side of Vessel A to the fore direction (see Chart 2.9).

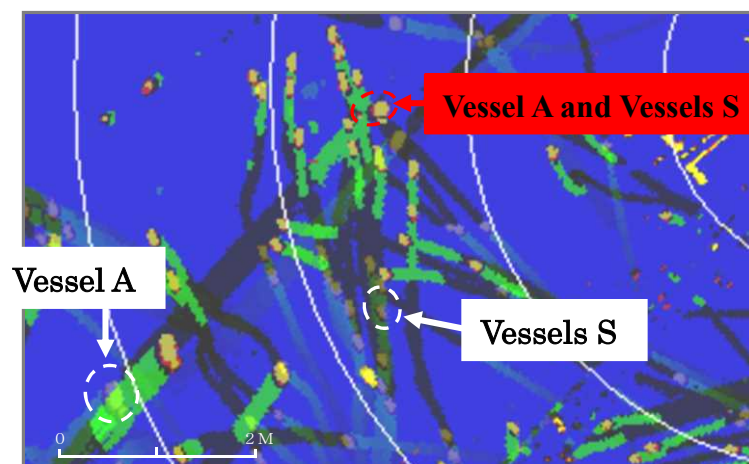
Figure 4: Superimposed radar image

(Superimposed images from about 05:45:00 and 06:00:00)
