MA2015-3

**MARINE ACCIDENT  
INVESTIGATION REPORT**

Vessel type and name: Car Carrier NOCC OCEANIC  
IMO number: 9624029  
Gross tonnage: 58,250 tons

Accident type: Collision  
Date and time: Around 09:44, June 23, 2013 (local time, UTC+9 hours)  
Location: Off the Southeast of Kinkazan, Ishinomaki City, Miyagi Prefecture  
Around 132° true bearing, 161 nautical miles from the Kinkazan Lighthouse (approximately 32°28.1'N, 144°05.4'E)

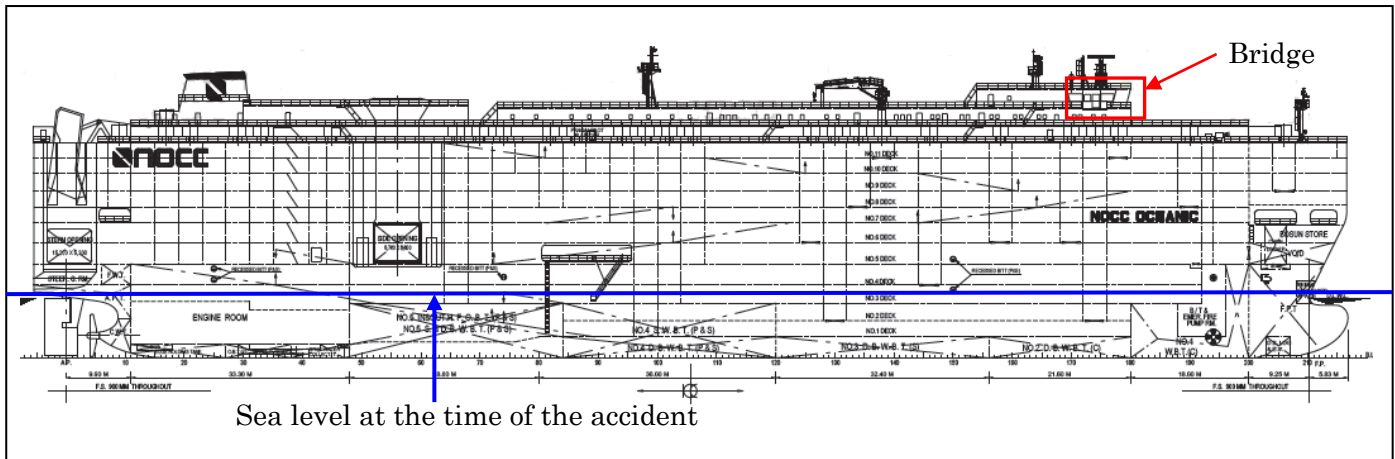
Figure 2.6-2 Vessel A General Layout Diagram

Vessel A is a car carrier that has 12 decks for carrying vehicles and a distance of approximately 33m from the front of the bridge to the front edge of the bow. At the time of the accident there were no faults or failures involving the hull, machinery, or equipment.

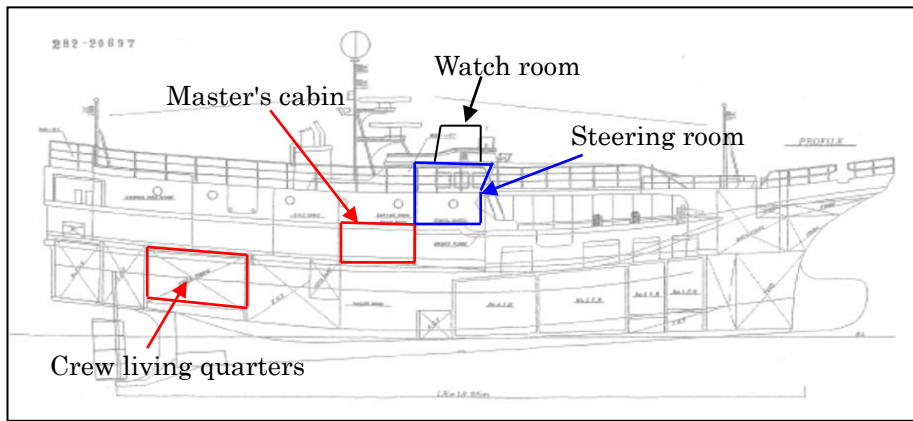
Figure 2.6-3 Vessel B General Layout Diagram

Vessel B is a tuna long-liner with a through single deck. The top deck contained in the following order from the bow to stern the boatswain's store, the steering room, the master's cabin, the upper engine room, and the dining room, while the lower deck contained in the following order from the bow to stern a void space (empty area), a fuel tank, fish holds 1 to 4, a fuel tank, the lower engine room, the crew's quarters, a fuel tank, and fish hold 5, while the life raft was installed at the port stern. At the time of the accident there were no faults or failures involving the hull, machinery, or equipment. (See Figure 2.6-3)

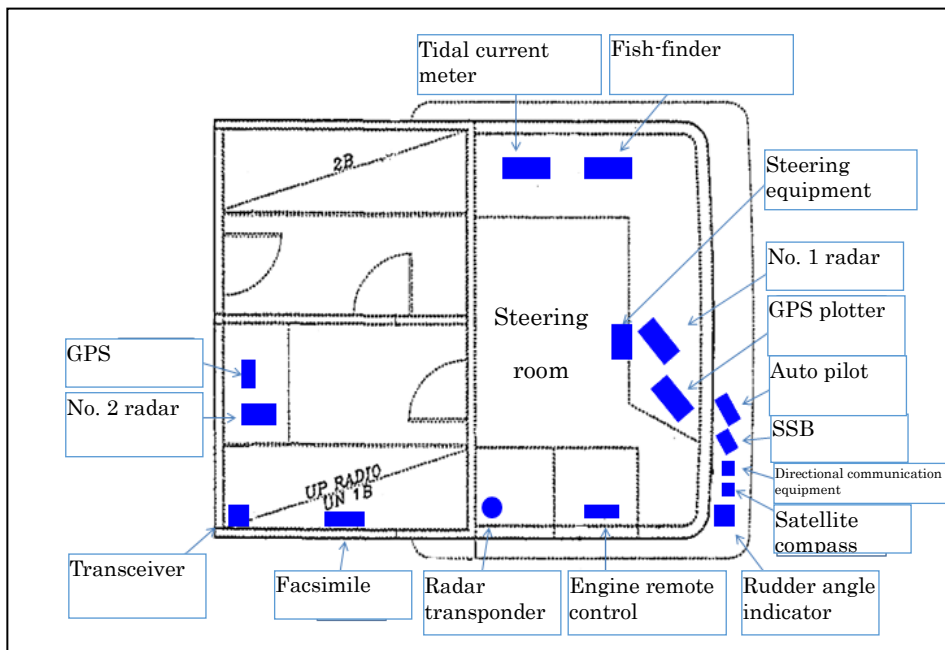
Figure 2.6-4 Vessel B Navigational Equipment

The area in front of the helm chair above the window frame was equipped in the following order from the port side to the starboard side with a rudder angle indicator, a satellite compass, a radio direction finder, radio communication equipment (SSB), and an automatic pilot, while the area in front of the helm chair was equipped with the rudder and main engine remote control, the area to the left of the helm chair was equipped with a GPS plotter, the No. 1 radar, steering equipment, a fish-finder, and a tidal current meter, and the master's cabin behind the steering room was equipped with GPS, the No. 2 radar, a facsimile machine, and a transceiver. The ship was not obligated to be equipped with AIS and did not have this equipment. (See Figure 2.6-4)

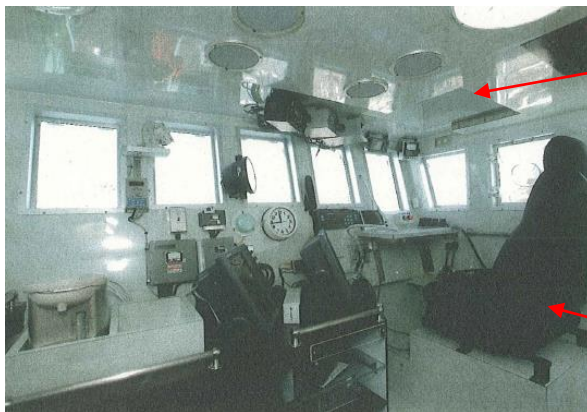
2.6-3 Near the Helm Chair in the Steering Room

In terms of visibility from the steering room there was a blind area within the range of approximately 23° to the left and 8° to the right of the bow when the sea is calm (peaceful) and if one looks forward in a seat position in the helm chair on the port side of the steering room. When the boat is pitching due to waves, one could see forward when the bow lowers, and when the boat was not pitching the blind area caused by

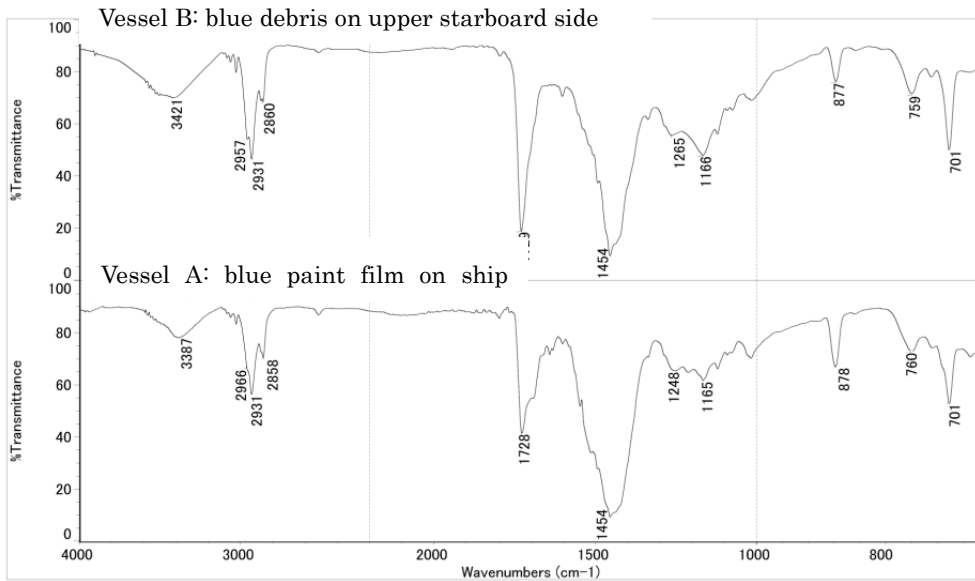
Figure 2.8-1 Identification Results for Comparison Sample 1

*A comparison of the IT spectrum of blue paint film on the ship body of Vessel A and blue debris on the upper starboard side of Vessel B and the IR spectrum of red paint film on the lower starboard side of Vessel B and red debris on the bow of Vessel A indicated that there was a positive match for the infrared absorption wavenumber domain and spectrum form for each of the above. (See Photo 2.8-1, Figure 2.8-1, and Figure 2.8-2)*

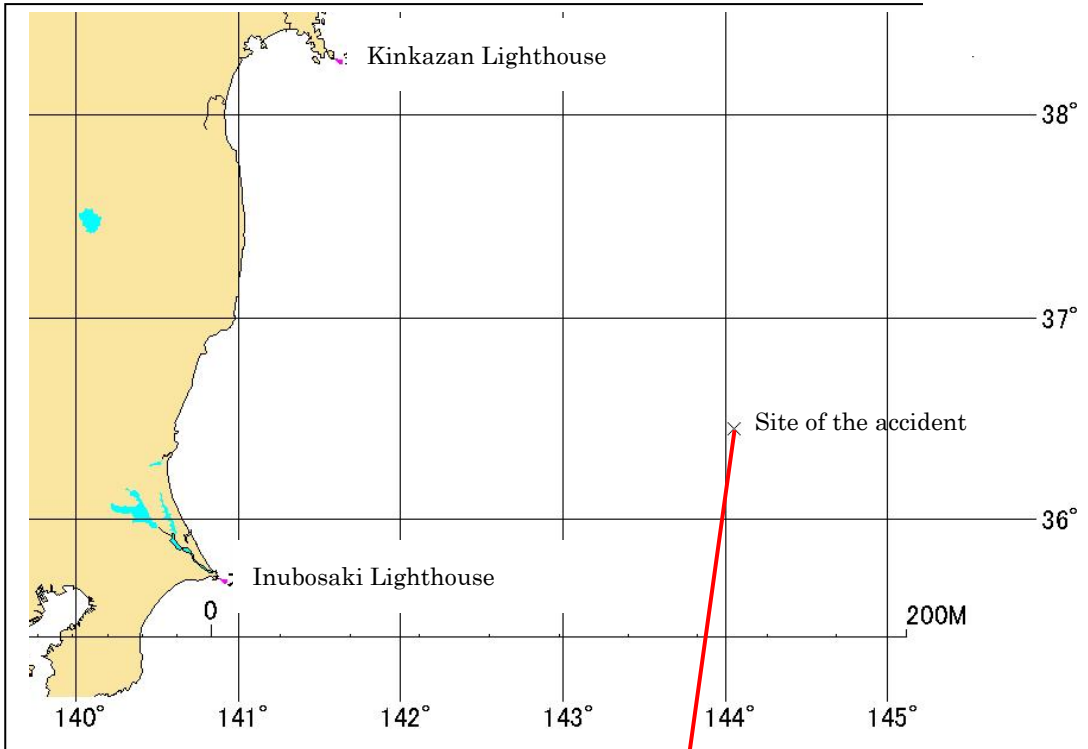
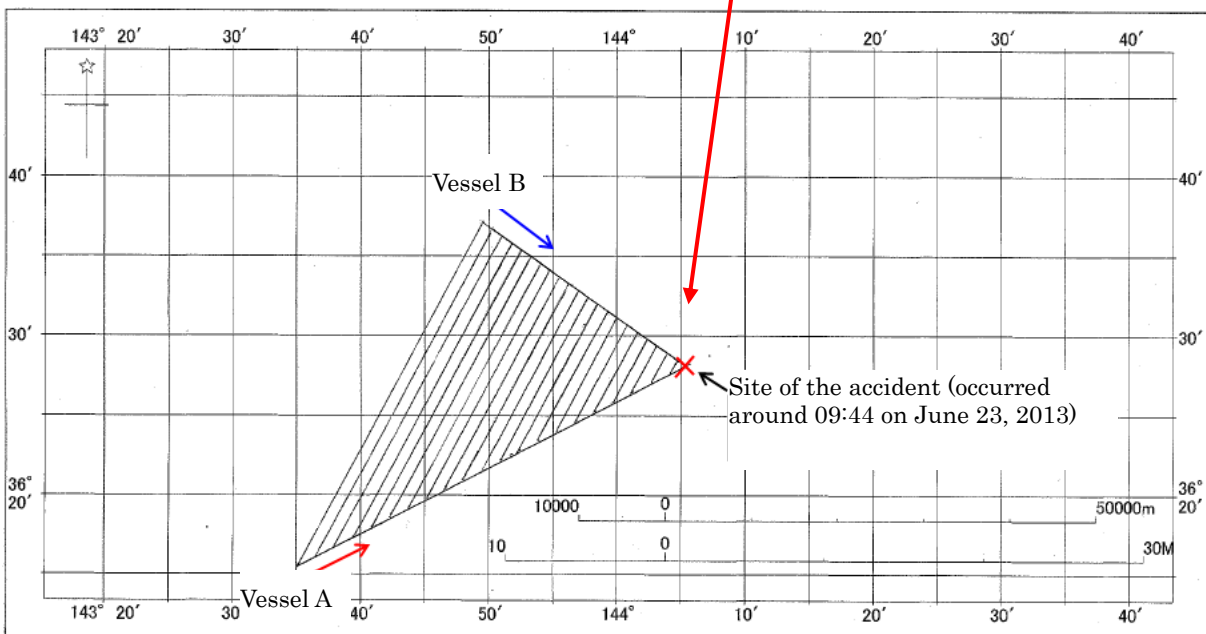
# Figure 1 Estimated Vessel Tracks

- (1) According to Figure 1, if one connects the positions of both ships with straight lines over five minute intervals from 08:00:12 to identify how each vessel saw the other vessel at each time interval, the direction of Vessel B as seen from Vessel A was approximately  $028^{\circ}$  (approximately  $35^{\circ}$  on the port bow of Vessel A) and the direction of Vessel A as seen from Vessel B was approximately  $208^{\circ}$  (approximately  $83^{\circ}$  on the starboard bow of Vessel B).

The figure below shows straight lines to connect the positions of Vessel A according to her VDR over five minute intervals from 08:00:12 and the estimated positions of Vessel B during the same period.

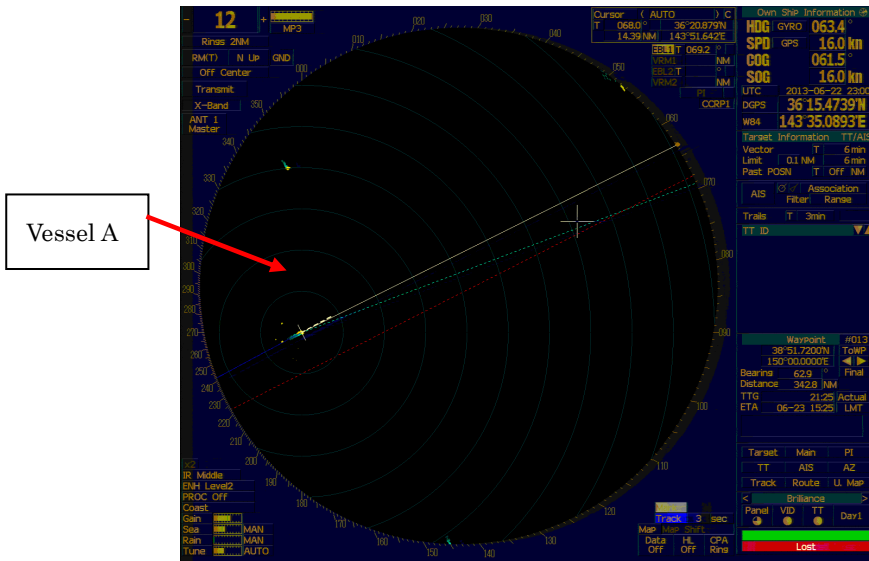
(1) Radar Image for 08:00 on June 23

When Third Officer A took over bridge duty from chief officer, there were no rain clouds ahead of Vessel A.

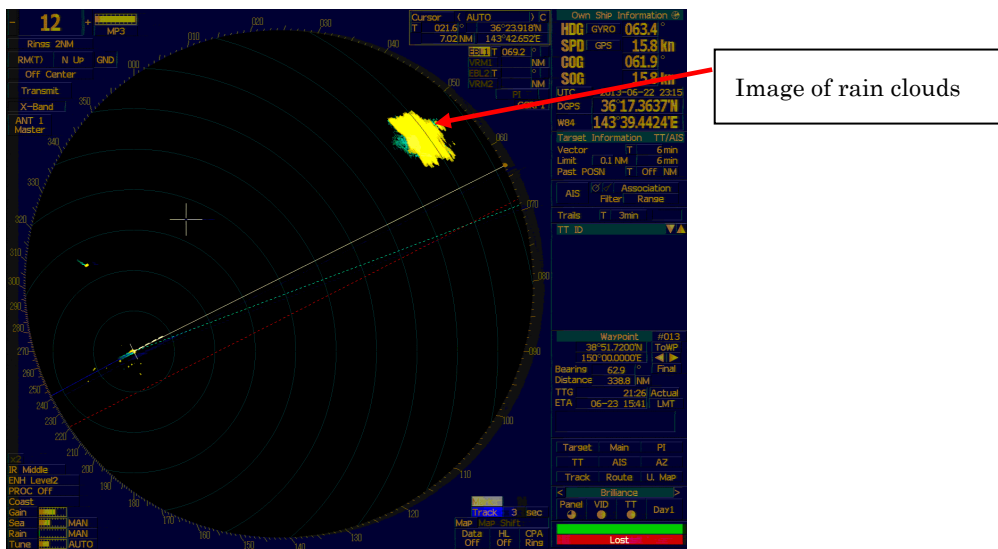
(2) Radar Image for 08:15 on June 23

Rain clouds occurred approximately 17M ahead of the port side of Vessel A. Third Officer A began sole lookout duty at around this time.

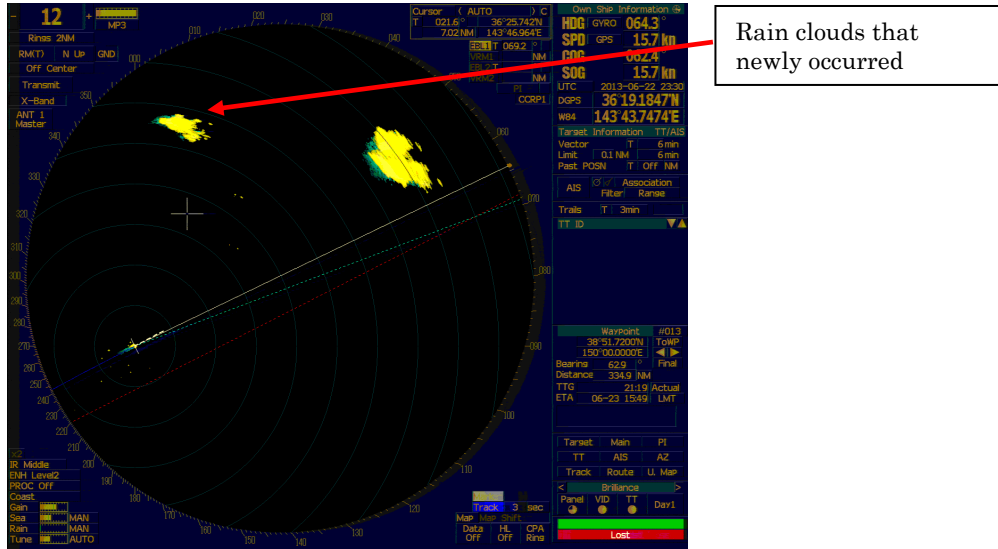
(3) Radar Image for 08:30 on June 23

Rain clouds that newly occurred

Rain clouds newly occurred approximately 50° to the port side of Vessel A.

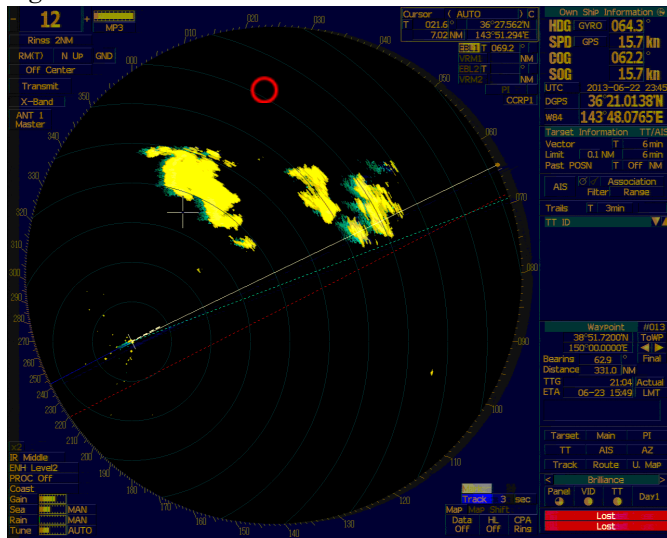
(4) Radar Image for 08:45 on June 23

Two rain clouds approached the front of Vessel A while developing. Vessel B is not displayed in the image.

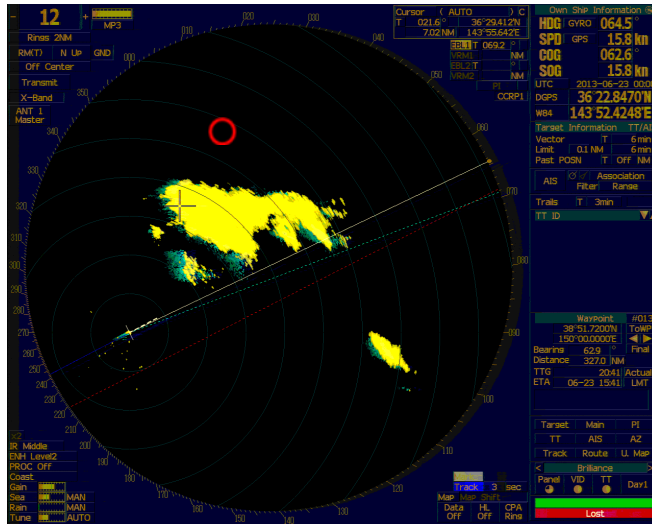
(5) Radar Image for 09:00 on June 23

The two rain clouds to the front of Vessel A came together and approached the vessel. Vessel B is not displayed in the image.

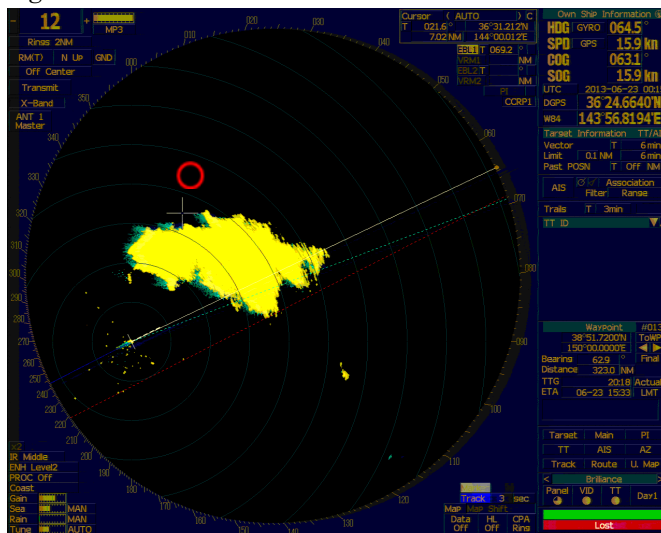
(6) Radar Image for 09:15 on June 23

The rain cloud approached while developing. Third Officer A recognized that a thick rain cloud was approaching ahead of the port side. Vessel B is not displayed in the image.

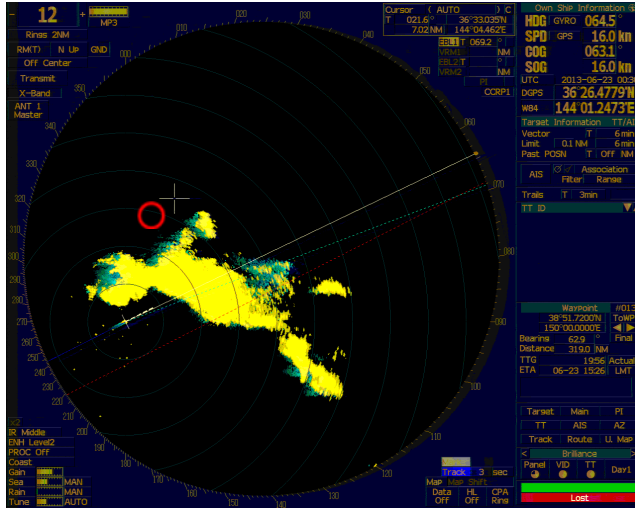
(7) Radar Image for 09:30 on June 23

The rain cloud approached while developing. Third Officer A recognized that a thick rain cloud was approaching ahead of the port side. Vessel B is not displayed in the image.

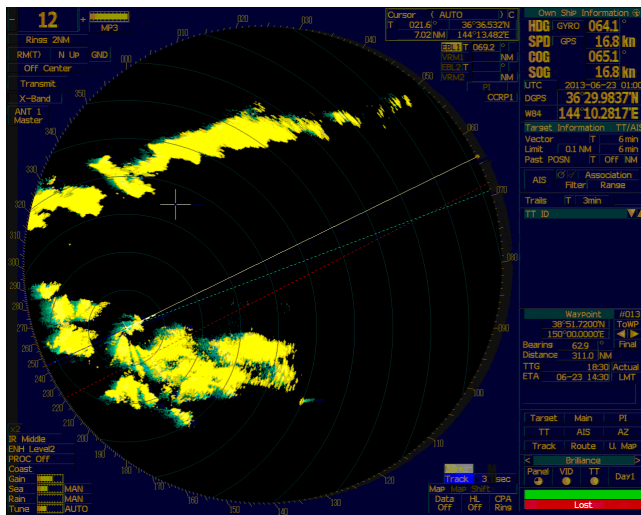
(10) Radar Image for 10:00 on June 23

Vessel A moved out of the rain cloud as 10:00.
