**MARINE ACCIDENT  
INVESTIGATION REPORT**

Vessel type and name: Cargo ship, FUKUKAWA

Vessel type and name: Fishing vessel, TSUNOMINE MARU

Accident type: Collision

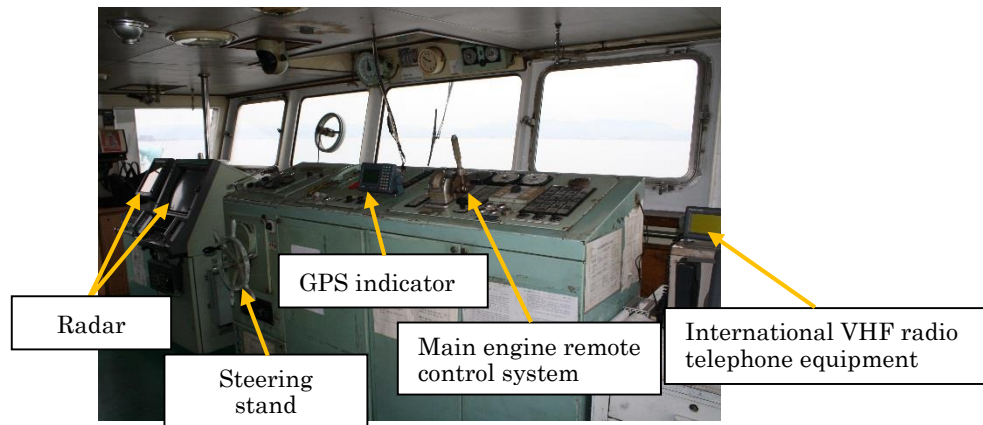
Photo 2.5 -2 Photograph of the ship bridge

On the bridge front, in the order from the port side, two radars, the steering stand, GPS indicator, main engine remote control system, and international VHF radio telephone equipment and the like were installed.

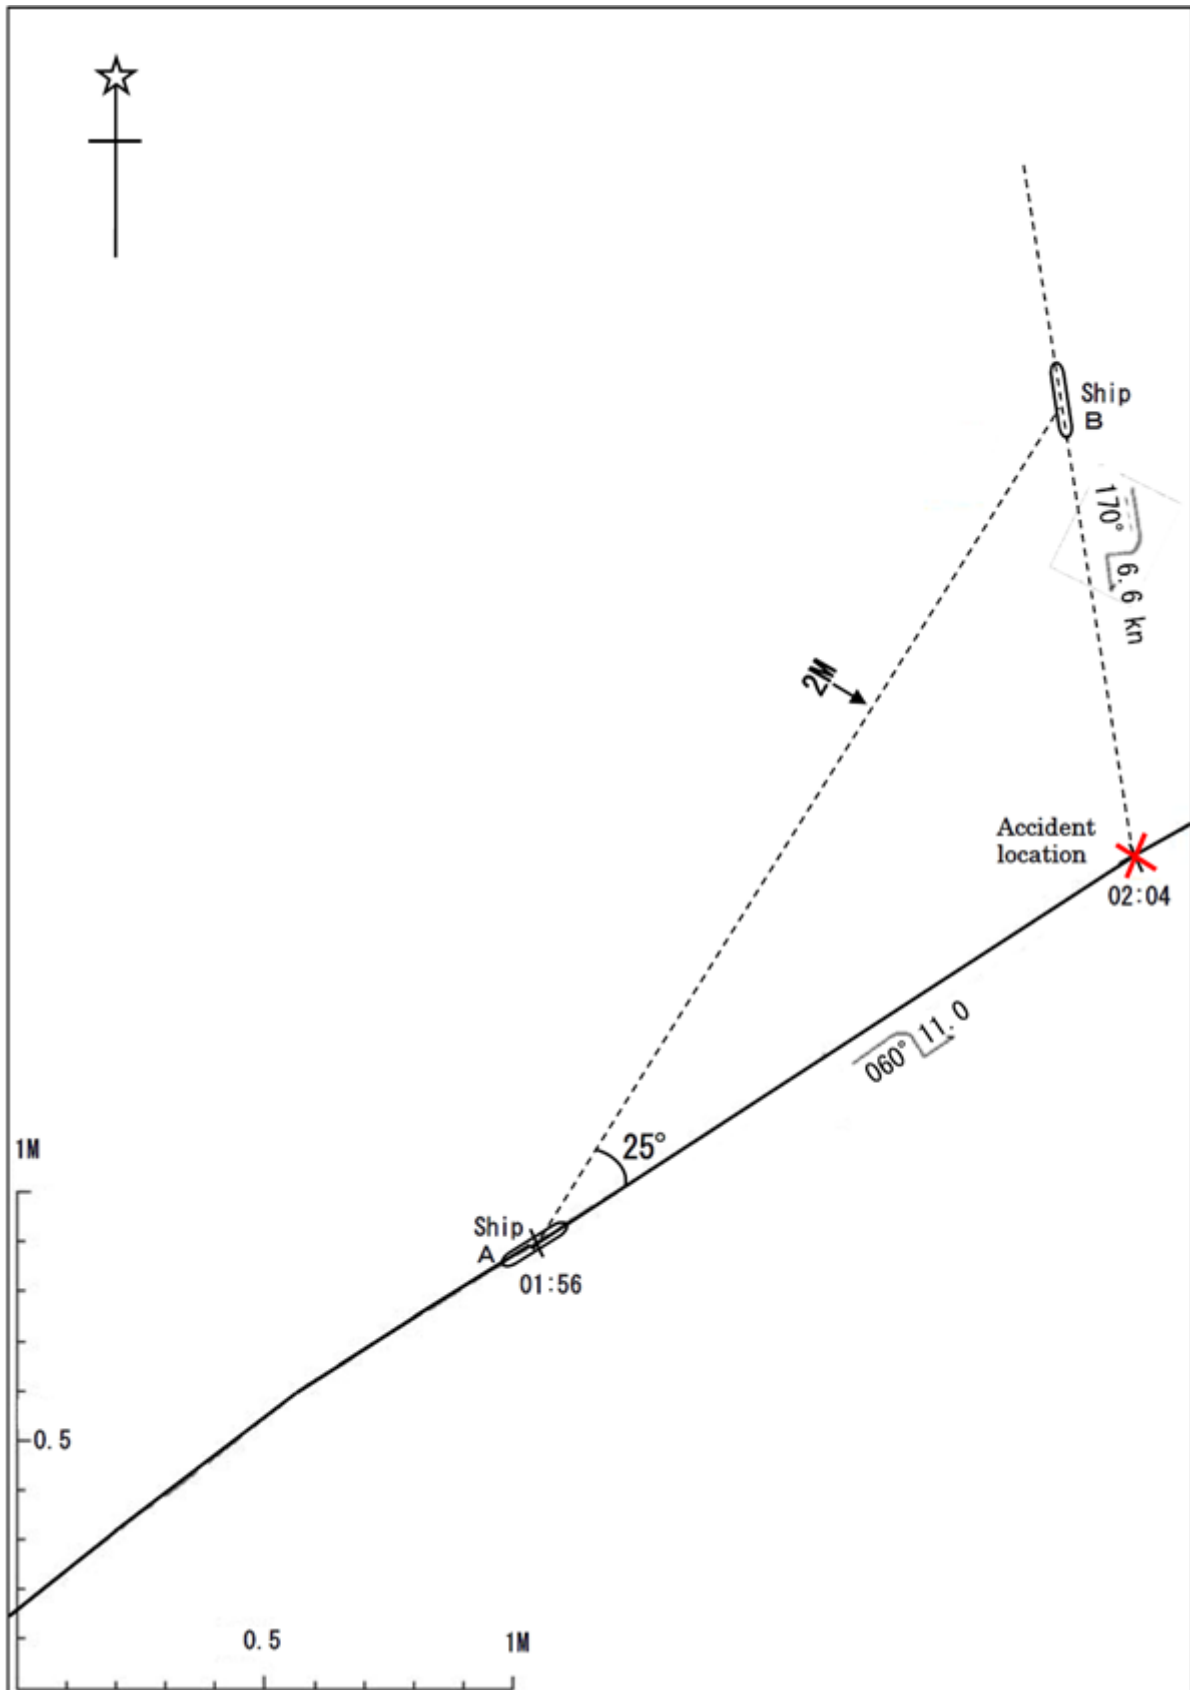
Figure 4 Position relationship diagram of the both ships until the collision

According to 2.3 and 2.10, it is probable that the port bow of Ship A and the bow section of Ship B collided, Ship A caused scratches on the port bow and port center, Ship B resulted in damage to the bow section.
