**MARINE ACCIDENT  
INVESTIGATION REPORT**

Vessel type and name: Cargo Ship "CITY"

Accident type: Grounding

Date and time: Around 05:09 on January 10, 2016 (local time, UTC + 9 hours)

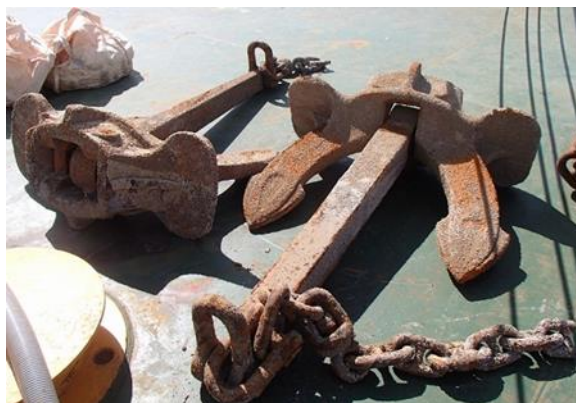
Photo 2.5 -2 Anchor and chain cable

The anchor is of Hall's type (JIS type) the weigh about 3,000 kg, and each board is provided with one. The chain cable has a diameter of about 50 mm, the one shackle is about 25 m, and each board is provided with 10 shackles. (See Photo 2.5 – 2.)
