**MARINE ACCIDENT
INVESTIGATION REPORT**

Vessel type and name: Cargo ship SWIFTNES

Vessel type and name: Work boat Fuji Maru

Accident type: Capsize

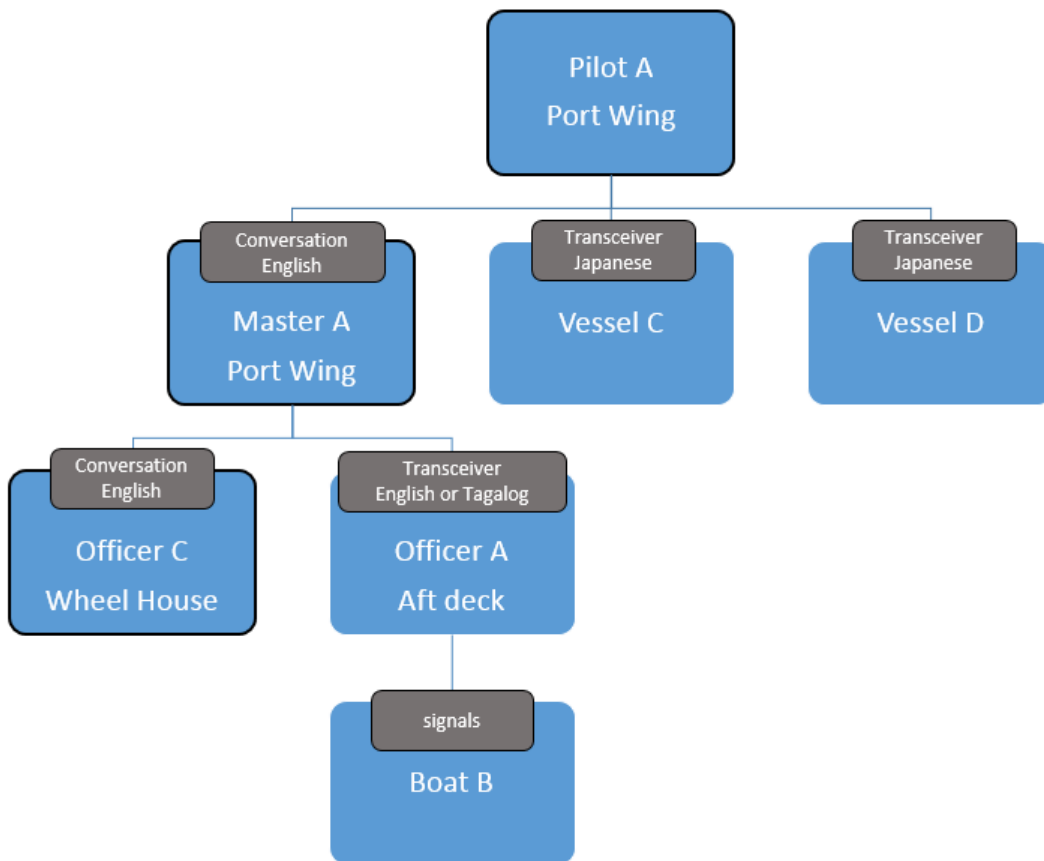
Figure 4 State of Communications

- ④ No reason were found for the discrepancy the oral statement from Officer A, that Officer A observed Workman B showing four fingers and waving his arm up and down at the foredeck of Boat B positioning on the starboard stern side of Vessel A, thought that Workman B send a signal to veer four stern lines, and the oral statement from Workman B Officer A, that After sending a signal to veer mooring lines for Officer A with waving his arm up and down, Officer A veered the four stern lines from the fairlead on the stern of Vessel A.
