# MARINE ACCIDENT INVESTIGATION REPORT

October 3, 2017

| <b>Accident type</b> | Grounding |
| <b>Summary of the Accident</b> | An oil tanker, SAGAN, with 18 crews, including the master, became unable to start and drifted due to failures in the main engine while heading northeast off the western coast of the Noma Peninsula, Satsuma-shi, Kagoshima. She grounded on the southwest coast of the Suwanosejima Island, Toshima-mura, Kagoshima.<br>SAGAN was completely destroyed with cracks, etc. on the bottom shell, but there were no casualties. |

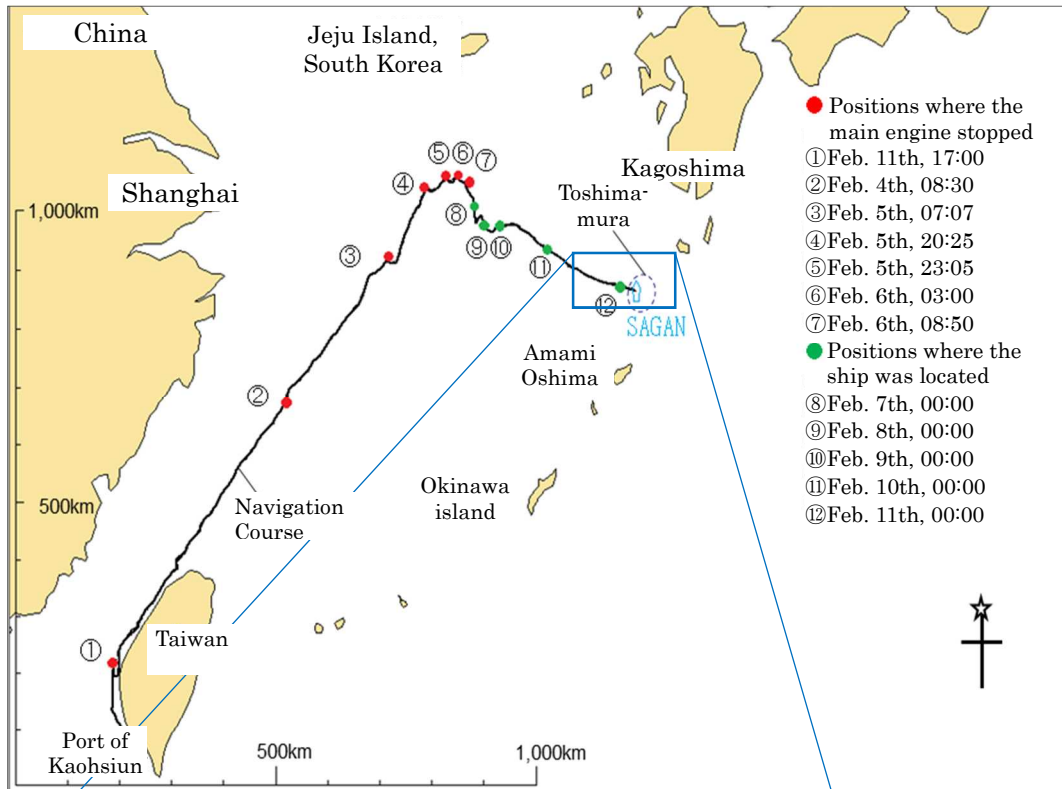
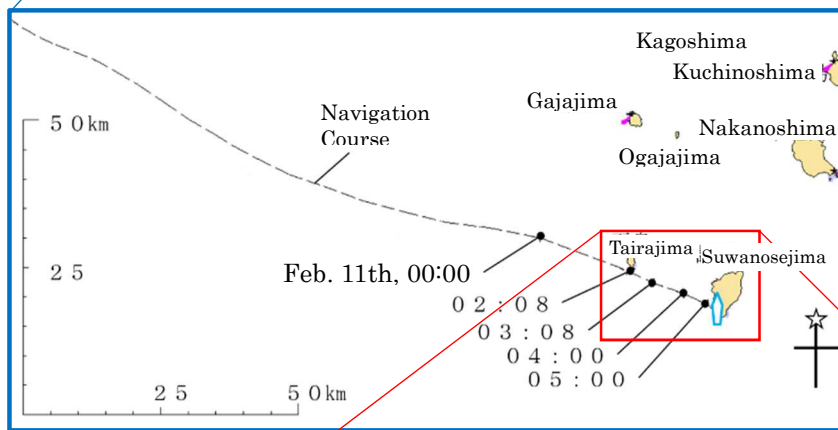
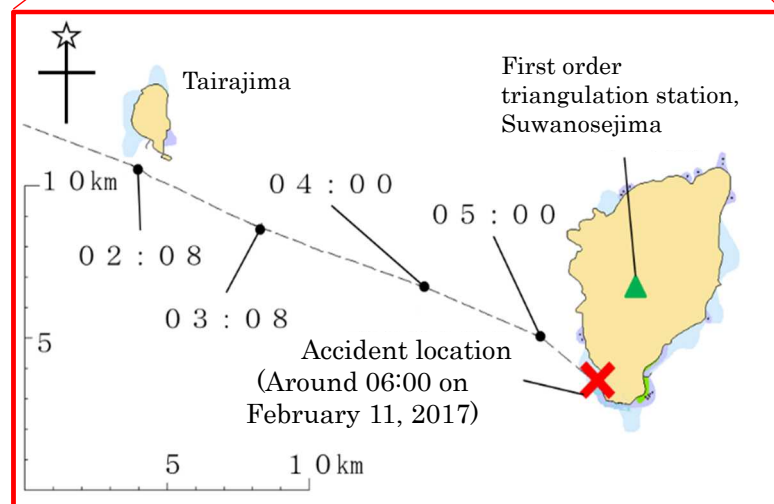
Attached Figure 1 Outline Map of Navigation Course

As the vessel continued drifting thereafter and grounded on the southwest coast of the Suwanosejima Island around 06:00. The Japan Coast Guard received a distress alert around 06:35. (see Figure 1, Figure 2, Attached Figure 1 Outline Map of Navigation Course, and Attached Table 1 GPS and AIS Records of the Vessel (Excerpt)).

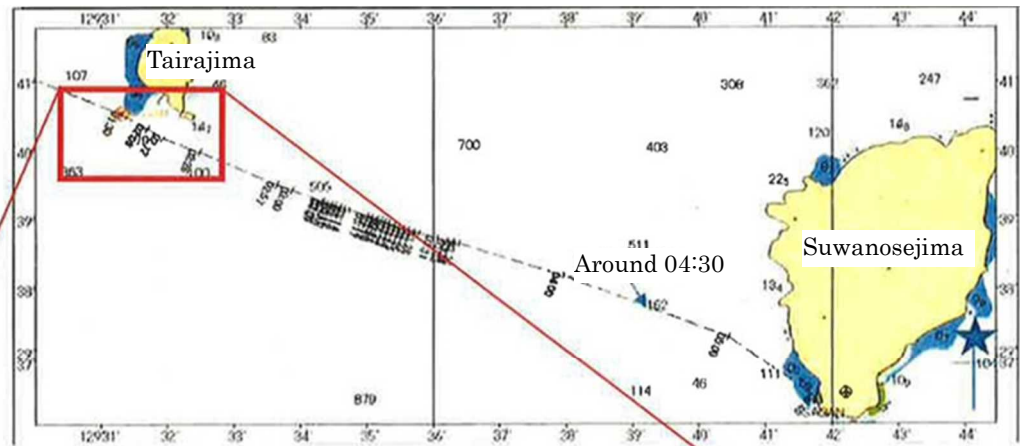
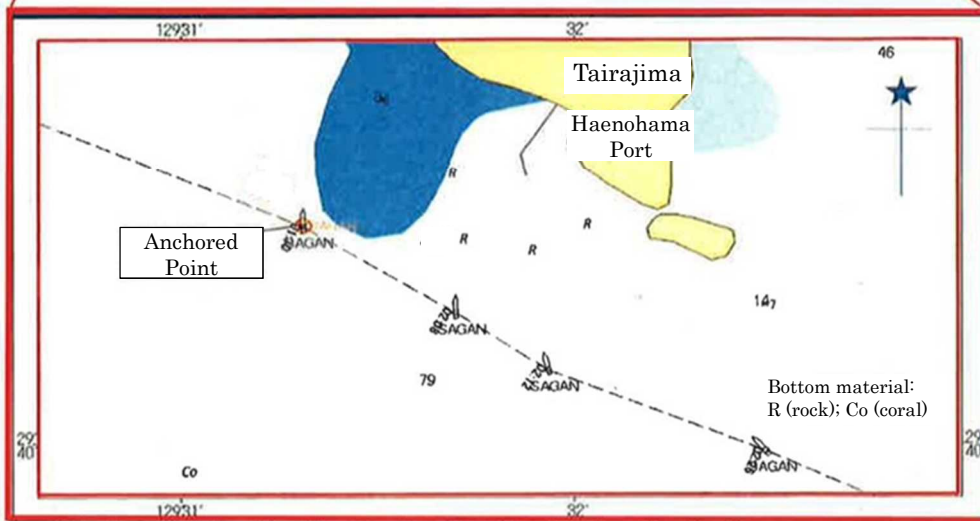
Attached Figure 2 Anchored Point

As the vessel approached the southwest coast (79-107 m deep; see Attached Figure 2 Anchored Point) of the Tairajima Island, Toshima-mura, Kagoshima around 01:30 on the 11th, the master felt the risk of grounding and let go the port anchor and veered the chain cable by seven shackles (about 193 m). However, the anchor and the chain cable were unable to hold the sea bed, and the vessel passed south of the Tairajima Island and continued drifting toward the Suwanosejima Island.
