MA2018-8

**MARINE ACCIDENT
INVESTIGATION REPORT**

Vessel type and name: Cargo ship ASIAN BEAUTY

Vessel type and name: Liquefied gas bulk carrier ZEUS

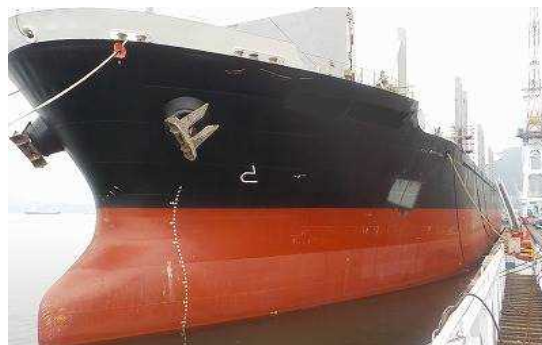
Photo 2

- (1) Vessel A suffered a dent on the portside shell plating on her bow, and the stanchion was broken. (See Photo 2)

- (1) Vessel A's portside front collided with Vessel B's starboardside bow. Vessel A suffered a dent on her portside front shell plating and broken portside front stanchion.
- (2) Vessel B suffered dents on its starboardside bow and starboardside center shell plating, and the starboardside bridge was destroyed.

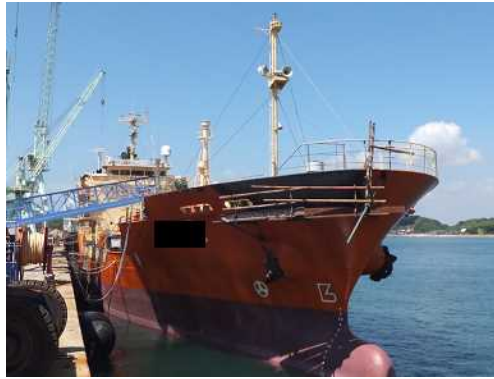
Photo 3

- (2) Vessel B suffered dents on her starboardside of the bow and starboardside center shell plating, and the starboardside bridge was crushed. (See Figure. 3)
